Western Iowa Missouri River Flooding— Geo-Infrastructure Damage Assessment, Repair, and Mitigation Strategies

SEPTEMBER 2013

Final Report

Federal Highway Administration
Iowa Highway Research Board
(IHRB Project TR-638)
Iowa Department of Transportation
(InTrans Project 11-419)

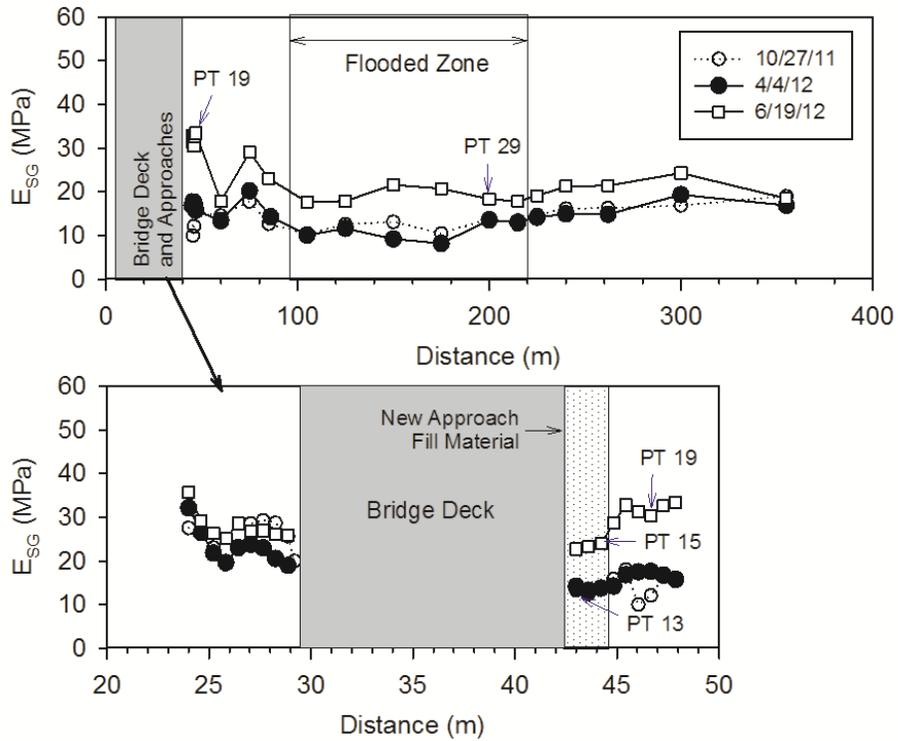
Figure 137. Subgrade modulus measurements at three different times after flooding on TS1 – Fremont County

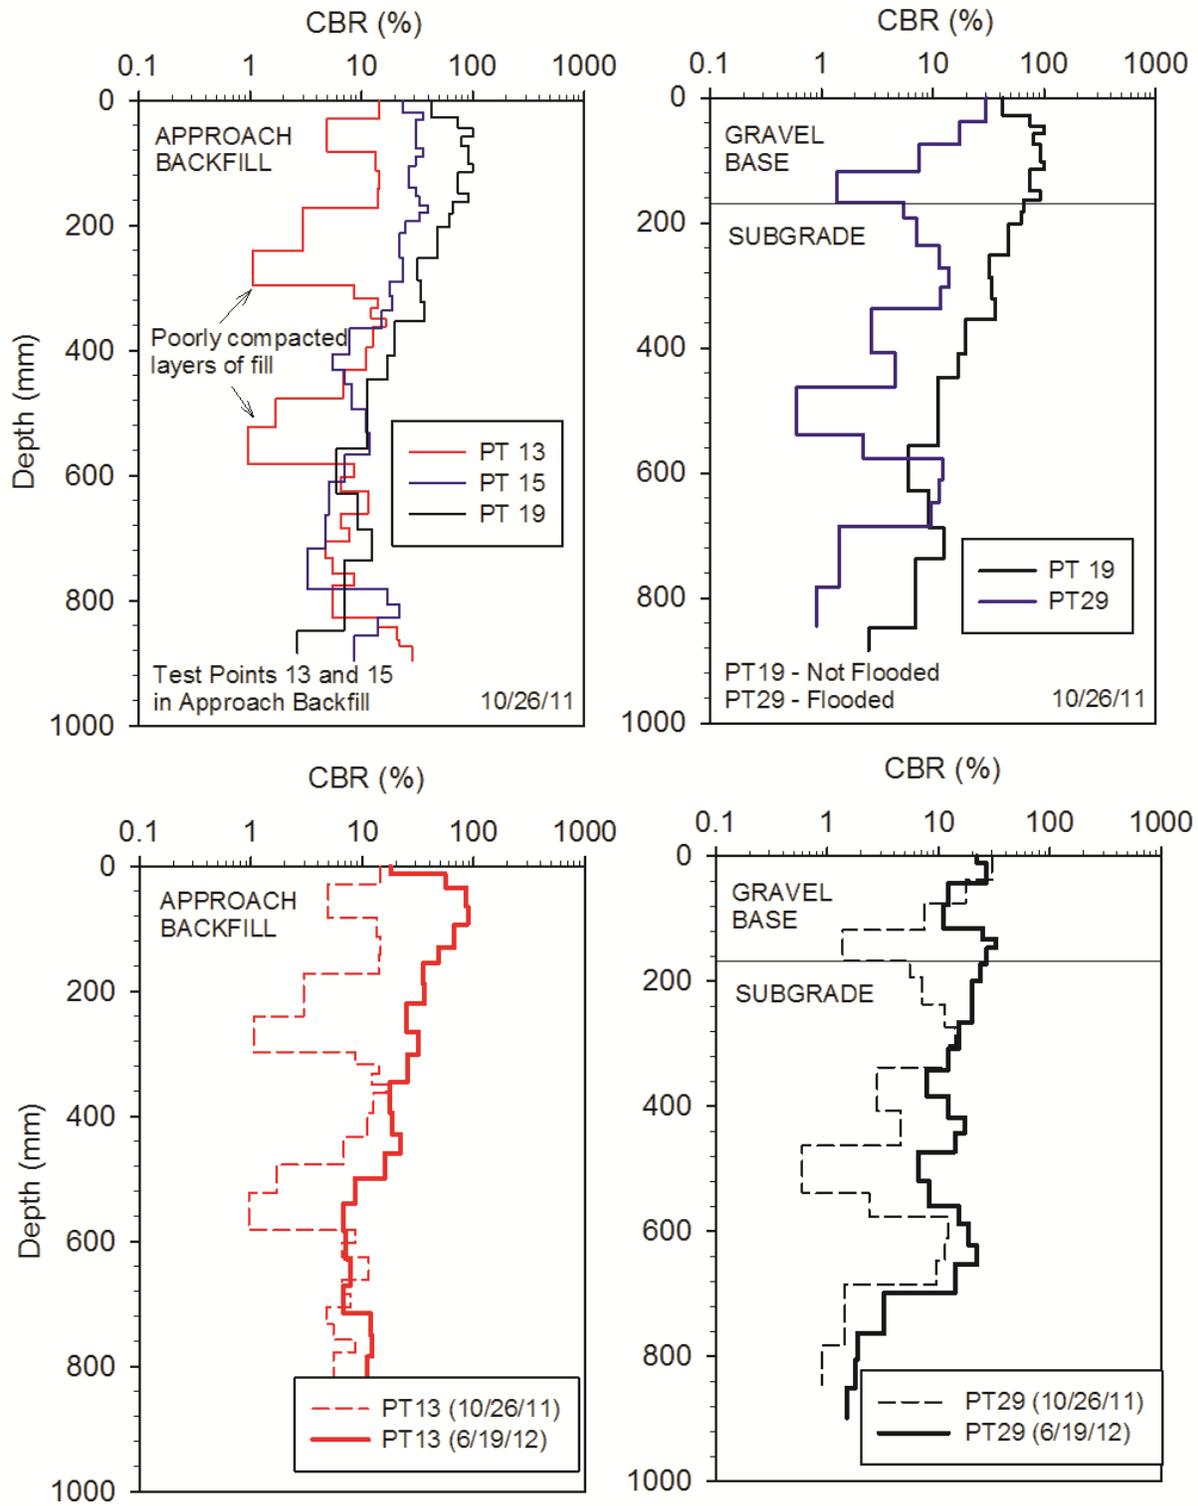
- DCP-CBR profiles (see PT13 on 10/26/11 in Figure 138) indicated that the approach backfill material close to the bridge approach (about 0.6 m away from the abutment) consisted of poorly compacted layers of fill with depth (with $CBR < 2$), which is typically a result of thicker lifts placed during compaction.

Figure 138. DCP-CBR profiles from two different testing times at five test locations on TS1 – Fremont County

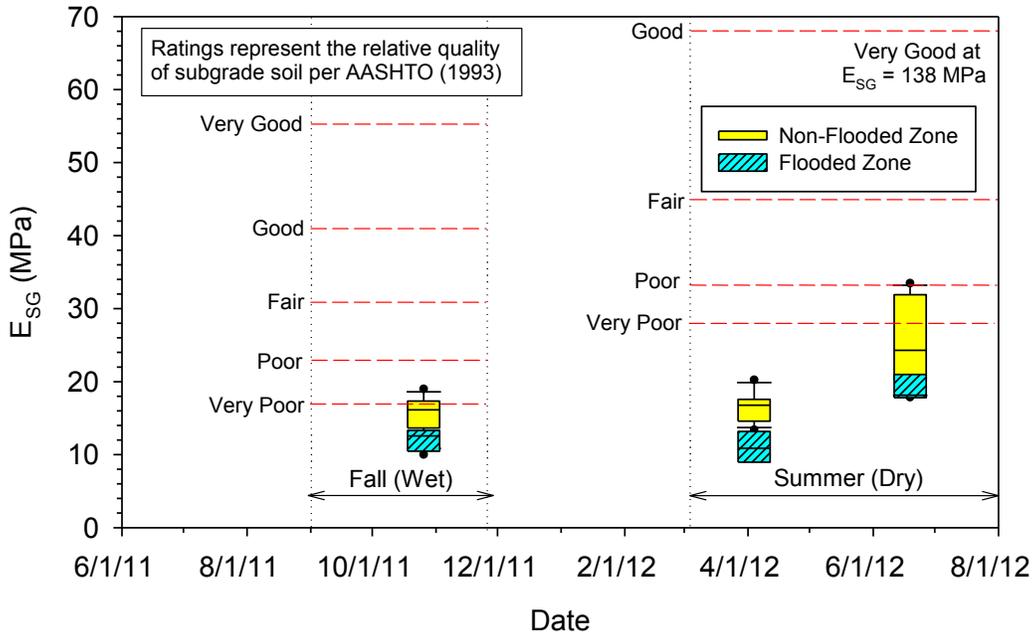
Figure 139. Box plots of subgrade modulus values in flooded and non-flooded zones in comparison with relative quality ratings on TS1 – Fremont County

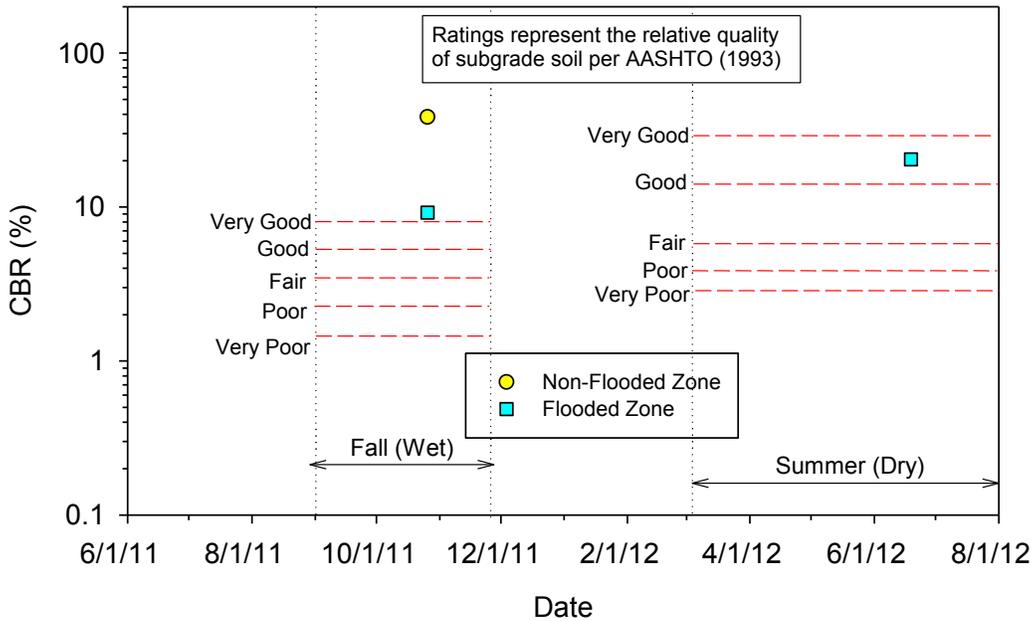
Figure 140. Comparison of subgrade CBR values in flooded and non-flooded zones with relative quality ratings on TS1 – Fremont County

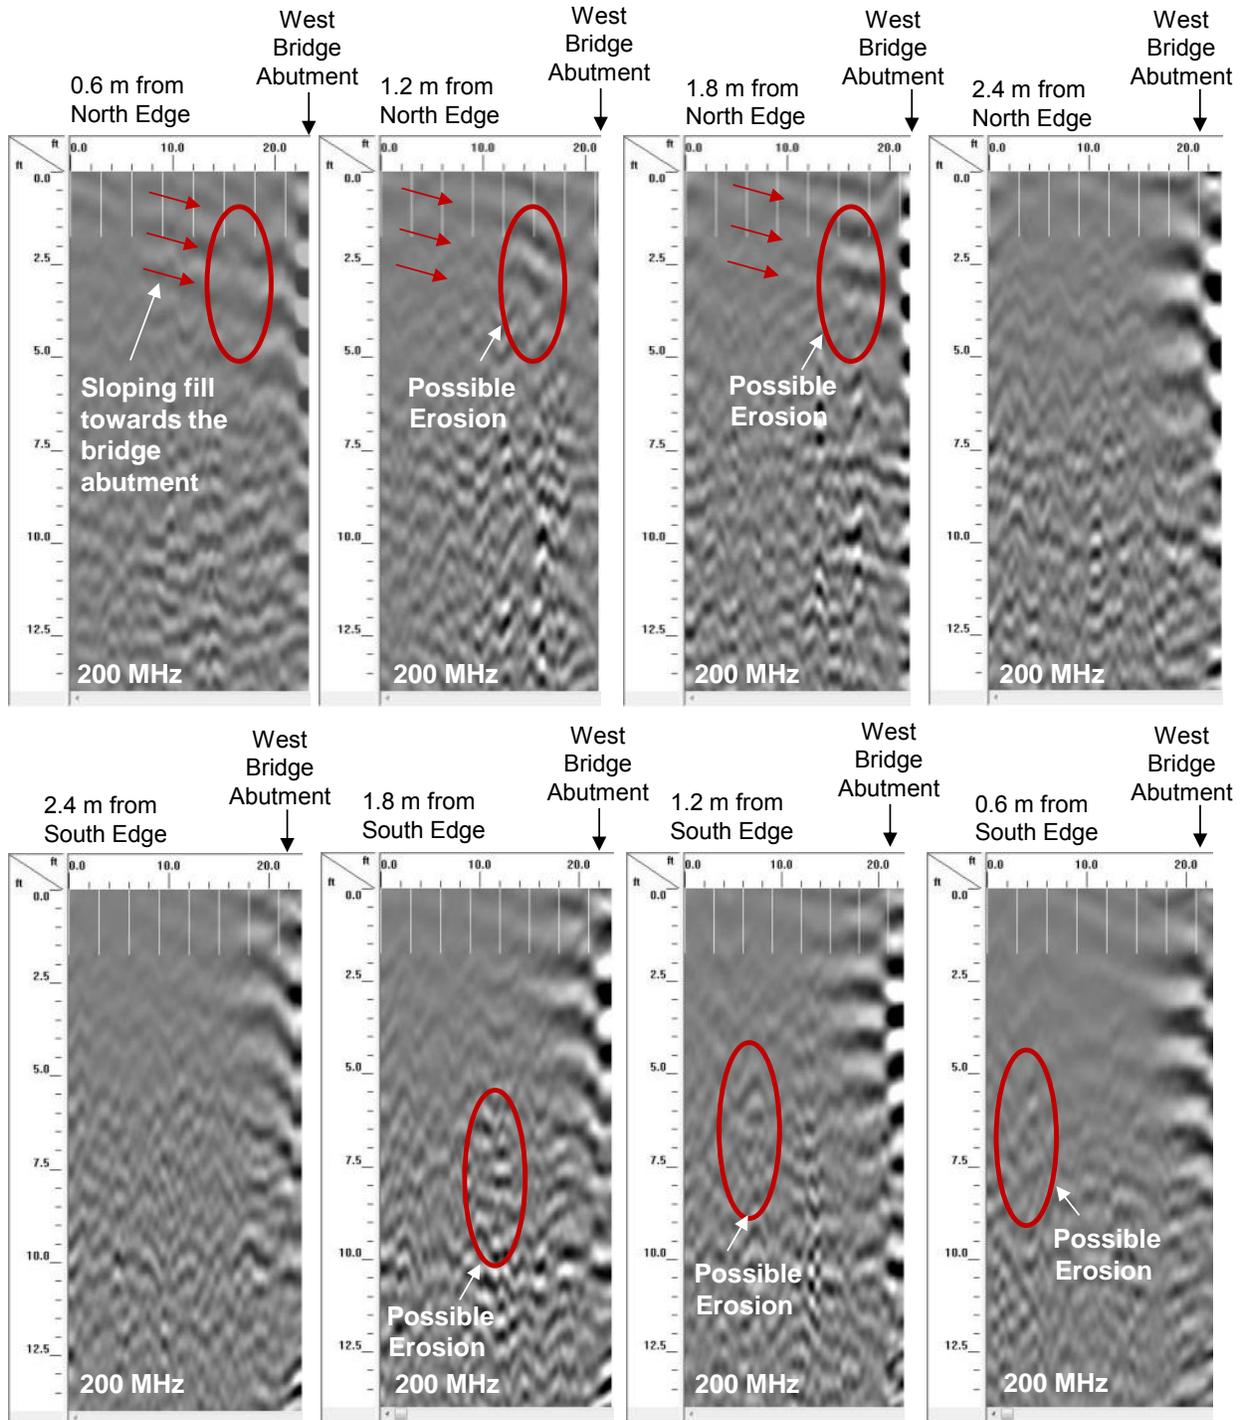
- Backfill material layers sloped towards the bridge abutment are detected in the scans. This sloping is more apparent in scans closer to the edges (within 1m of the edge) than in scans that are close to the center.
- Areas with potential voids/backfill erosion are detected at about 0.76 m to 2.4 m beneath the surface.

Figure 141. GPR scans using 200 MHz antenna on TS1 longitudinally along the west bridge approach backfill at 0.6 to 2.4 m away from the north and south edges of the bridge (note: 0 ft mark on the horizontal scale represents about 6.7 m (22 ft) away from the west abutment) – Fremont County

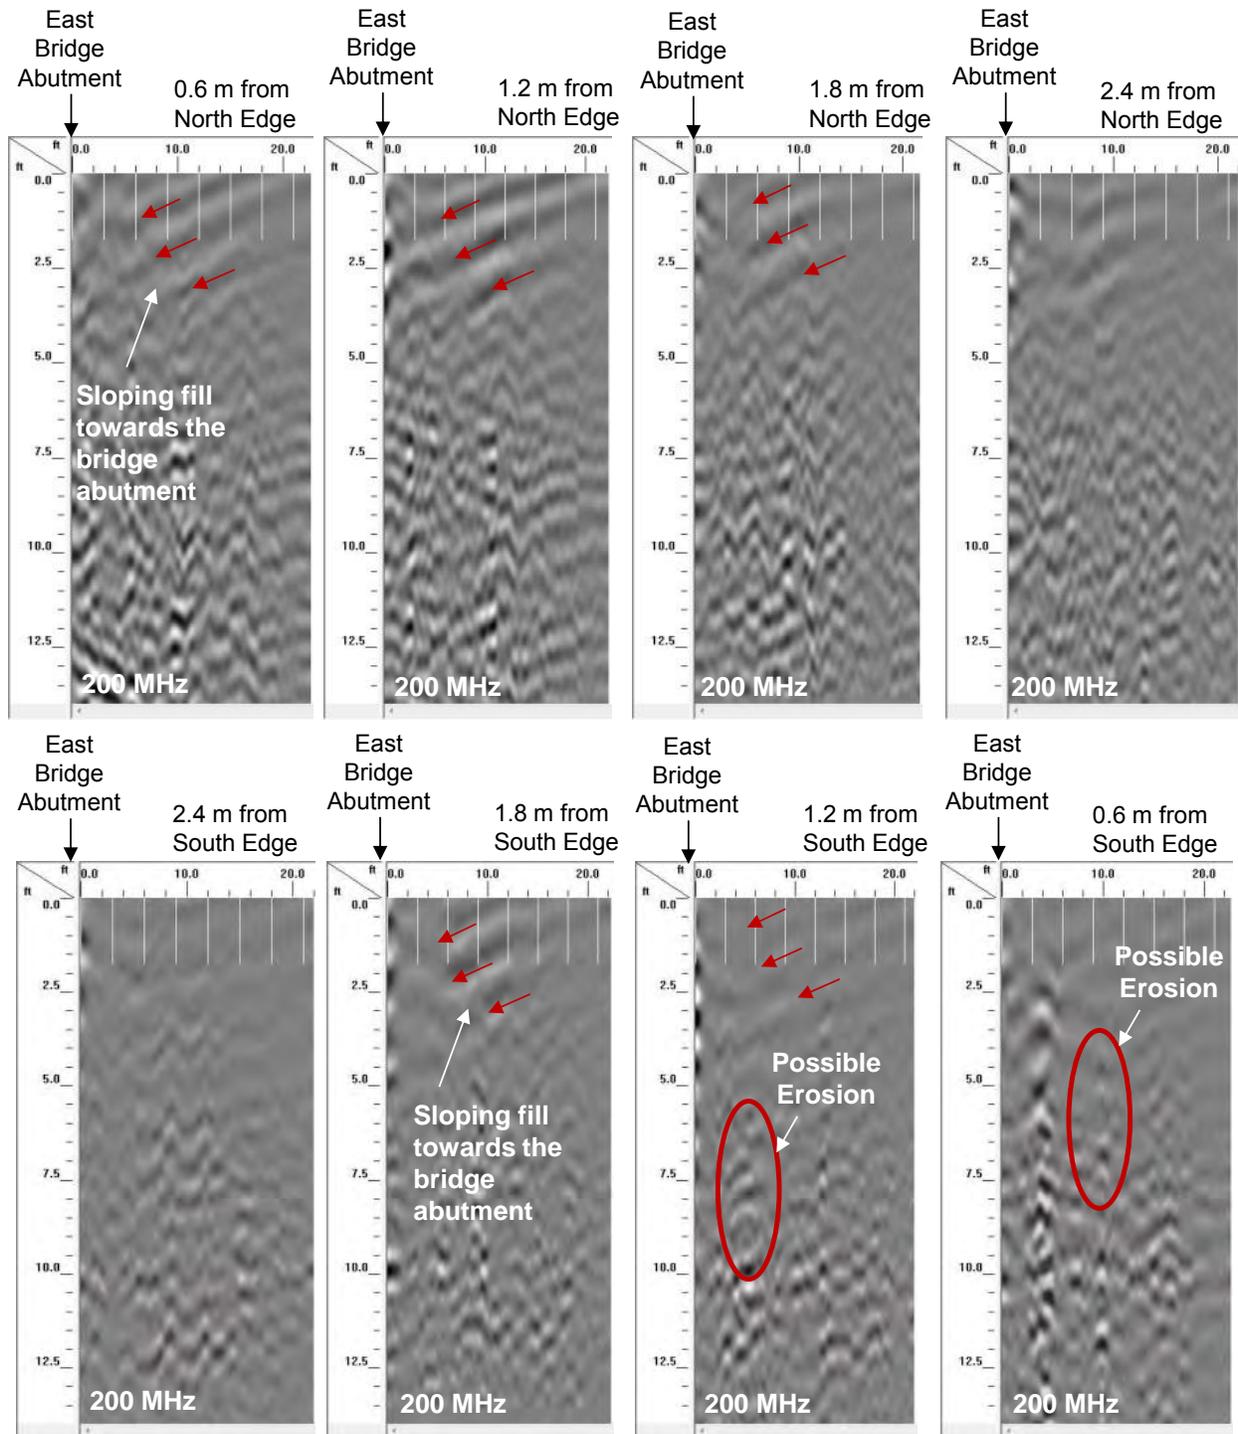
Figure 142. GPR scans using 200 MHz antenna on TS1 longitudinally along the east bridge approach backfill at 0.6 m to 2.4 m away from the north and south edges of the bridge (note: 0 ft mark on the horizontal scale represents about 6.7 m (22 ft) away from the west abutment – Fremont County

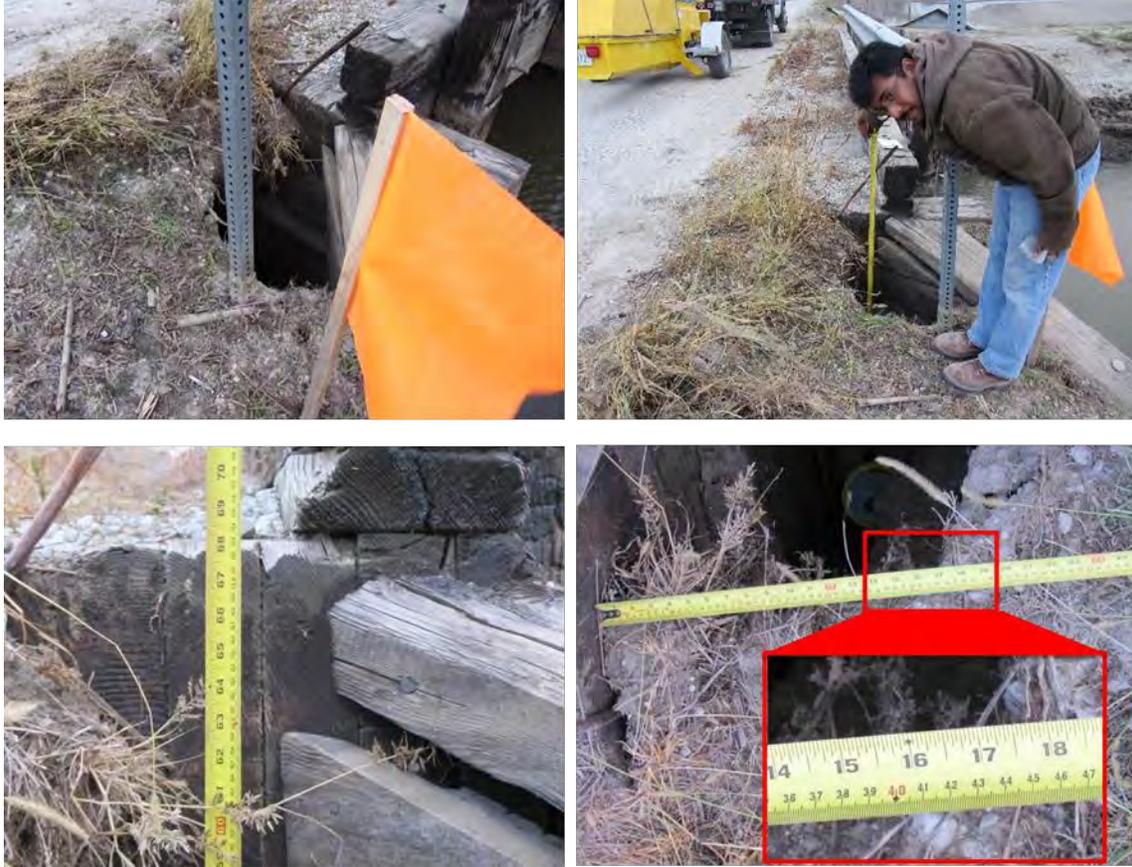
During the 2011 flood event, the TS was partially submerged for about two to three months (Figure 143). Reportedly, the flood waters receded in the area during mid-September 2011. During the flood event, backfill material behind the west bridge approach was eroded away forming voids beneath the surface gravel layer. Pictures taken on 10/26/11 are shown in Figure 144 to Figure 146. Field observations on 4/4/12 indicated that the eroded backfill material on the west abutment was repaired, but some surface subsidence was observed, and new voids were observed on the east abutment (Figure 147).

Figure 146. Void behind the west abutment wall due to erosion of backfill material at TS2 bridge (Pictures taken on 10/26/11) – Fremont County

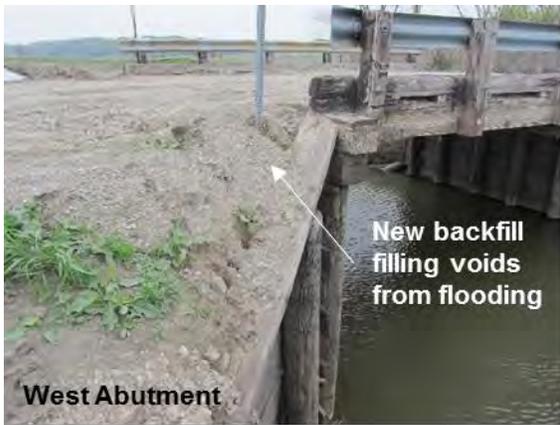
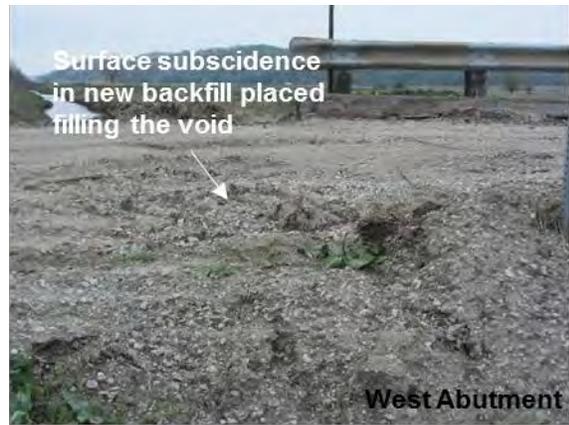
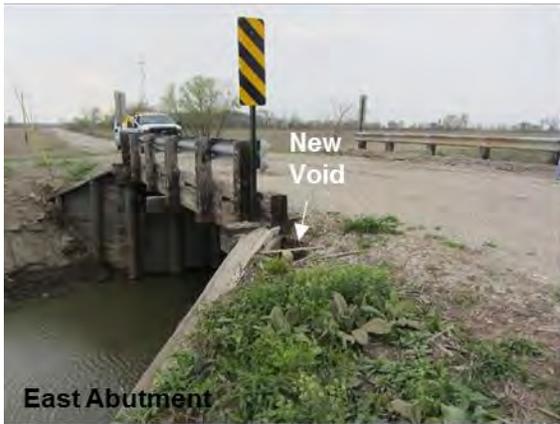
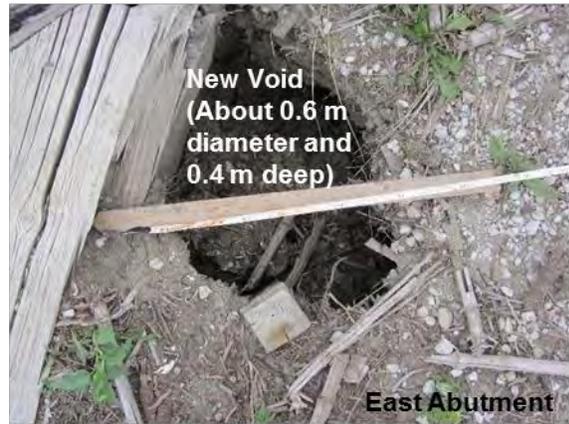
Figure 147. West and east abutments on TS2 bridge (Pictures taken on 4/4/11) – Fremont County

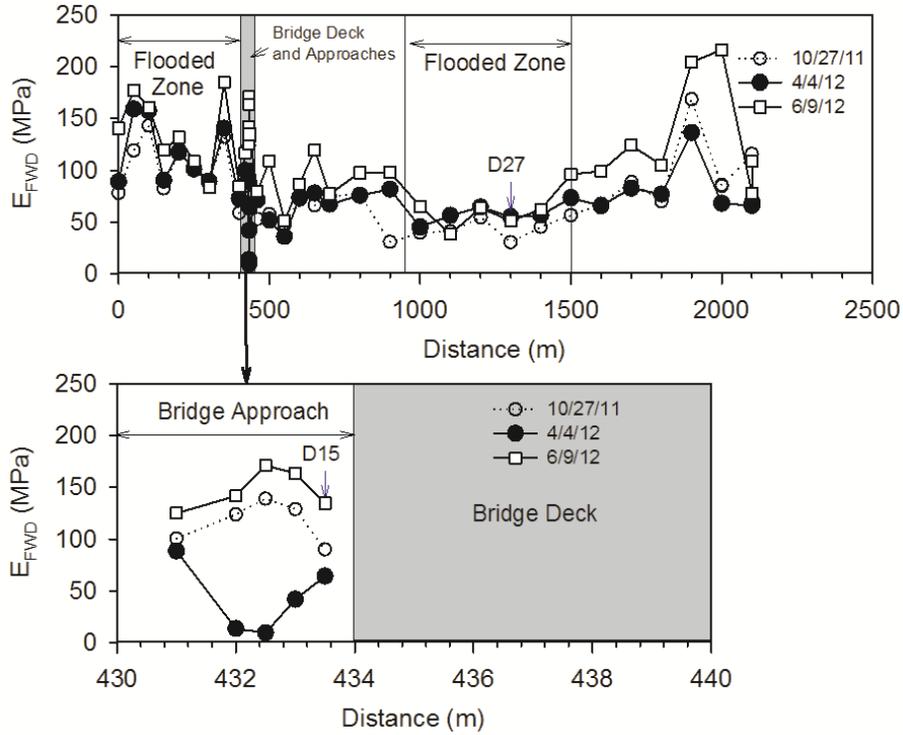
“poor,” per AASHTO (1993). Lowest values were located in the flooded zone (close to D-27 as noted on Figure 148 and Figure 149) that is located at a lower elevation (i.e., area that experienced deep waters above the roadway).

Figure 148. Surface FWD modulus at three different times after flooding on TS2 – Fremont County

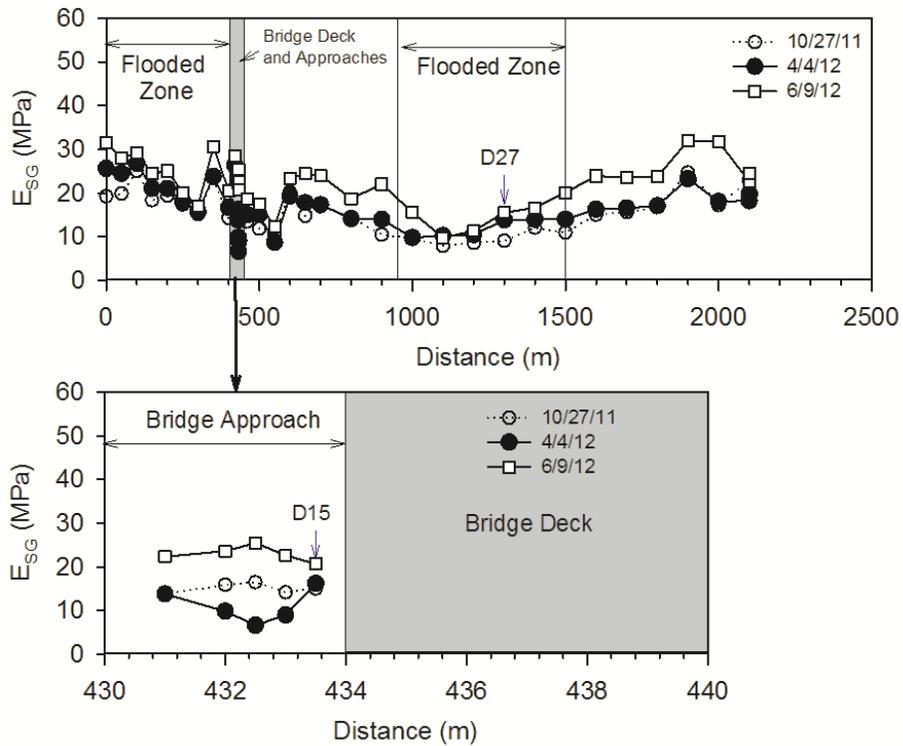
Figure 149. Subgrade modulus measurements at three different times after flooding on TS2 – Fremont County

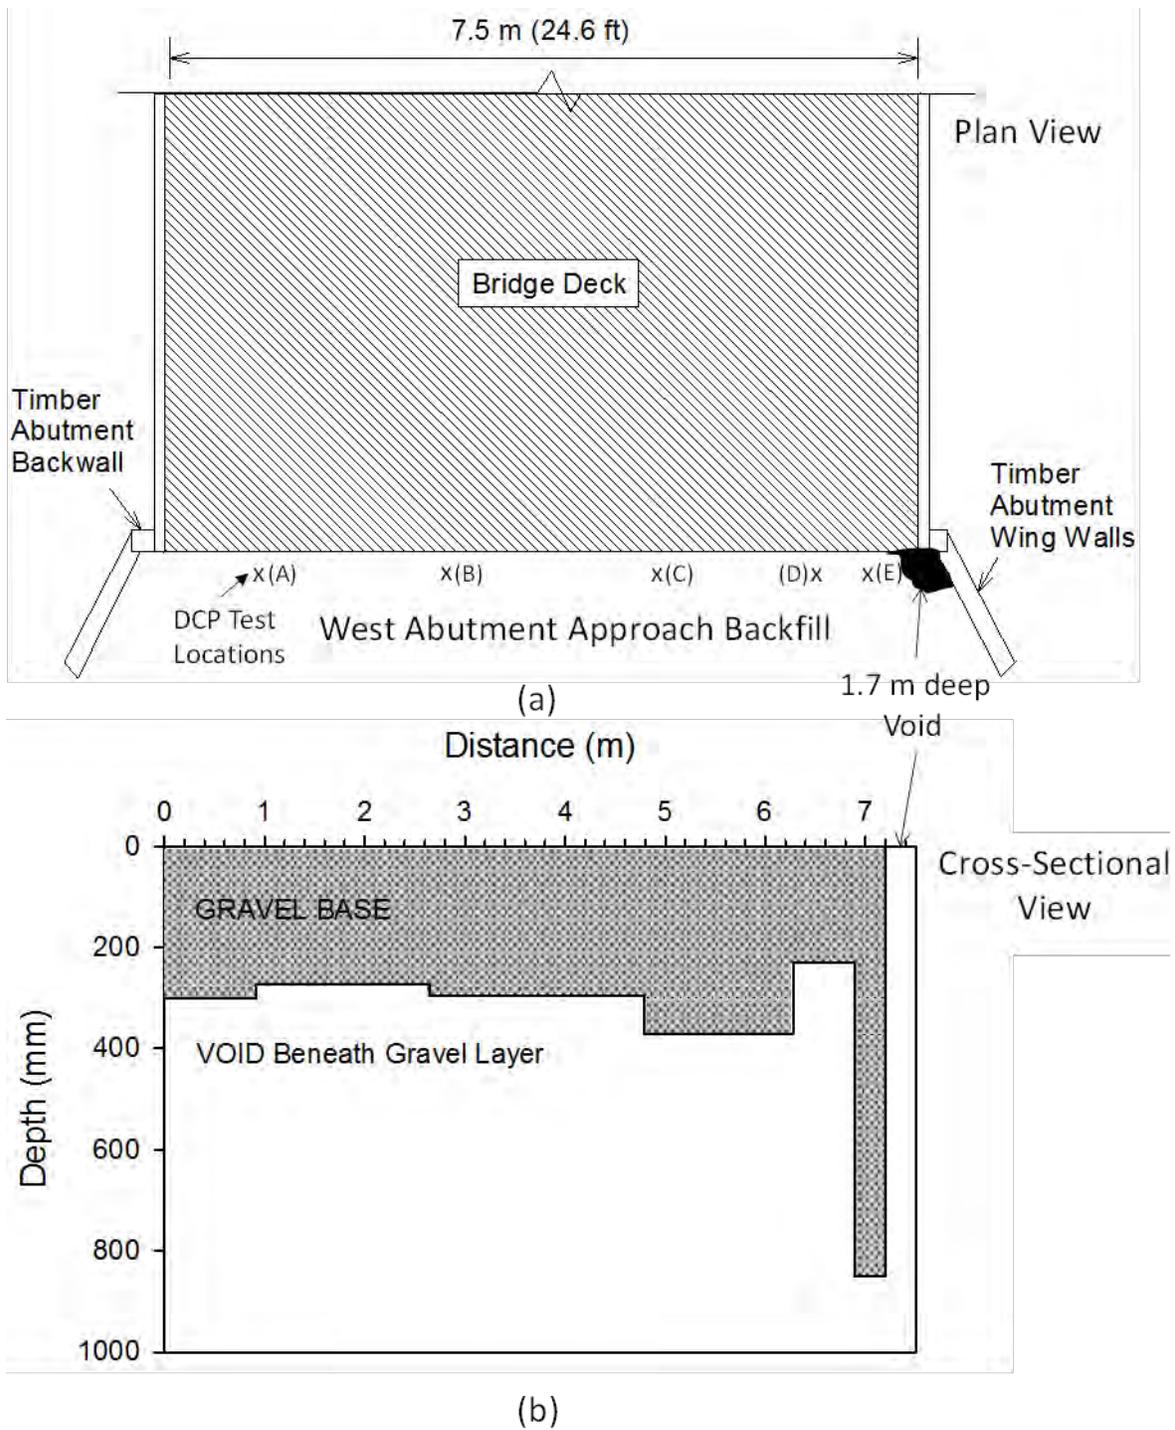
- DCP tests indicated void at depths of about 300 to 850 mm below surface (Figure 150).

Figure 150. TS2 bridge approach: (a) Bridge deck plan view showing DCP test locations on the approach backfill, and (b) cross-sectional view showing thickness of gravel base and void beneath the gravel layer across the bridge (tests conducted on 10/25/11) – Fremont County

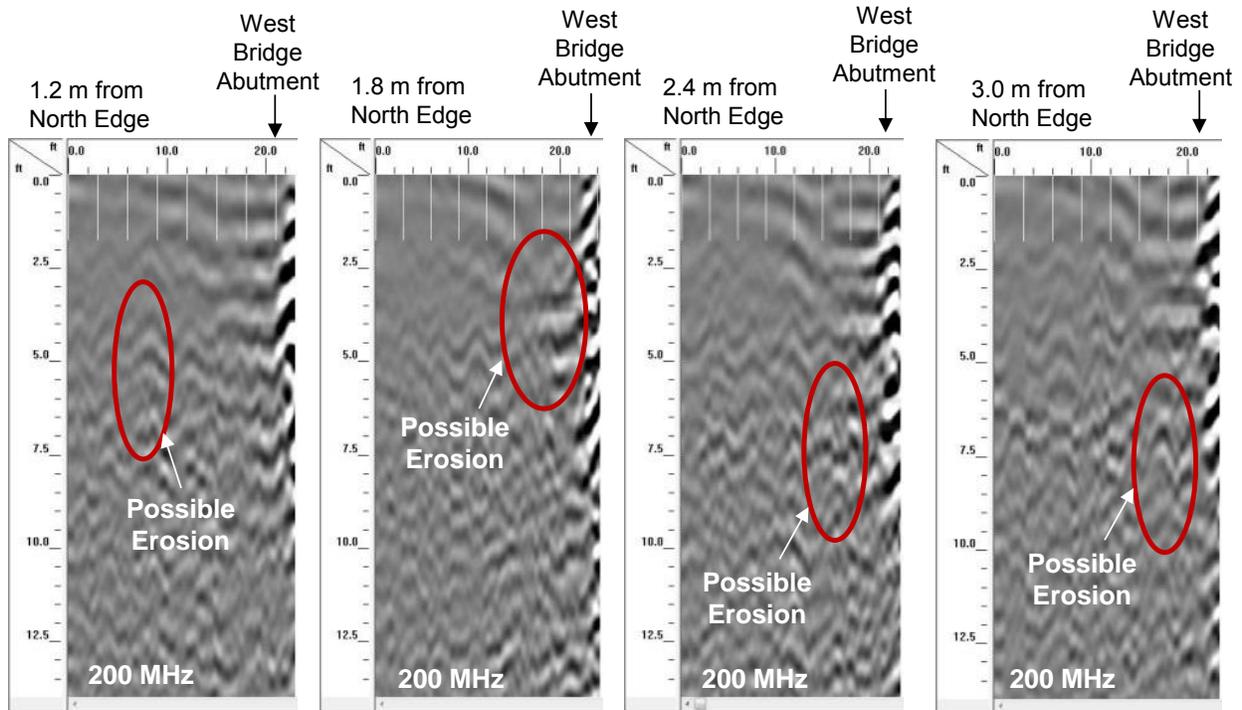
GPR scans were performed using a 200 MHz antennas on 6/19/12 along the west approach at 1.2 m to 3.0 m away from the north and south edges of the bridge. The scanning was conducted to identify potential voids/erosion beneath the surface in the backfill material, which can potentially cause gradual or sudden subsidence of the backfill material. GPR scan results are shown in Figure 153. Some key features observed in the GPR scans are as follows:

Figure 153. GPR scans using 200 MHz antenna on TS2 longitudinally along the west bridge approach backfill at 1.2 to 3.0 m away from the north edge of the bridge (note: 0 ft mark on the horizontal scale represents about 6.7 m (22 ft) away from the west abutment) – Fremont County

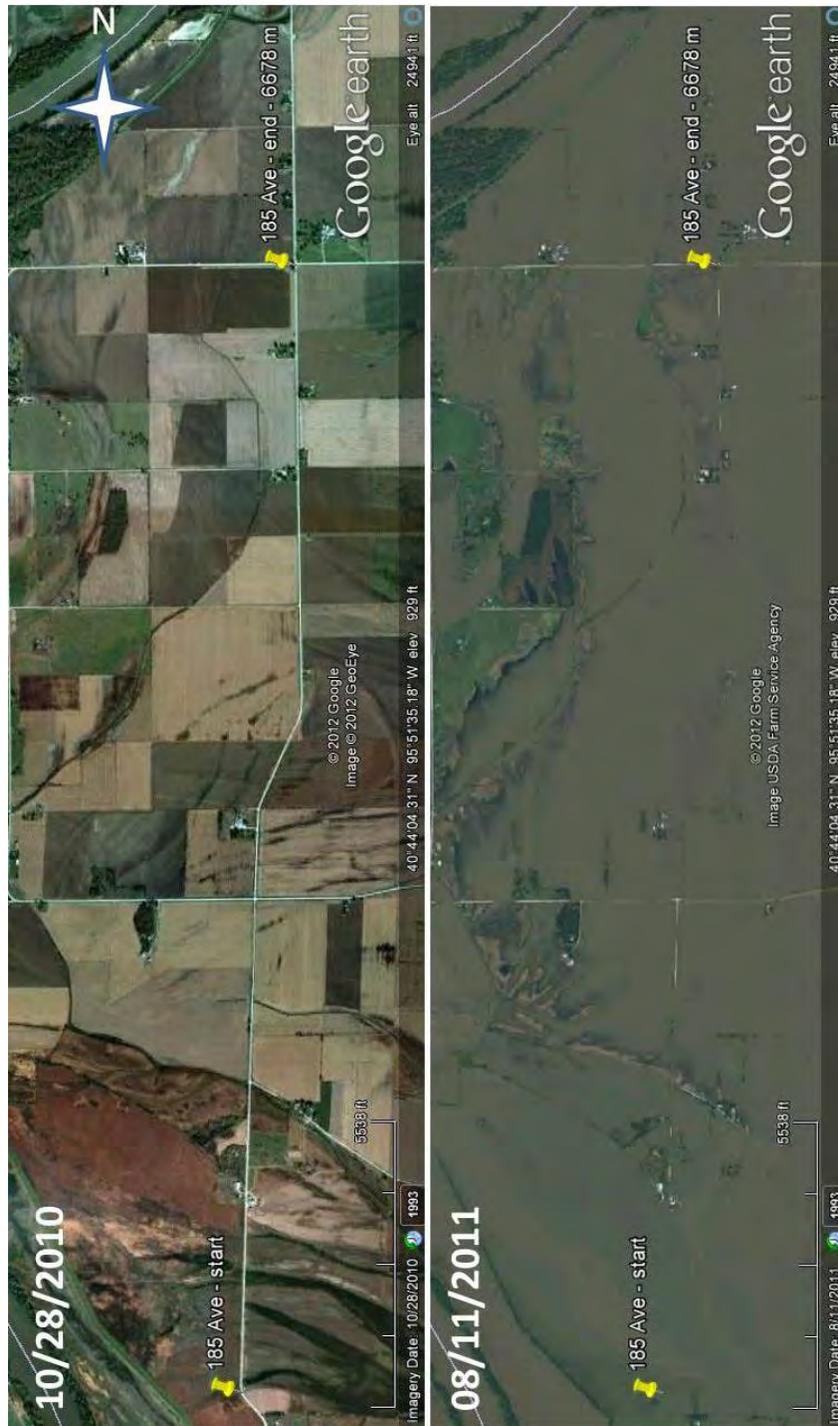
During the 2011 flood event, the test segment was fully submerged for about one to three months (Figure 154). Reportedly, the flood waters receded in the area during mid-September. Roadway damages noted on this test segment include eroded gravel surface layer, sand/silt deposits on the road, rutting under wheel loads at isolated locations (Figure 155, Figure 156).

Figure 154. Aerial imagery before flooding on left (from 10/28/10) and during flooding on right (from 8/11/11) on TS3 – Fremont County

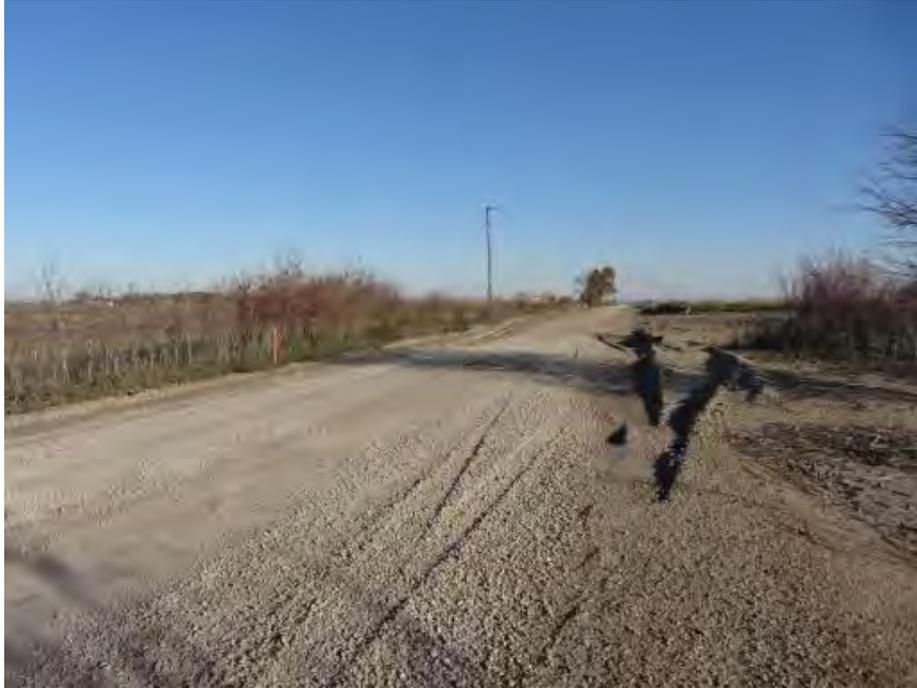
Figure 155. Newly placed gravel near a culvert at about 4700 m station on TS2 (Picture taken 10/27/11)

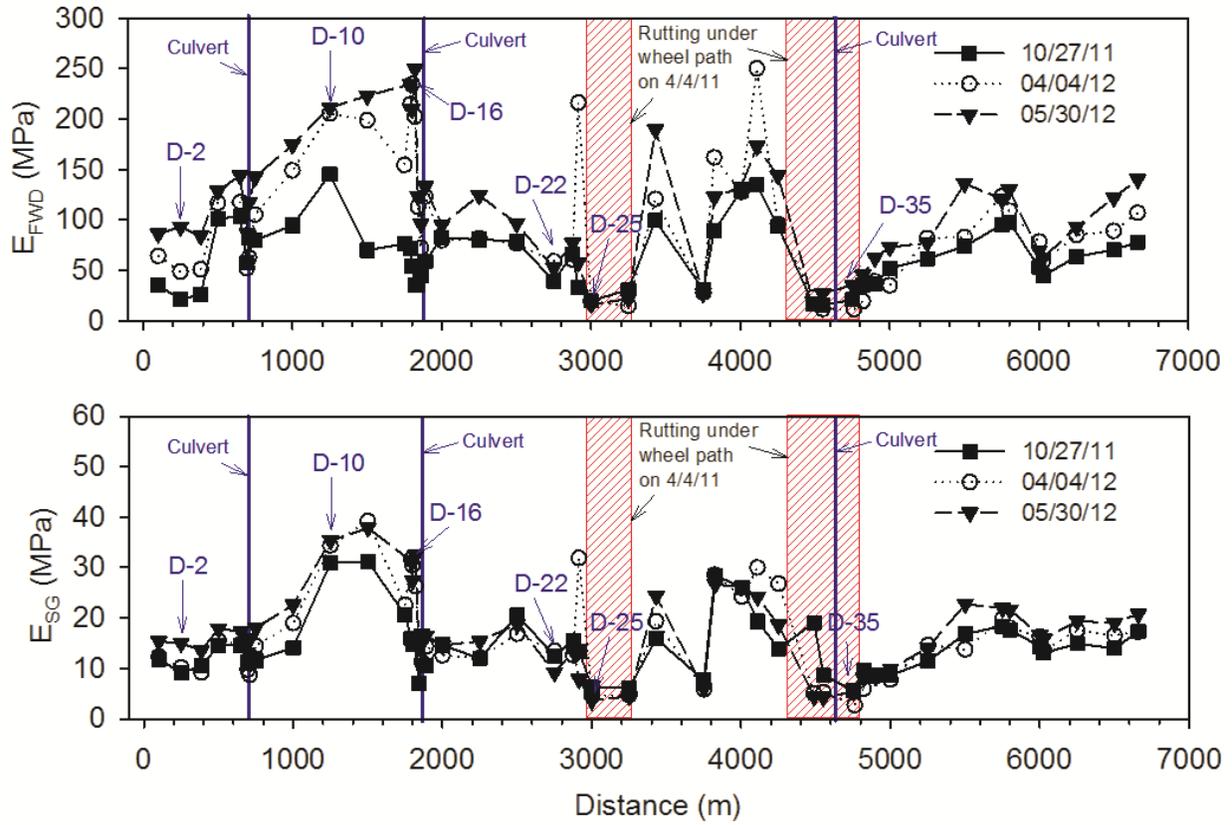
E_{FWD} and E_{SG} results from four different testing times along the test segment are shown in Figure 157. E_{SG} values were calculated based on deflections from the sensor located at 300 mm (12 in.) away from the center of the loading plate. DCP-CBR profiles at the two test locations from different testing times are shown in Figure 158. Box plots of E_{SG} values at different test times are shown in Figure 159. Subgrade CBR values (averaged in the top 300 mm of subgrade) at two different test times are shown in Figure 160. Some key findings from these in situ testing are as follows:

Figure 157. Surface FWD modulus (top) and subgrade modulus (bottom) at three different times after flooding on TS3 – Fremont County

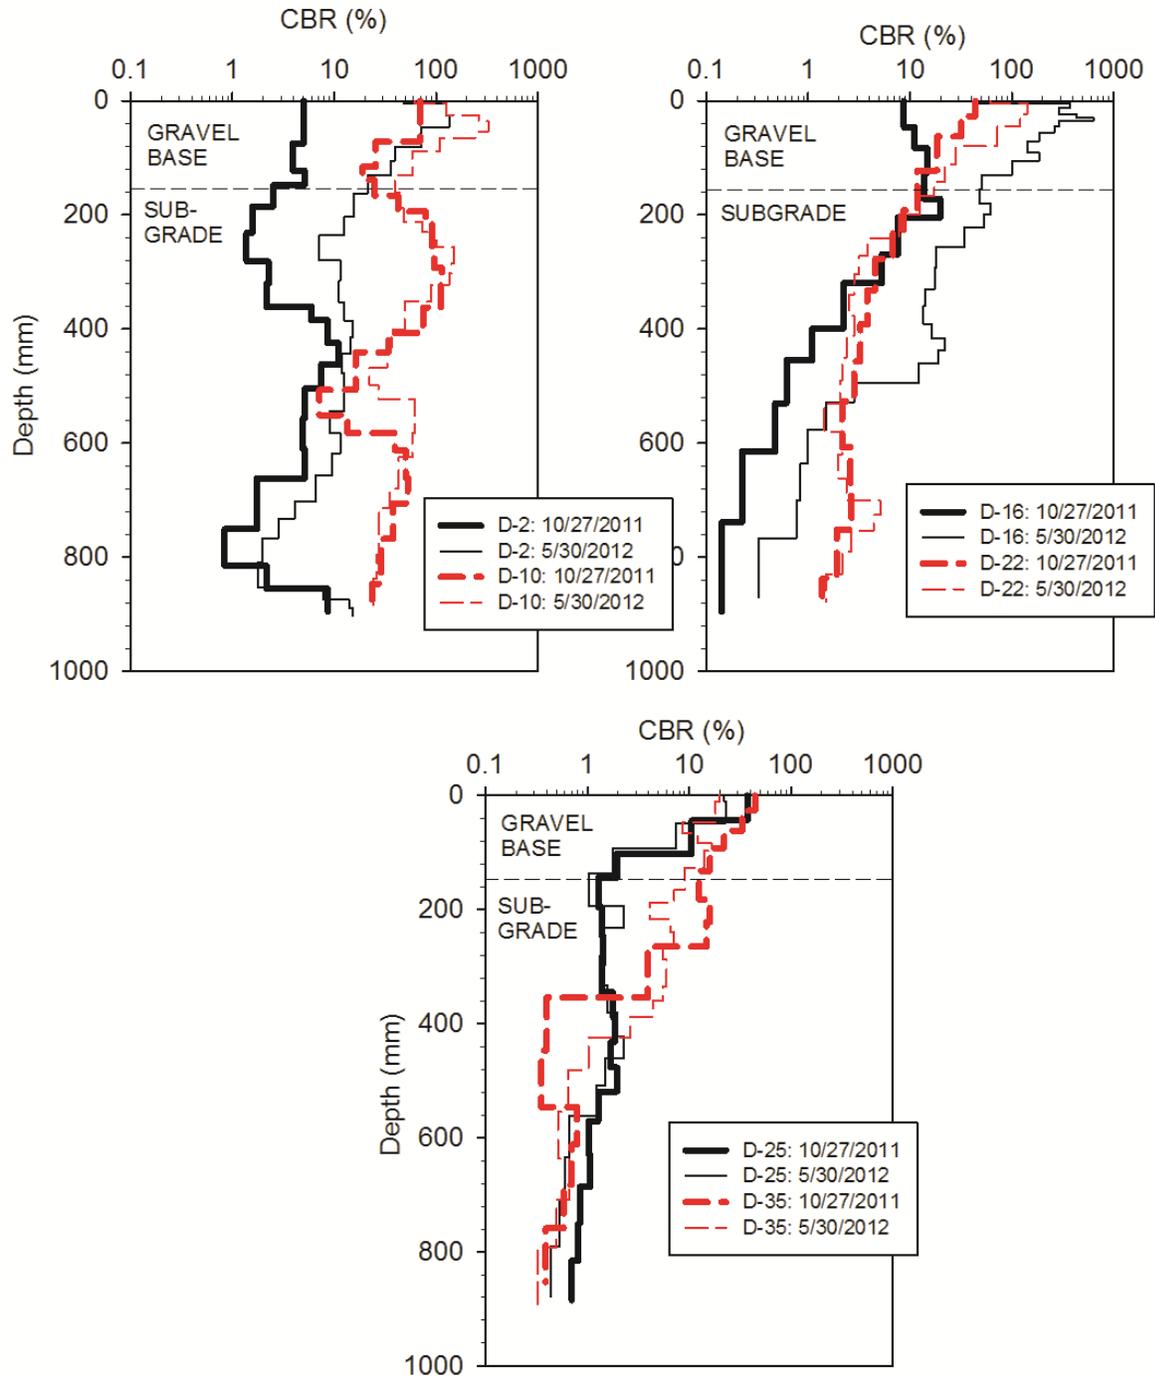
- Subgrade CBR values (in the top 300 mm of subgrade) indicated mixed results with quality varying from “poor” to “very good.” Some locations with low CBR values in the subgrade showed improvement over time (e.g., at PT2 from about 5.2 to 17), while some locations did not (e.g., at PT25 which remained at about 1.8).

- Significant rutting (about 125 mm) was observed under wheel paths near PT25 (near Sta. 3000), where the subgrade CBR was about 1.9. Rutting was also observed at PT 35 (near Sta. 4700), where subgrade CBR (averaged in the top 300 mm) was higher than at PT 25 (7.9). Examining the full CBR profile indicated that CBR in the subgrade ranged from about 0.3 to 2.0 below about 420 mm.

Figure 158. DCP-CBR profiles at three different times after flooding at six test locations on TS3 – Fremont County

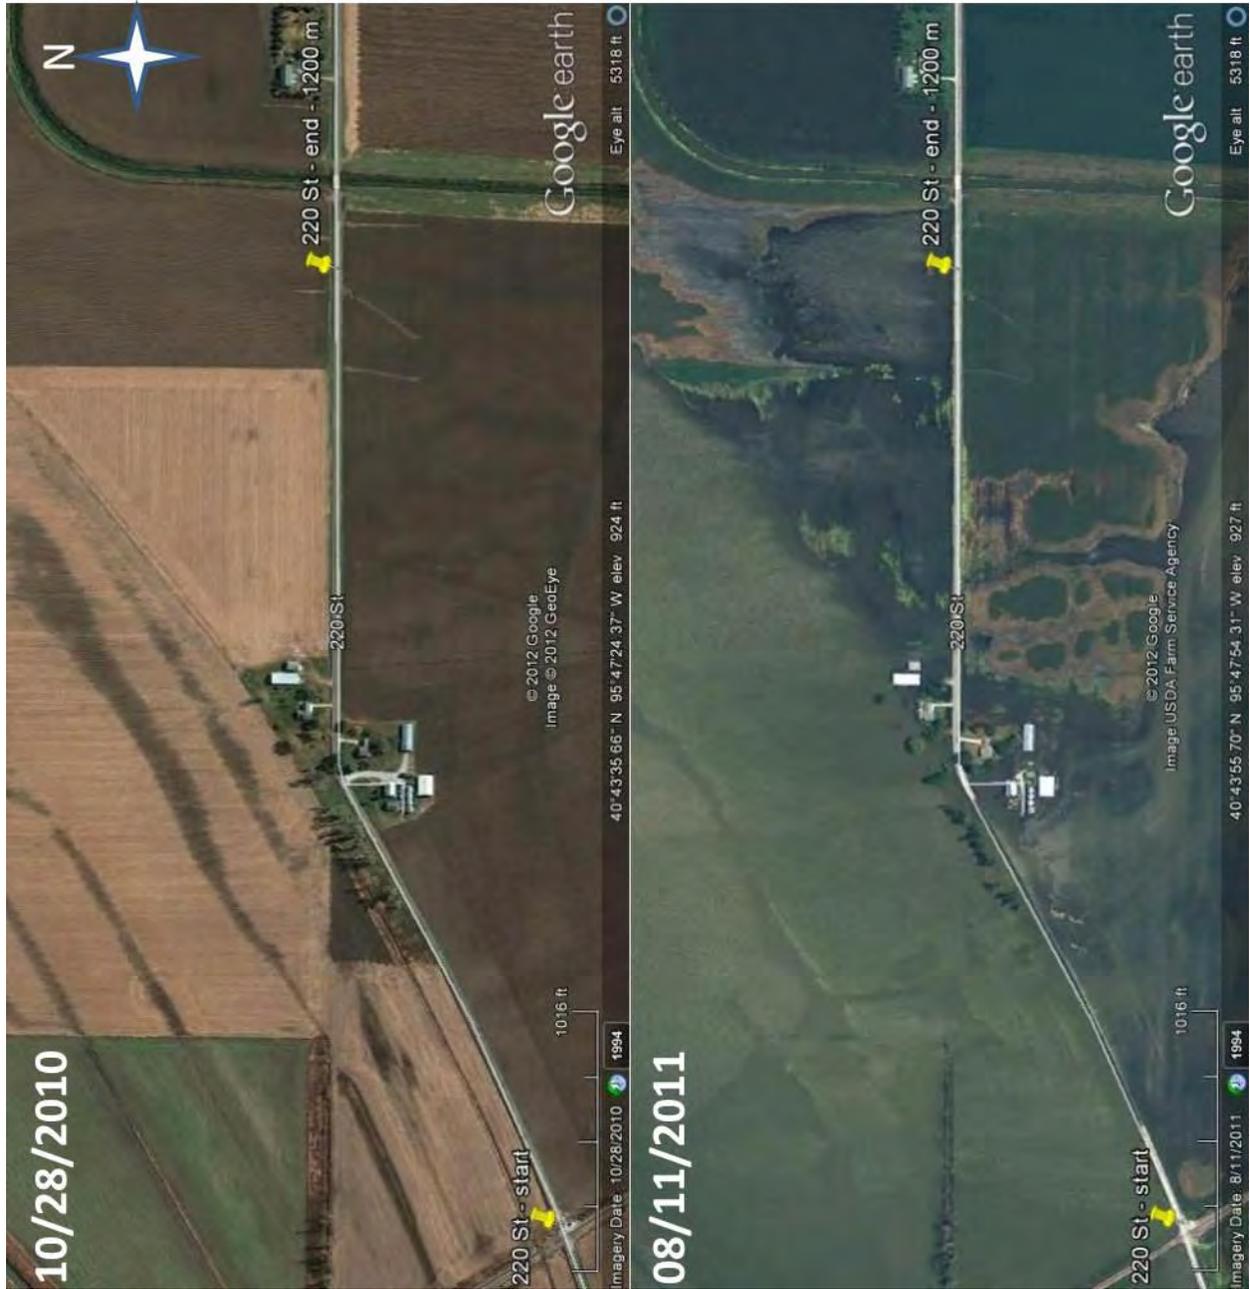
During the 2011 flood event, the test segment was partially submerged for about two to three months (Figure 161). Reportedly, the flood waters receded in the area during mid-September 2011. Roadway damages noted on this test segment include rutting under wheel paths and cracks on the chipseal surfacing, eroded chipseal and gravel over culvert location (patched prior to testing), and eroded granular shoulders. Pictures from this test segment are shown in Figure 162 and Figure 163.

Figure 161. Aerial imagery before flooding on left (from 10/28/10) and during flooding on right (from 8/11/11) on TS4 – Fremont County

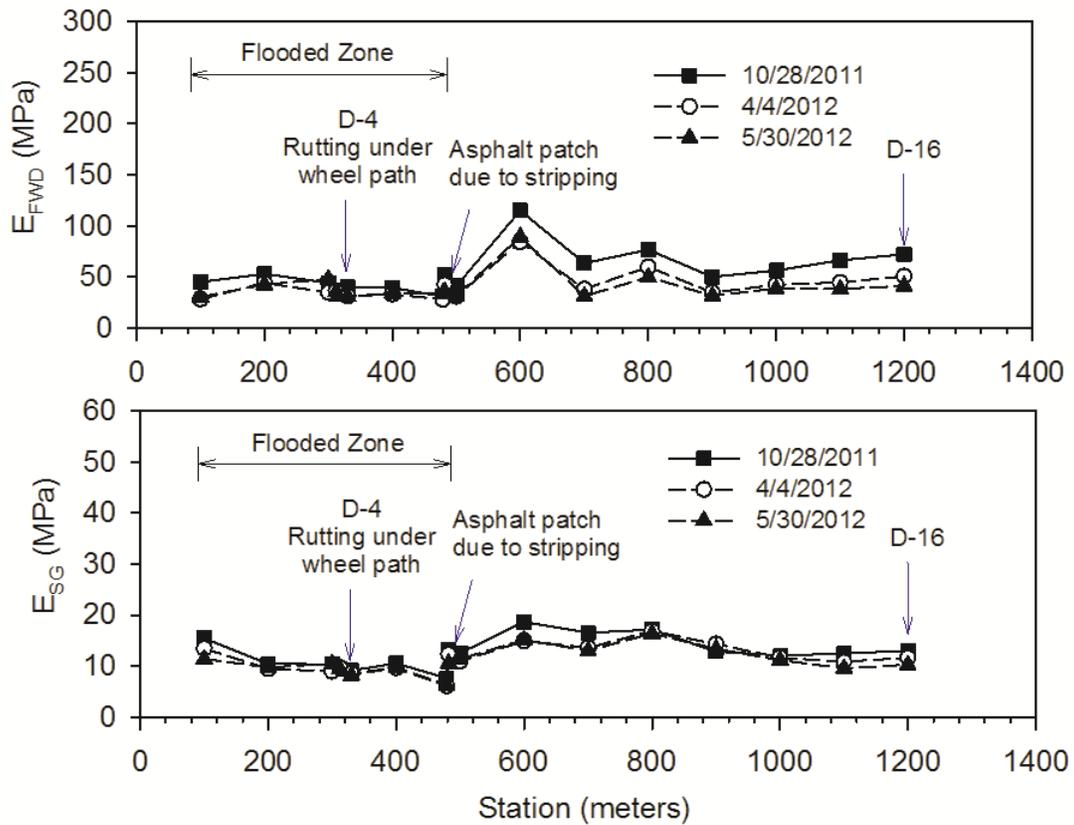
E_{FWD} and E_{SG} results from three different testing times along the test segment are shown in Figure 164, identifying the flooded/non-flooded areas and the bridge. E_{SG} values were calculated based on deflections from the sensor located at 300 mm (12 in.) away from the center of the loading plate. DCP-CBR profiles at the four test locations from different testing times are shown in Figure 165. Box plots of E_{SG} values comparing measurements in the flooded and non-flooded areas at different test times are shown in Figure 166. Some key findings from these in situ testing and observations are as follows:

- On average, E_{FWD} values were about 1.3 to 1.7 times higher in the non-flooded area than in the flooded area, at all times of testing. Similarly, E_{SG} values were about 1.3 times higher in the non-flooded area than in the flooded area. The E_{FWD} values, however, have decreased over time. On average, the E_{FWD} values decreased from about 71 to 46 MPa in the non-flooded area, and from about 42 to 36 MPa in the flooded area, from about 1 month after flooding to about 7 months after flooding. The E_{SG} values did not vary much over time (varied from 15 to 13 MPa in non-flooded area and 11 to 10 MPa in flooded area).
- The E_{SG} values in the whole TS were low and the quality is rated as “very poor,” per AASHTO (1993). Lowest values were located in the middle of the flooded zone.

Figure 164. Surface FWD modulus (top) and subgrade modulus (bottom) at three different times after flooding on TS4 – Fremont County
