Western Iowa Missouri River Flooding— Geo-Infrastructure Damage Assessment, Repair, and Mitigation Strategies

SEPTEMBER 2013

Final Report

Federal Highway Administration
Iowa Highway Research Board
(IHRB Project TR-638)
Iowa Department of Transportation
(InTrans Project 11-419)

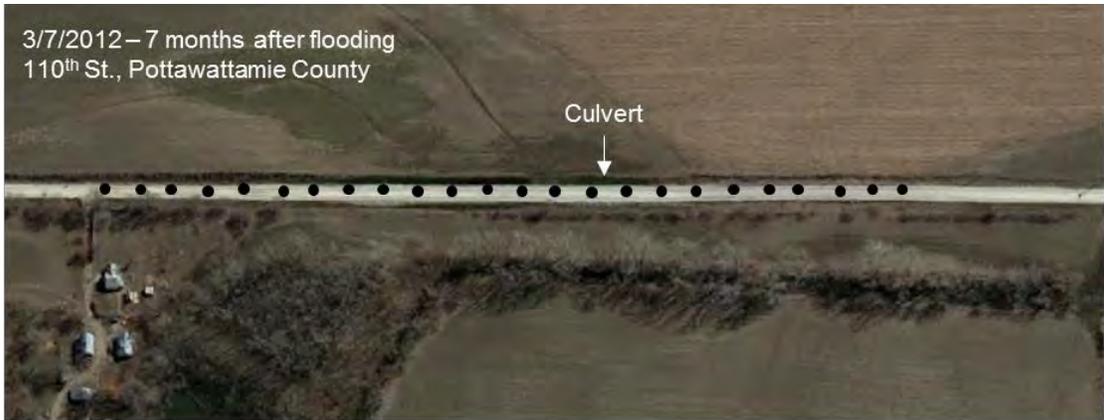
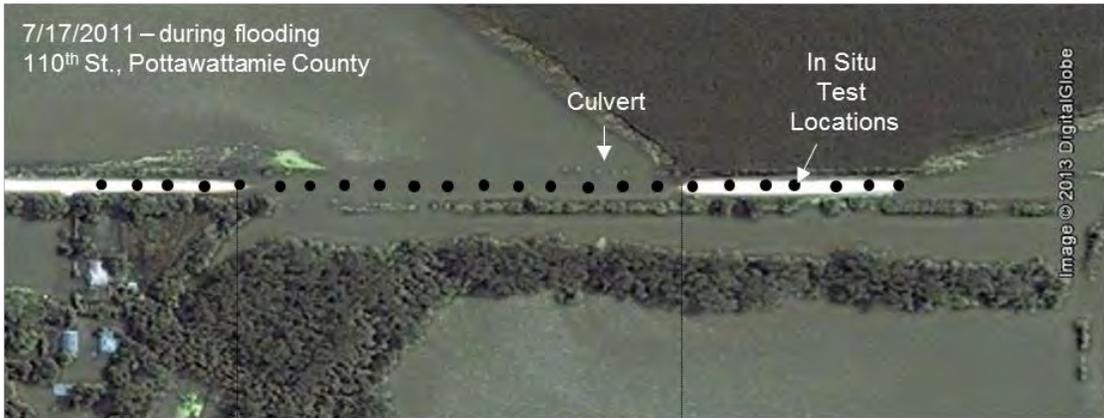
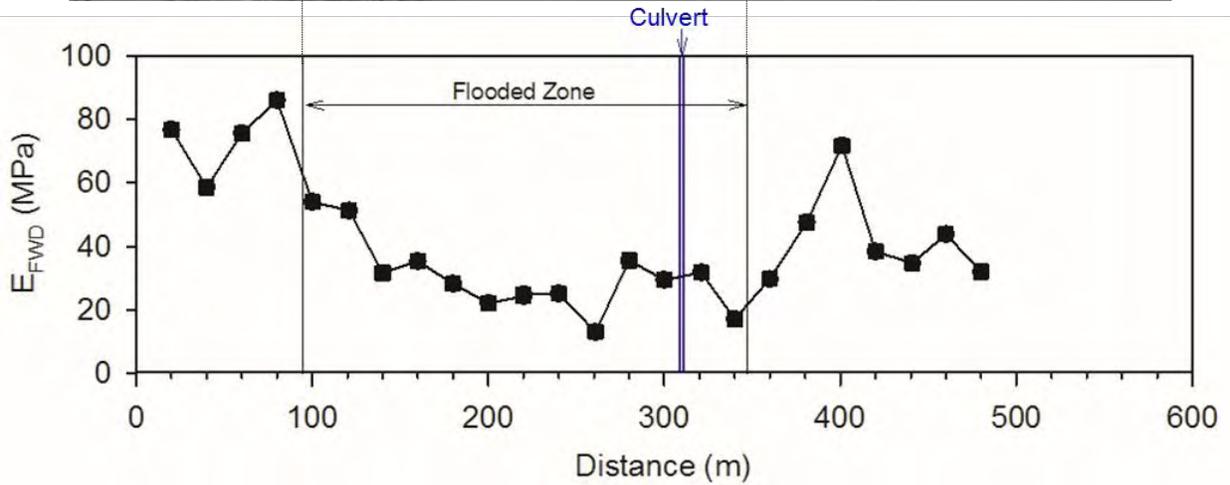
Review of aerial imagery is recommended to select areas for potential testing when assessing damage on roadways. An example to illustrate this is shown in Figure D2. Light Detection and Ranging (LiDAR) based elevation data (in 0.6 m (2 ft) contours) is now available for all Iowa Counties through the Iowa Department of Natural Resources (DNR). According to Iowa DNR, the LiDAR elevation data has an accuracy of about 0.2 m (8 in.). The data is available as metadata and can be downloaded and visualized using ArcGIS. As an example, LiDAR data overlaid on Pottawattamie County map is shown in Figure D3.

Figure D2. Aerial imagery showing during flood and after flood conditions, and FWD test results in flooded and non-flooded areas (imagery from Google Earth)

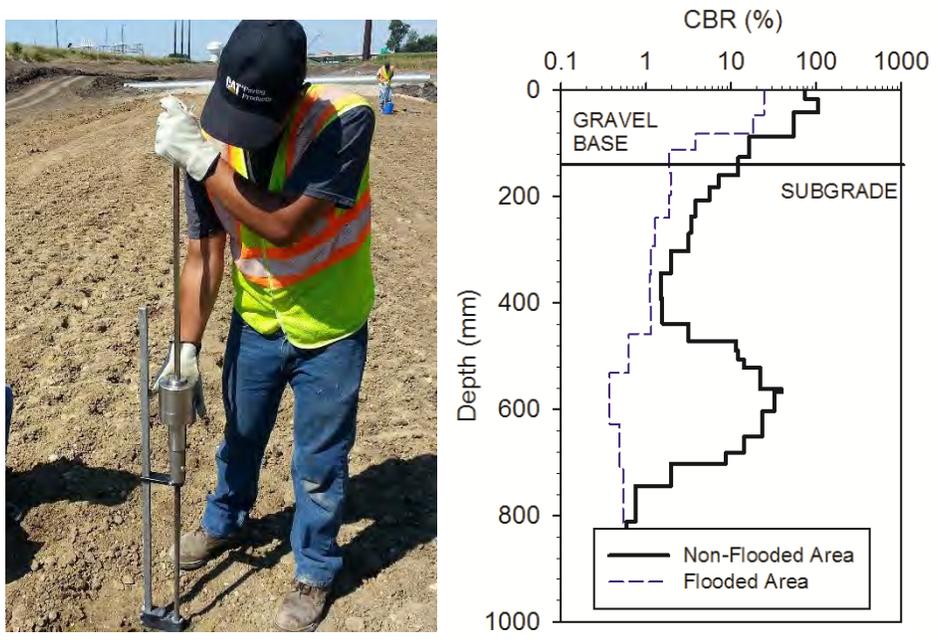
Figure D9. Dynamic cone penetrometer testing (left) and an example plot comparing DCP-CBR profiles in flooded and non-flooded areas

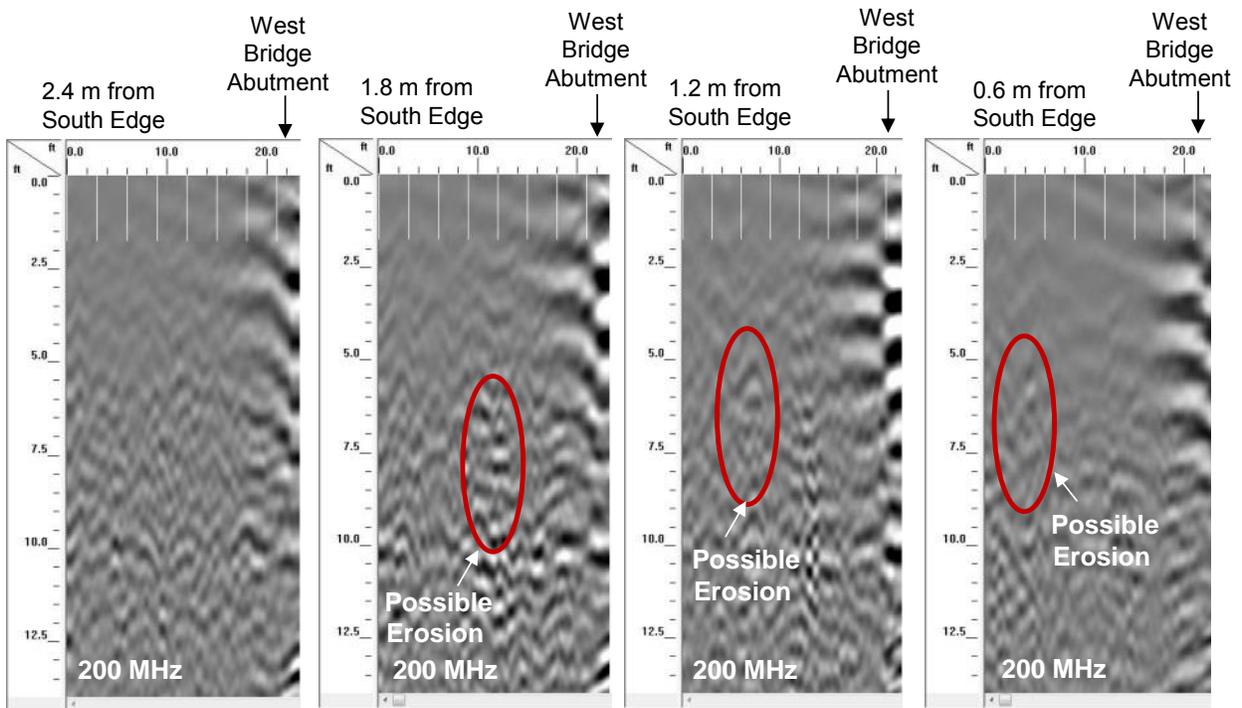
Figure D14. GPR scans using 200 MHz antenna on bridge approach backfill materials at several locations from the edge of the bridge identifying possible erosion/voids beneath surface

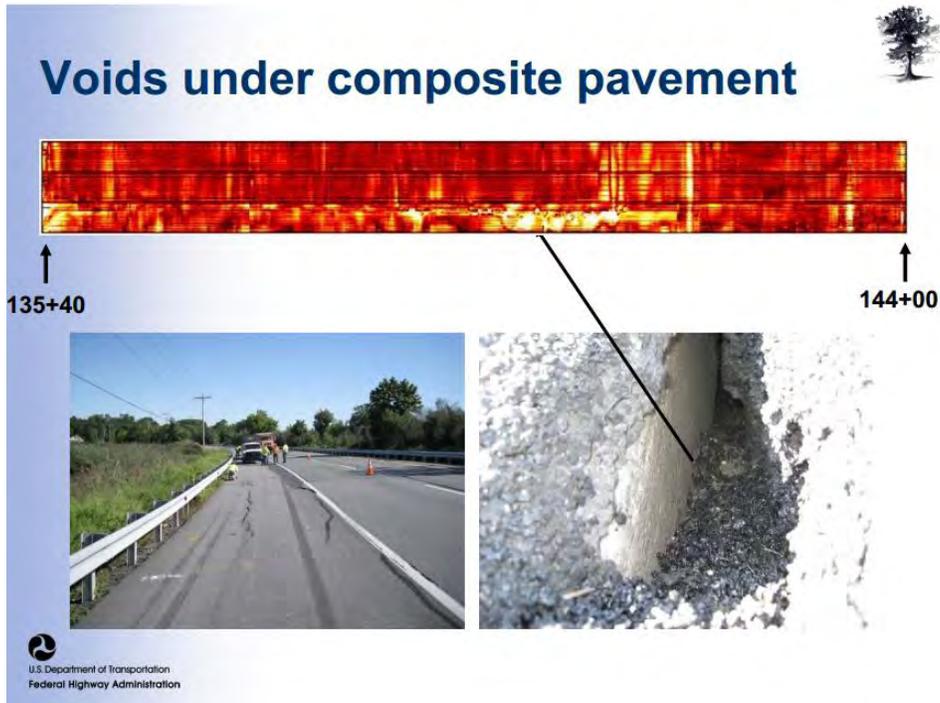
Figure D17. GPR scan map showing voids under composite pavement (Yu 2012)

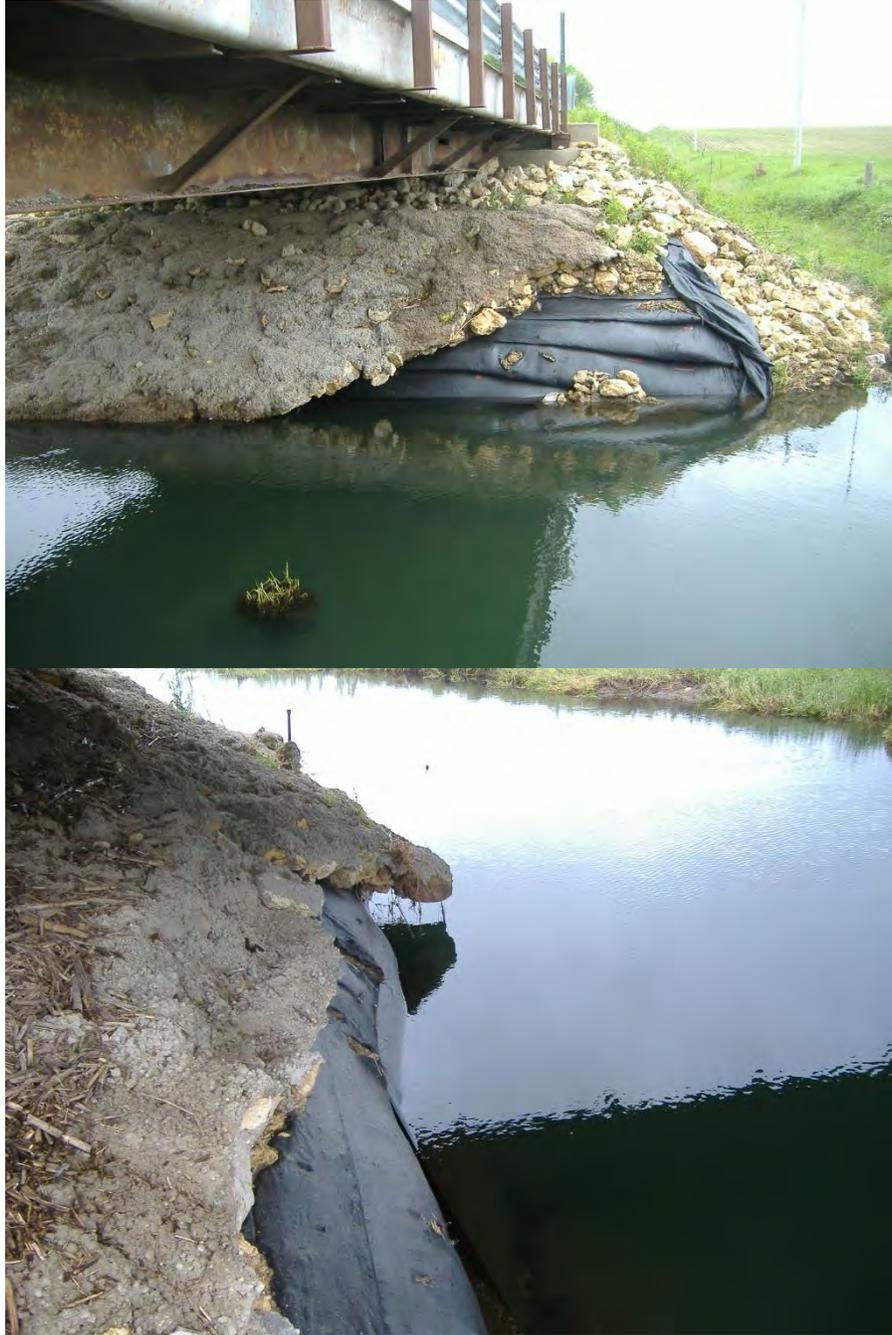
Recently, two case study projects are documented in Vennapusa et al. (2012) for bridges constructed in Buchanan County using GRS fill in bridge abutments. One of the bridge sites (Olympic Ave.) included GRS fill constructed with a slope and riprap capped with cement grout was used for erosion protection (Figure D38, Figure D39). Another bridge site (250th St.) included supporting the bridge on GRS fill using the existing bridge abutment and soil as facing (Figure D40). A summary of the 250th St. bridge construction costs are provided in Table D6. Both these bridges experienced flash flooding during summer of 2013 and flood waters overtopped during the flood event. At the Olympic Ave. bridge site, some of the rip rap facing was eroded (Figure D41) and at the 250th St. bridge site, some of the gravel surfacing was eroded into the ditches. Despite these, no other distresses were observed at the two sites (Figure D42).

Figure D41. Pictures of a bridge site in Buchanan County (Olympic Ave.) after flash flooding occurred in May 2013

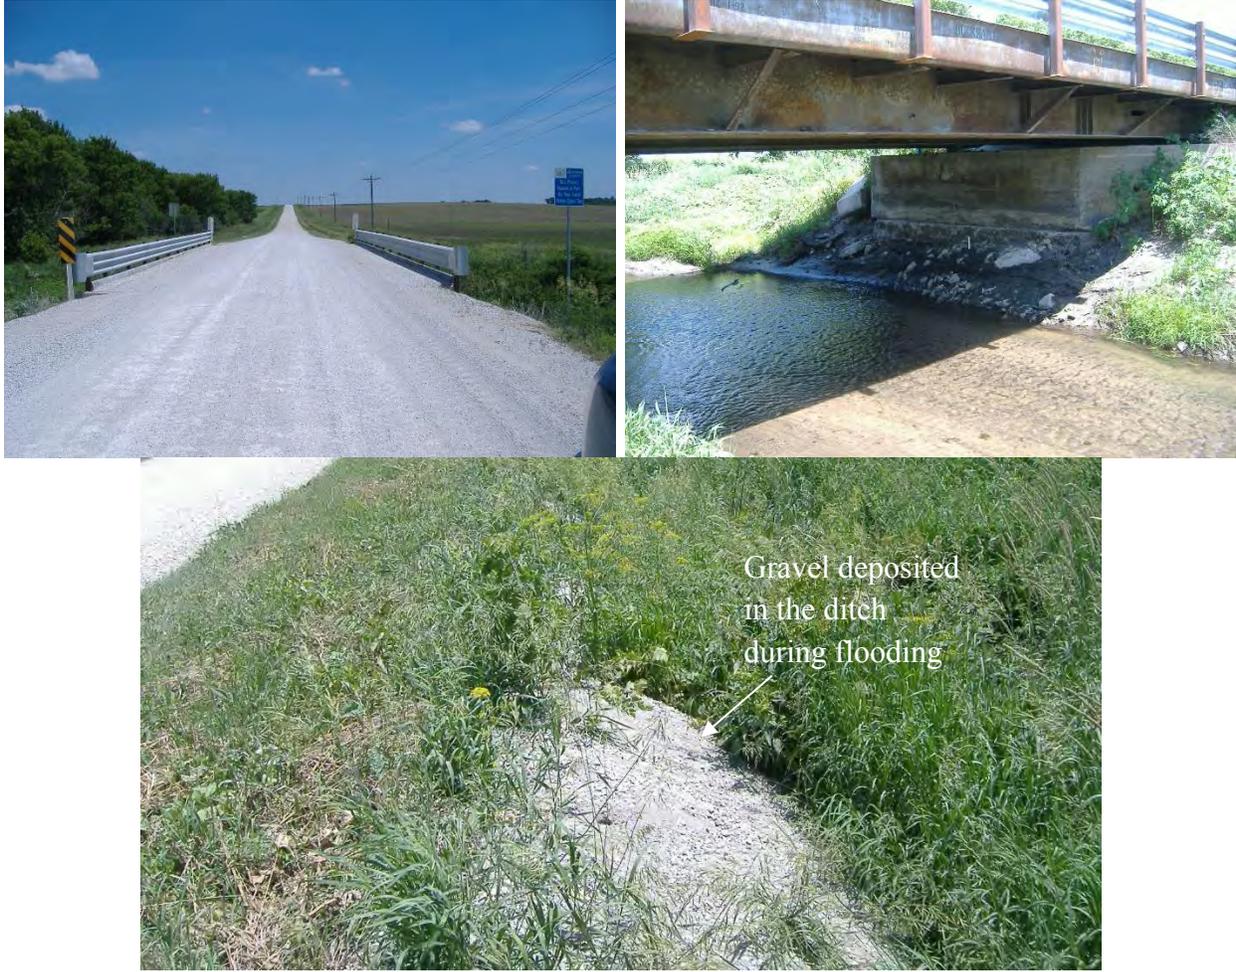
Figure D42. Pictures of a bridge site in Buchanan County (250th Street) after flash flooding occurred in May 2013
