Laboratory and Field Testing of an Accelerated Bridge Construction Demonstration Bridge: US Highway 6 Bridge over Keg Creek

Final Report
April 2013

Sponsored by
Federal Highway Administration
Iowa Department of Transportation
(InTrans Project 11-411)

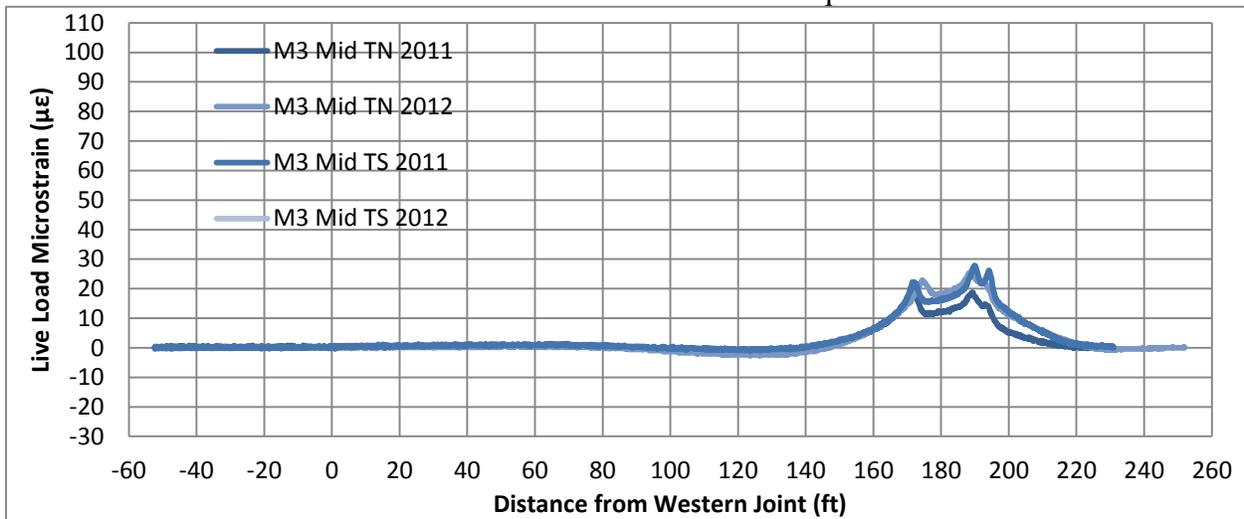
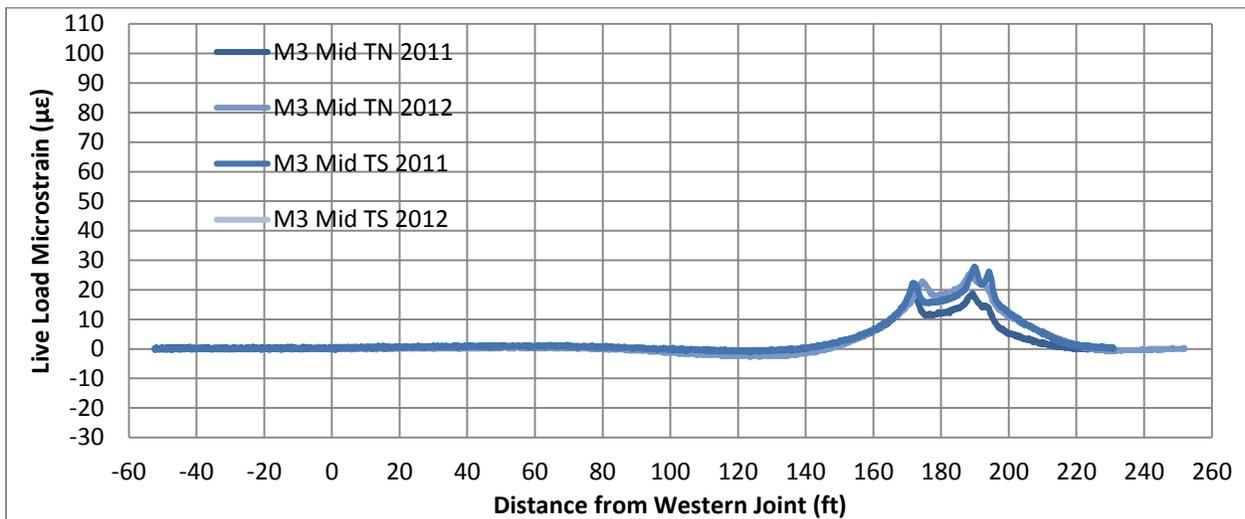
Figure 4.22. Comparison of live load strains from 2011 to 2012 of transducers on top flange of girder at midspan for module 3 from load path 4

Figure 4.21 and Figure 4.22 show comparisons of representative samples of data between the 2011 and 2012 test for module 3 strains recorded in the top and bottom flanges for load path 4. The differences between the tests are then quantified in
