Flame Hardened Snow Plow Blades

Final Report

RB13-012

April 2013

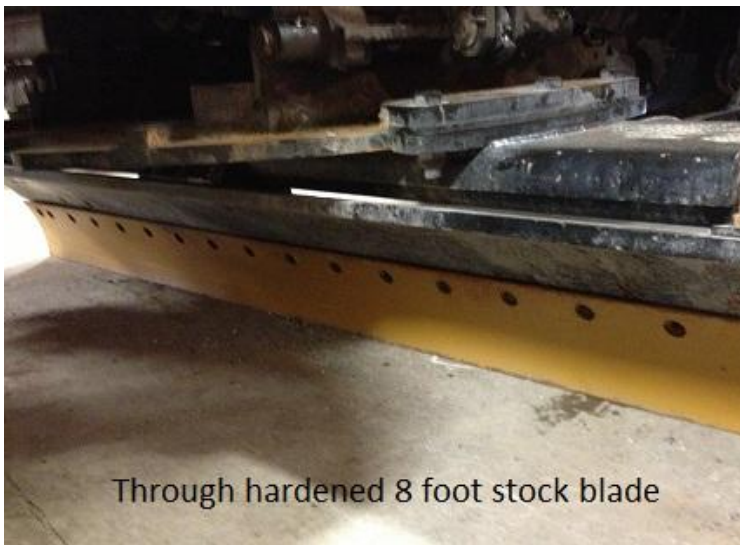
Seventy-five percent of the flame hardened blades were found to have vertically broken into two or more pieces causing one garage to remove the blade with usable life remaining due to safety concerns. The testing garages indicated that this is not typical with our current blades.

It is not recommended that the DOT pursue the purchase of these blades at this time due to the increased cost without seeing significantly increased lifespan and the safety concerns associated with broken blades.
