SUBMERGED VANES FOR FLOW CONTROL AND BANK PROTECTION IN STREAMS

A. Jacob Odgaard and Hong-Yuan E. Lee

the Highway Division of the Iowa Department of Transportation
and
the Iowa Highway Research Board
Project HR-255

IHR Report No. 279

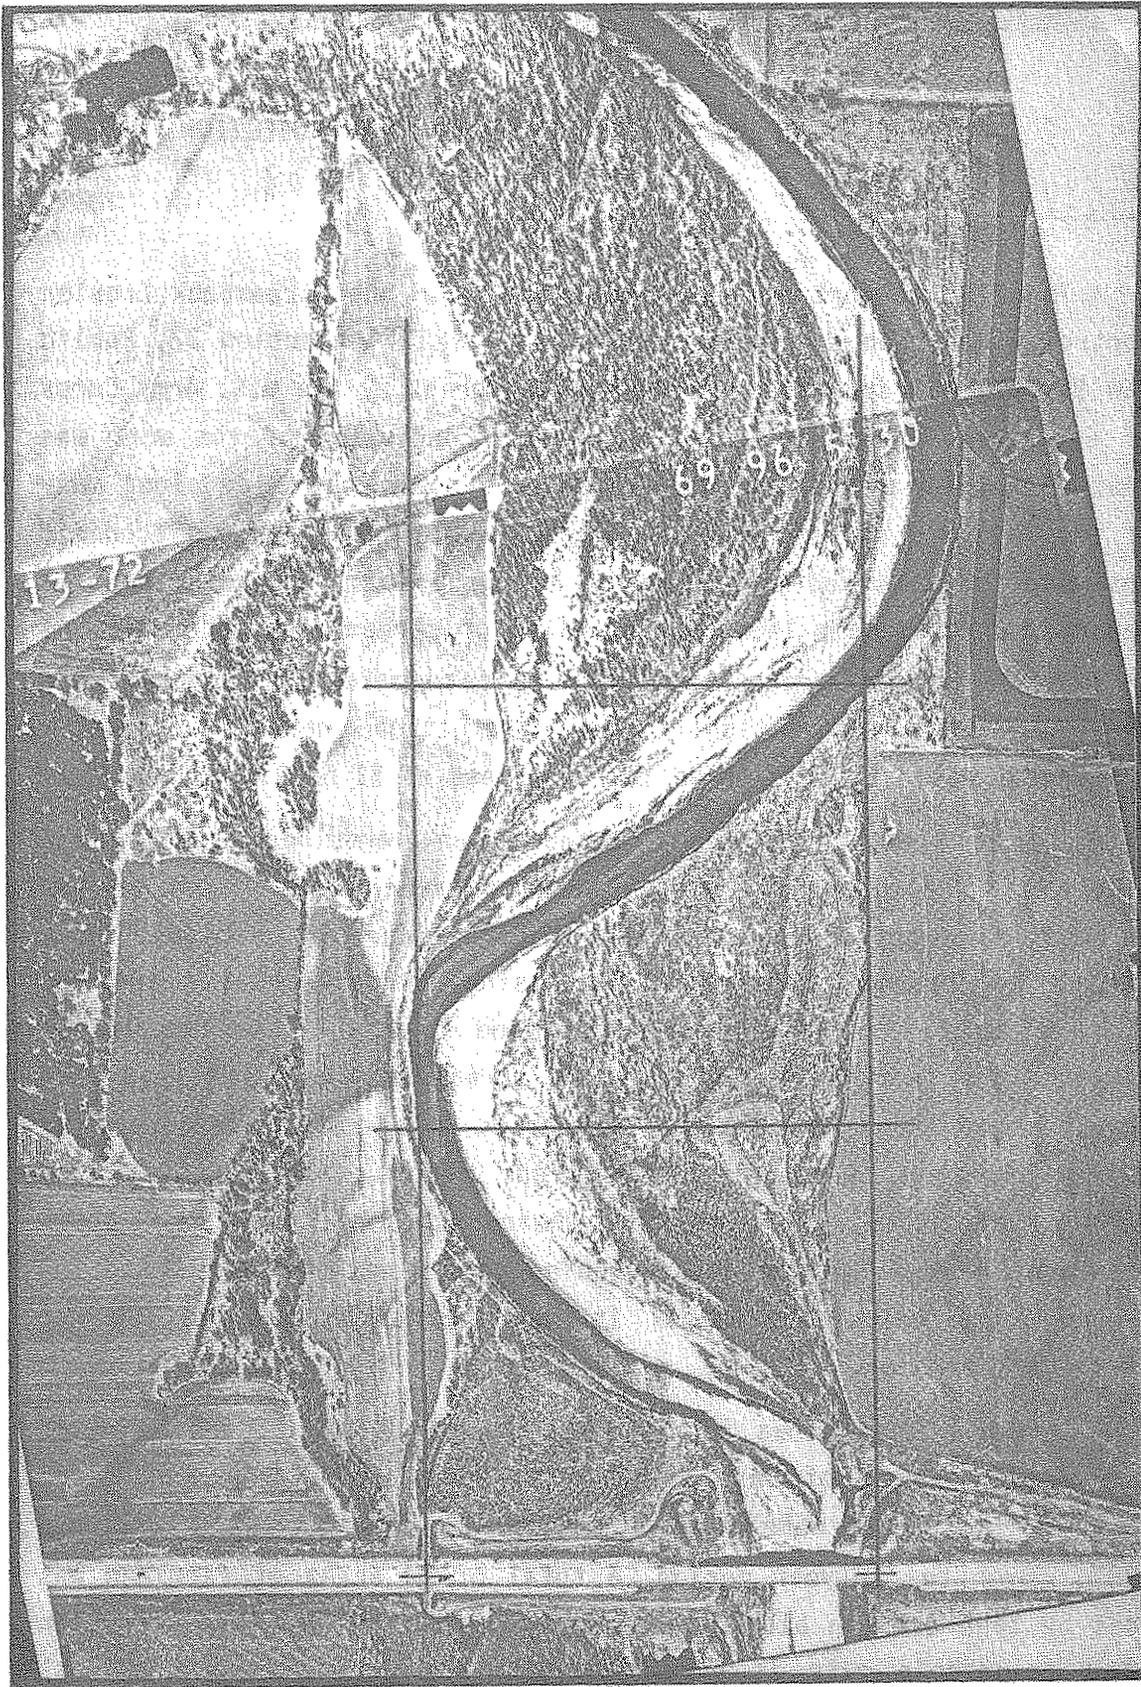
Figure 1. Aerial Photo of East Nishnabotna River and U.S. Highway 34 at Red Oak, Montgomery County, Iowa, March 13, 1972

The problem in Iowa is illustrated in Figs. 1, 2, and 3, which show aerial photos of East Nishnabotna River at Red Oak, Montgomery County. The photos were taken at 5-year intervals in 1972, 1977, and 1982. Over the 10-year period, a total of 20 acres of farmland was lost by bank erosion along this 1.6-mile reach of the river. Erosion at a comparable rate is occurring along the entire length of East

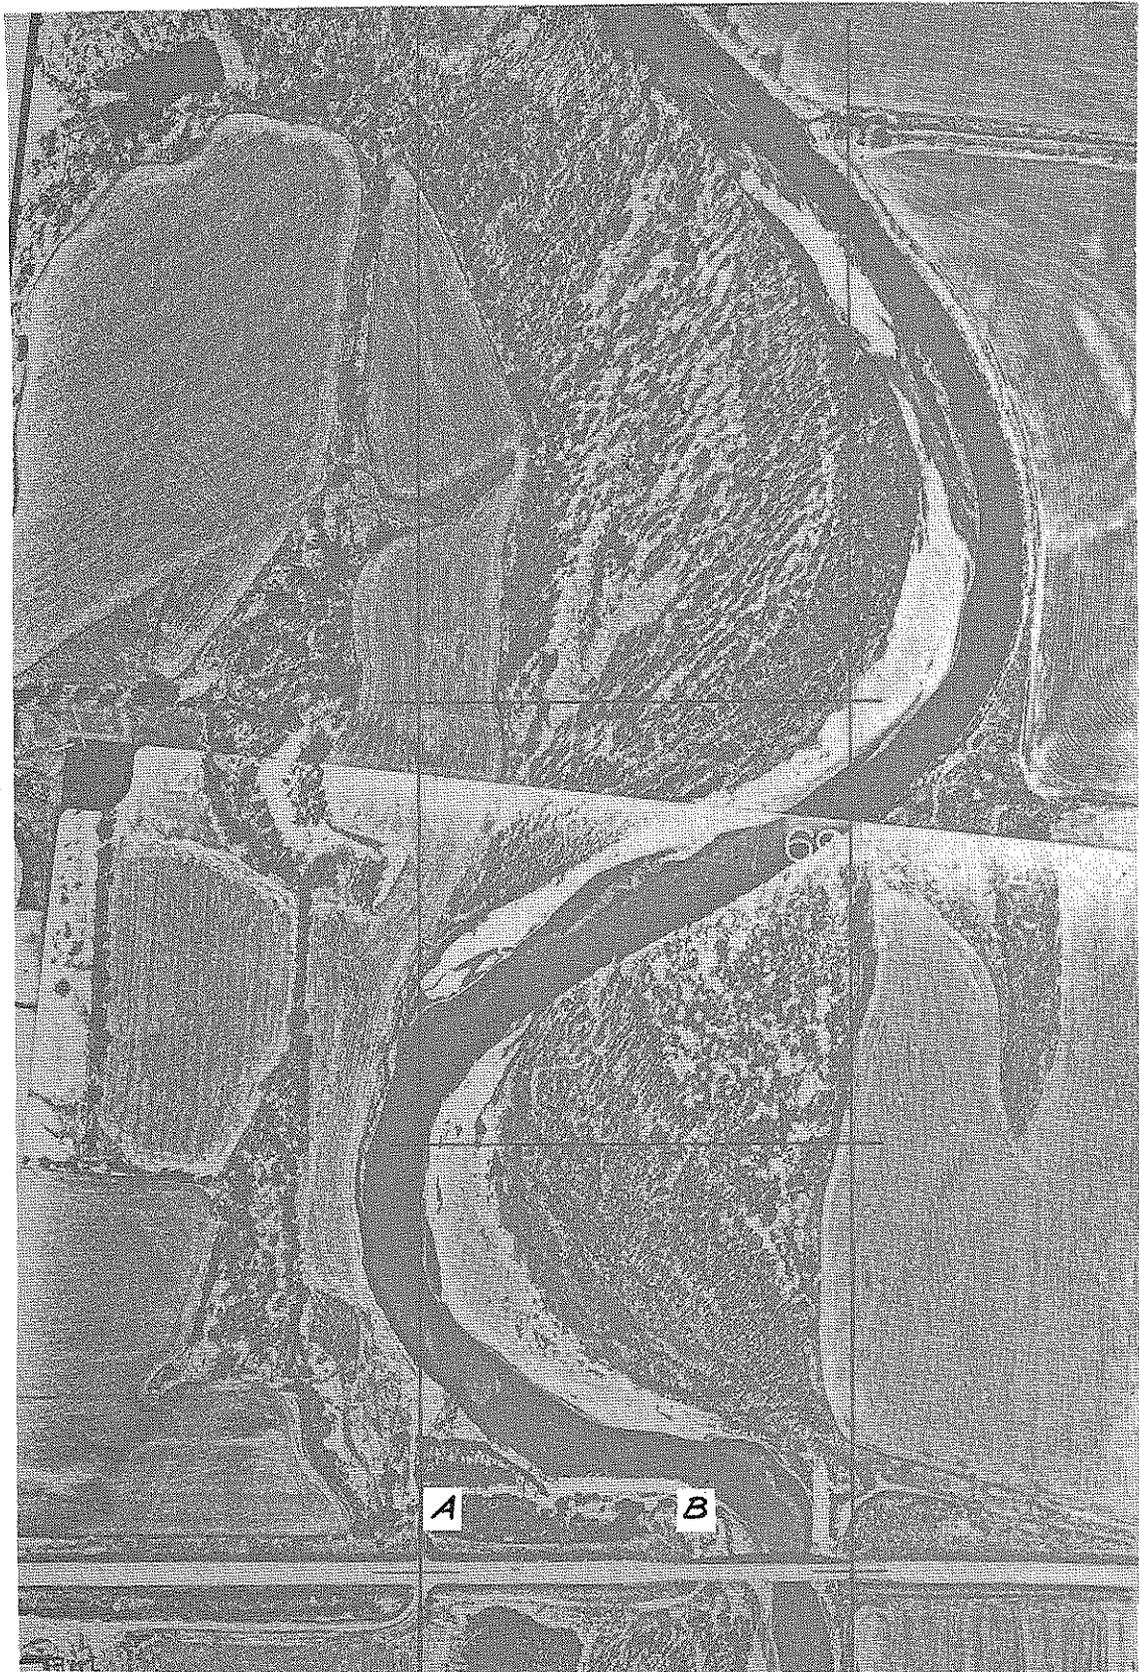
Figure 2. Aerial Photo of East Nishnabotna River and U.S. Highway 34 at Red Oak, Montgomery County, Iowa, March 7, 1977

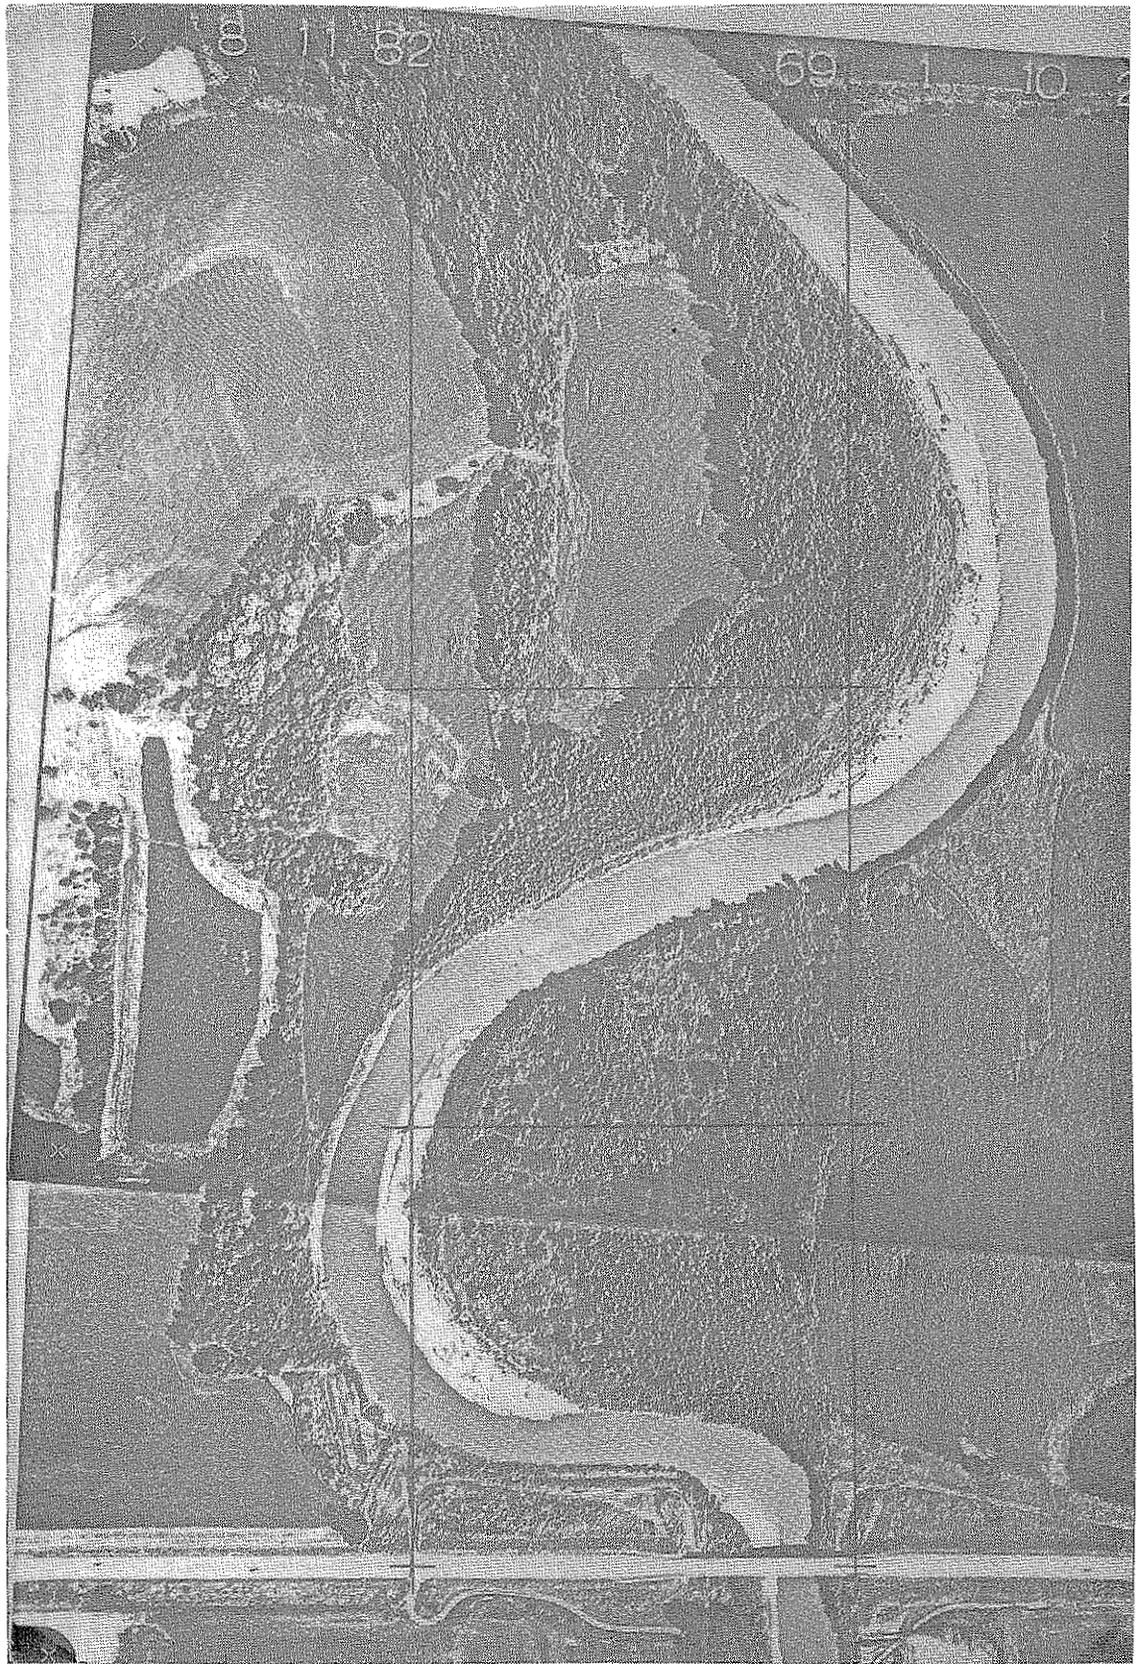
Figure 3. Aerial Photo of East Nishnabotna River and U.S. Highway 34 at Red Oak, Montgomery County, Iowa, August 11, 1982

orientation on the channel bed. A relatively small number of vanes can produce bend flows which are practically uniform across the channel. The height of the vanes is less than half the water depth, and their angle with the flow direction is of the order of 10°. In this study, design relations have been established (Chapter II). The relations, and the vanes' overall performance, have been tested in a laboratory model under different flow and sediment conditions (Chapter III). The results are used for the design of an Iowa-Vane bank protection structure for a section (Fig. 3) of East Nishnabotna River along U.S. Highway 34 at Red Oak, Iowa (Chapter IV).

The results of the theoretical analysis and the laboratory-model experiments were used for the design of a vane structure for the meander bend in Fig. 3 for the protection of U.S. Highway 34 and its bridge over East Nishnabotna River. The flume in which the aforementioned experiments were conducted, models, with some idealization, this meander bend at an undistorted scale of approximately 1:10. Fig. 37 shows the IIHR flume overlaid the prototype bend, using the scale ratio 1:10.

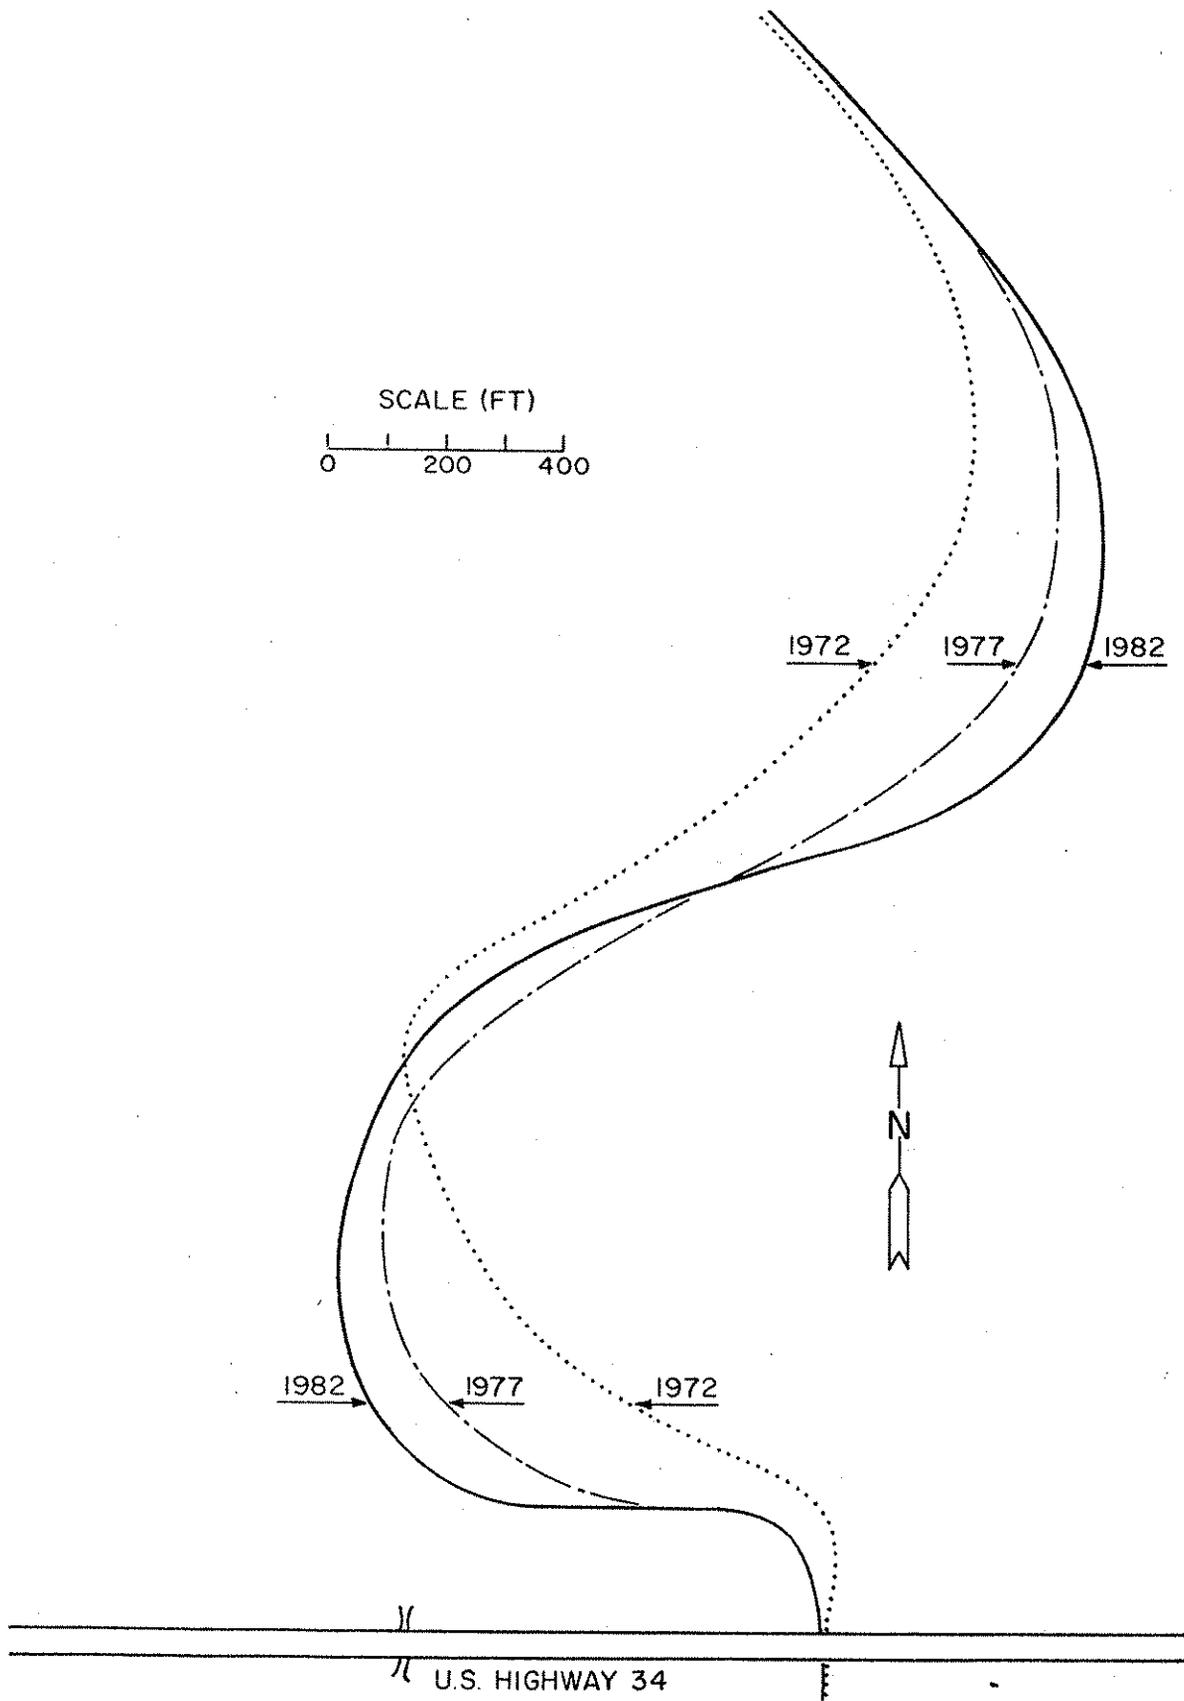
Fig. 4 - Sequential Centerlines of East Nishnabotna River at Red Oak, Montgomery County, Iowa.

At some of these locations protective measures have been installed by the Iowa Department of Transportation. The methods in current general use involve either armoring of concave banks by one means or another, ranging from paving with stone or concrete to enhanced vegetative cover; or reduction of the nearbank velocity by dikes or other structures that increase the local channel roughness. Many of these methods are of a temporary nature and do not solve the problem on a long-term basis. For example, HW 34's crossing of East Nishnabotna River (at Red Oak, Montgomery County) is presently being protected by rip-rap structures along certain reaches of the river bank just upstream from the crossing. In a few years time a major section of the rip-rap structure is going to be undermined from behind and washed away unless substantial, additional protection work is undertaken. The problem at this location is seen very clearly on the aerial photos in Figs. 1, 2, and 3; and in Fig. 4 which shows the location of the channel-center line in 1972, 1977, and 1982). The present rip-rap structure along the right bank of the river (between the points A and B in Fig. 2, a total of 600 ft), which was installed in 1977, has so far offered excellent protection of the highway. However, during the 10-year period, shown in the figures 1, 2, 3, and 4, apex of the lower meander curve has moved approximately 500 ft southward and is now only about 500 ft from the

highway. It is obvious that the present bank protection will be insufficient for the protection of the highway in the future. At the present rate of bank erosion at this site, the rip-rap structure between A and B will be undercut and 1000 ft of Highway 34, including the highway bridge, will be seriously damaged within the next 5 to 7 years unless additional protection is provided. Problems of similar nature are being faced at several other highway sections and bridge crossings in Iowa, some of which were mentioned in the preceding paragraphs.

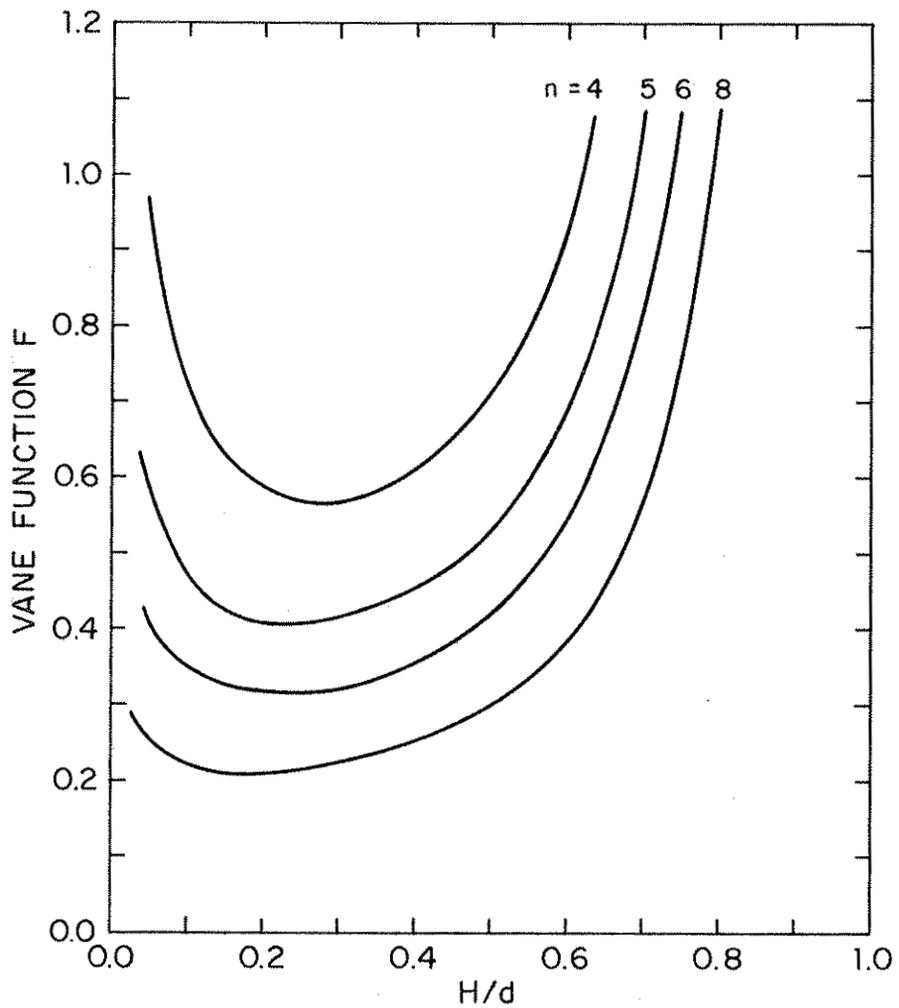
Figure 5. Vane Function F as a Function of Vane Height-Water Depth Ratio, H/d, for Four Values of n

Eq. 9 yields the total vane area (lifting surface) needed per unit surface area of channel bed $[NHL/(r_c \phi b)]$ as a function of the radius-depth ratio of the channel, r_c/d ; lift coefficient, c_L ; and the vane function, $F = F(n, H/d)$. The vane function is graphed in Fig. 5. It is seen that for given value of H/d the value of F , and therefore the required lifting surface, increases when n decreases (i.e., when the frictional resistance increases). The vane function has its minimum at $H/d = 2(n+1)/(n+2)^2$:

Corresponding values of F_{\min} , H/d , and n are listed in Table 1. The vane function is seen to be relatively insensitive to variations of H/d over a fairly large range of H/d -values. For example, for $n = 4$, F is within 20% of its minimum value (the design value) when H/d is within the range of $0.12 < H/d < 0.48$ (that is, when the water depth is between 2 and 8 times the vane height). A typical river bend

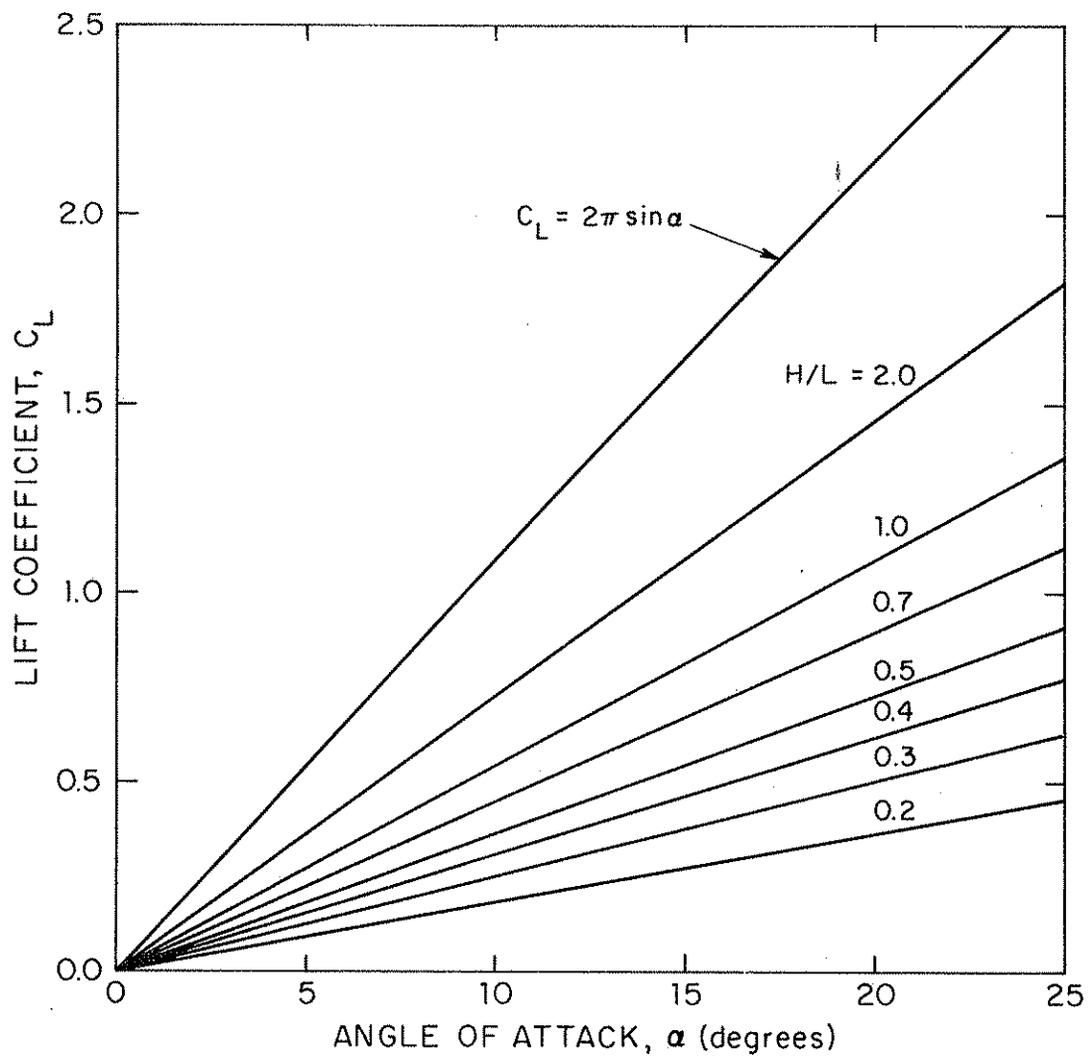
Figure 6. Lift Coefficients for Flat-Plate Vane

The study has verified that Eqs. 9, 14, and 16 can provide a reasonably accurate estimate of the vane-lift surface required to obtain a specified reduction in near-bank velocity or corresponding transverse bed slope. The lift coefficients, c_L , used in the experiments (0.4 to 0.6) were obtained from Fig. 6 which was developed by extrapolation using a procedure that has been verified for aspect ratios (H/L) greater than or equal to one. The dependence of c_L on angle of attack (α) and aspect ratio (H/L) depicted in Fig. 6 has not been verified experimentally for aspect ratios less than one. The results of the theoretical analysis and the model tests suggest that:

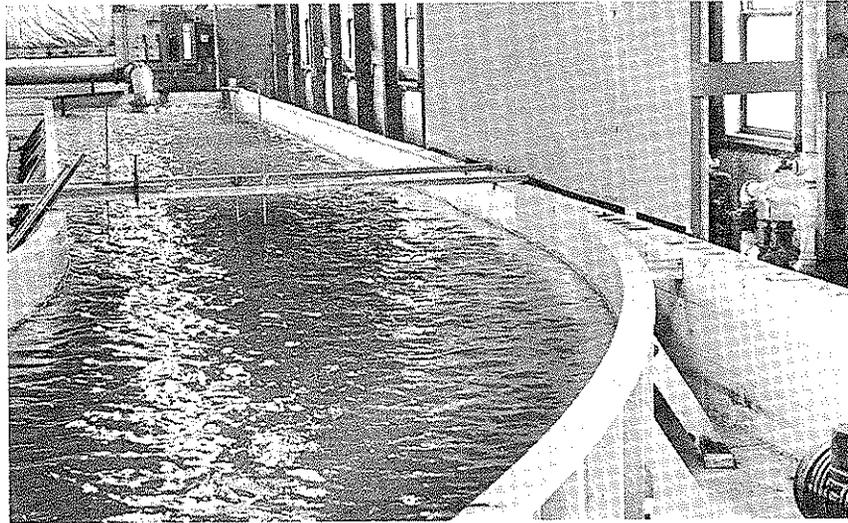
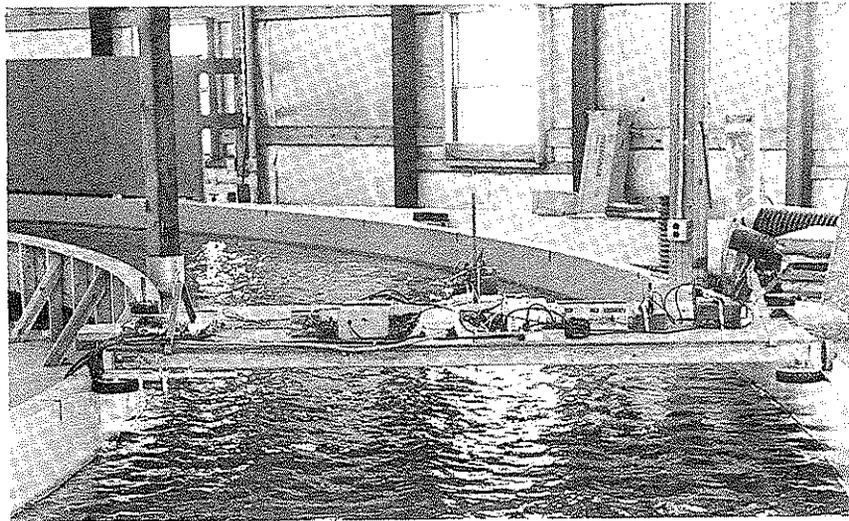
Figure 7. IIHR's Curved Sediment Flume; (a) Viewed Upstream Toward the Flume Inlet; and (b) Viewed Upstream Around the Curve

The validity of the foregoing design relations, and the effectiveness of the vanes in producing more uniform lateral distributions of depth and velocity, were tested in IIHR's 250-ft long, 8-ft wide, and 2-ft deep, curved, recirculating sediment flume (Fig. 7) Fig. 8 shows the layout of the flume with section numbers, which are the distances, in feet, from the inlet, measured along the inner flume wall. The center-line radius of the curved part of the flume is 43 ft. The instrumentation and measurement technique were described by Odgaard and Kennedy (1983). Tests were conducted with both uniform and nonuniform bed material with smooth and rough banks; with different vane lengths and emplacement; and with vanes composed of modeled sheet piling and steep-sided windrows of rock. A summary of test conditions is given in Table 2.

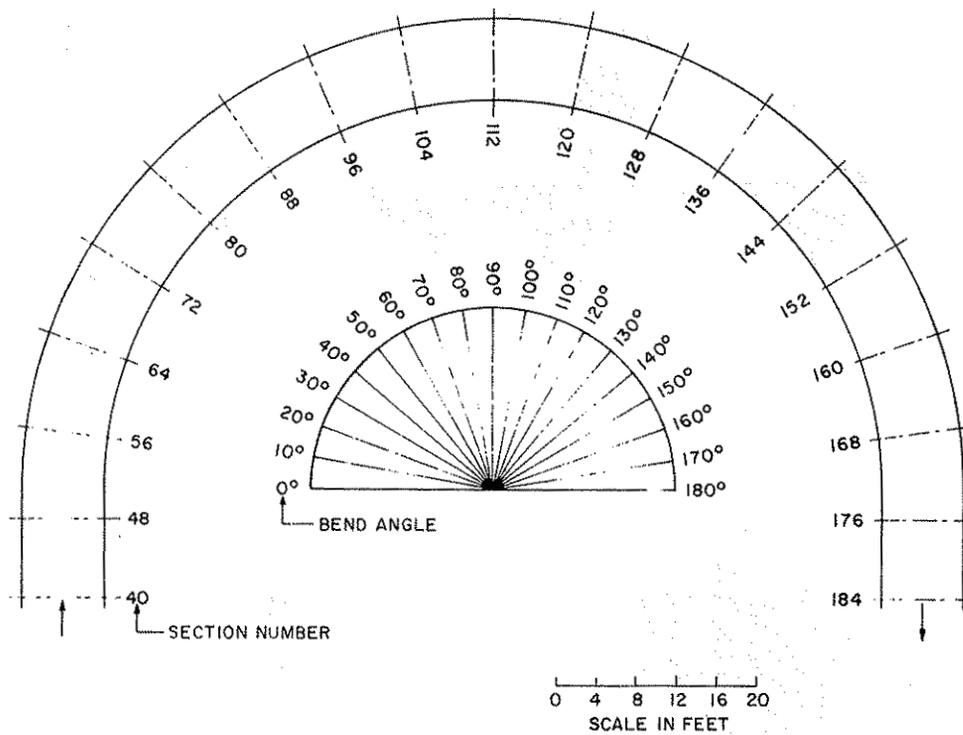
Figure 8. Layout of IIHR's Curved, Recirculating Sediment Flume, with Section Numbers and Bend Angles

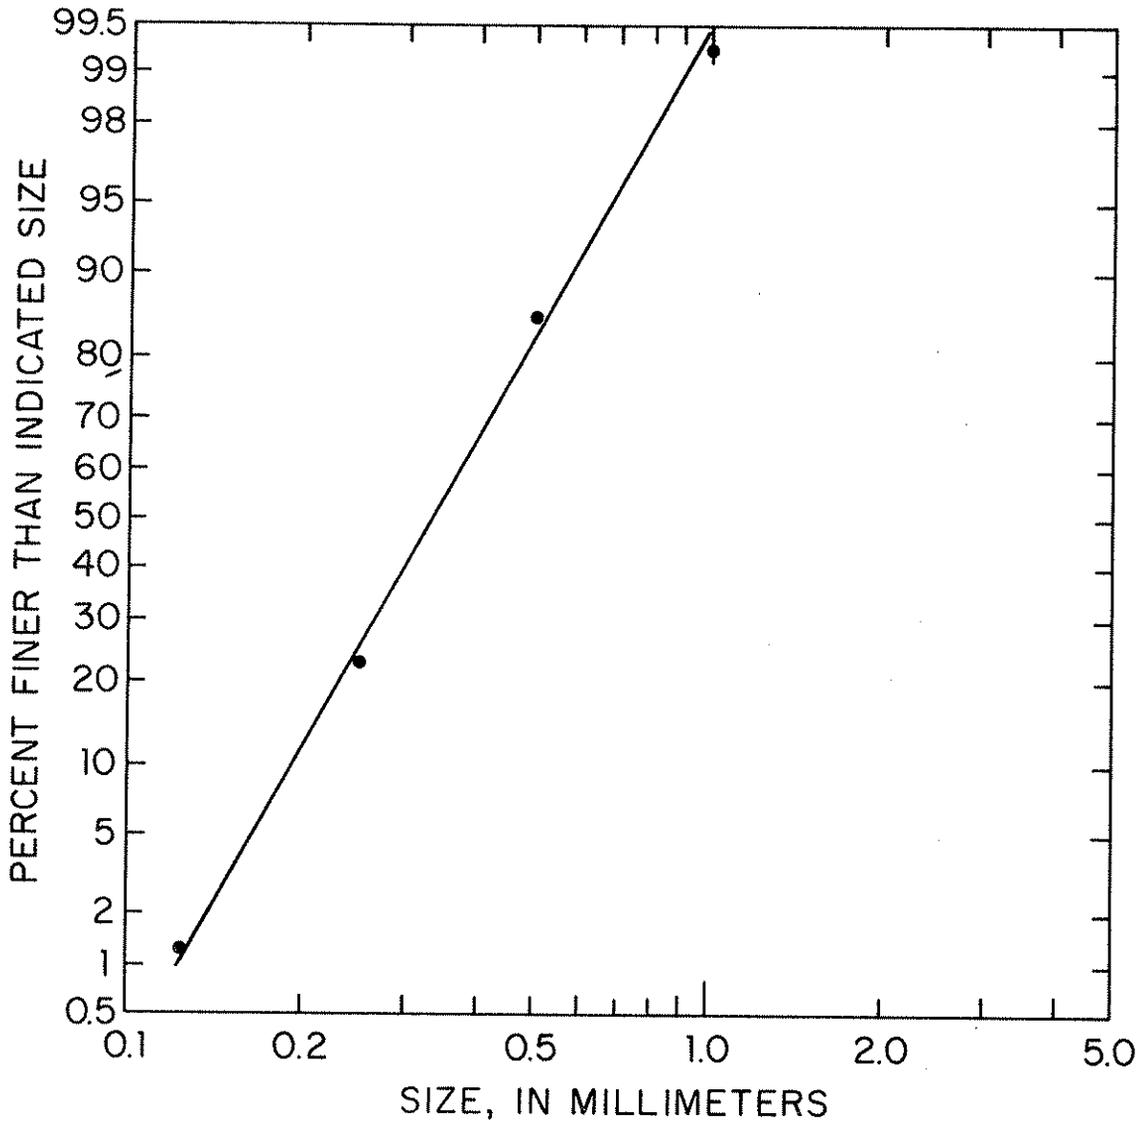
Figure 9. Grain-Size Distribution for Uniform Bed Sediment, Test Series 1 and 2

1. Uniform Bed Sediment - In Test Series No. 1, the sediment was sand with a median diameter of 0.30 mm and a geometric standard deviation of 1.45 (Fig. 9). The sand was placed in the flume in a 9-in. thick layer throughout. After about an hour of gentle wetting, the sand bed was subjected to a flow of 5.2 cfs for a period of 160 hours. The bed topography was measured after periods of 10, 20, 40,

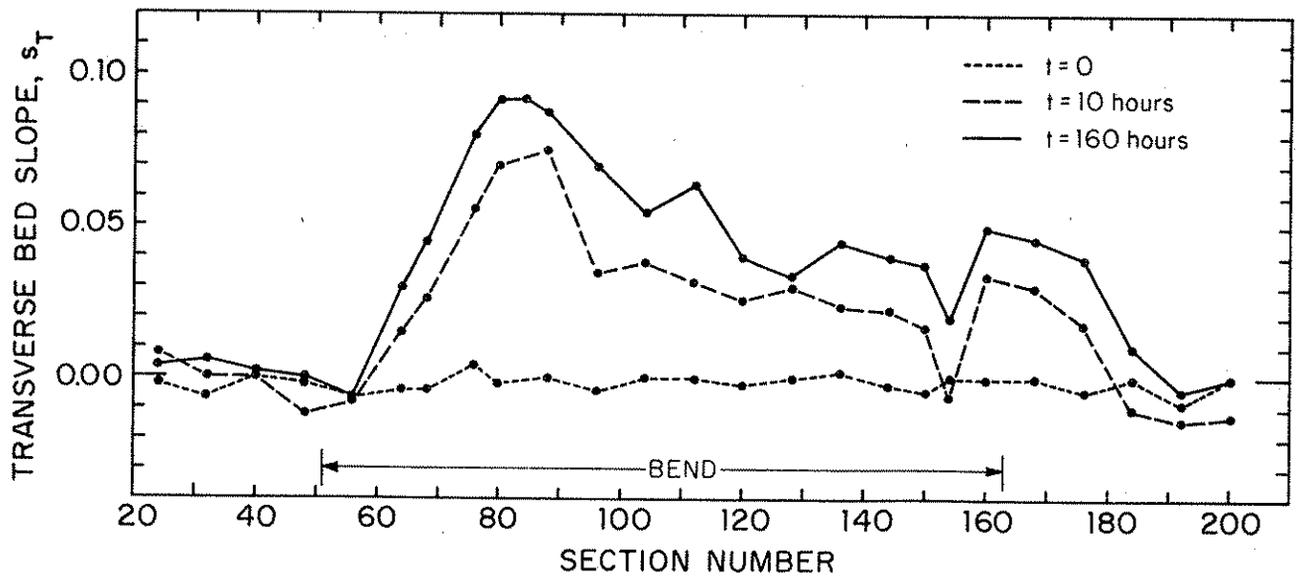
Figure 10. Streamwise Variation of Transverse Bed Slope Development, Test Series No. 1

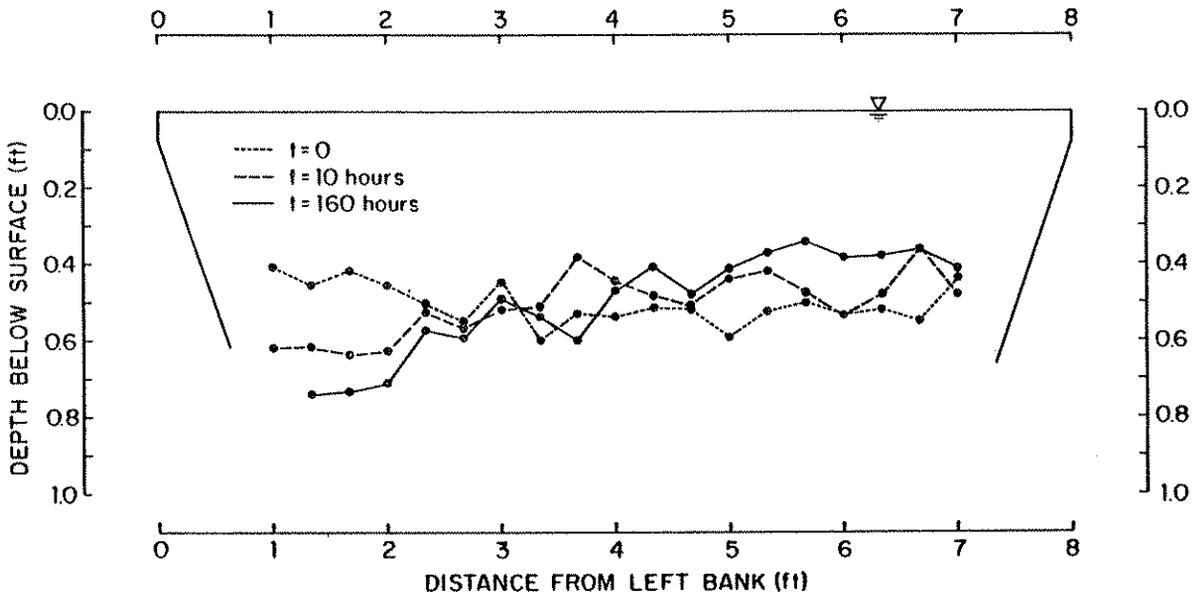
Figure 11. Development of Bed Profile at Section 80, Test Series No. 1

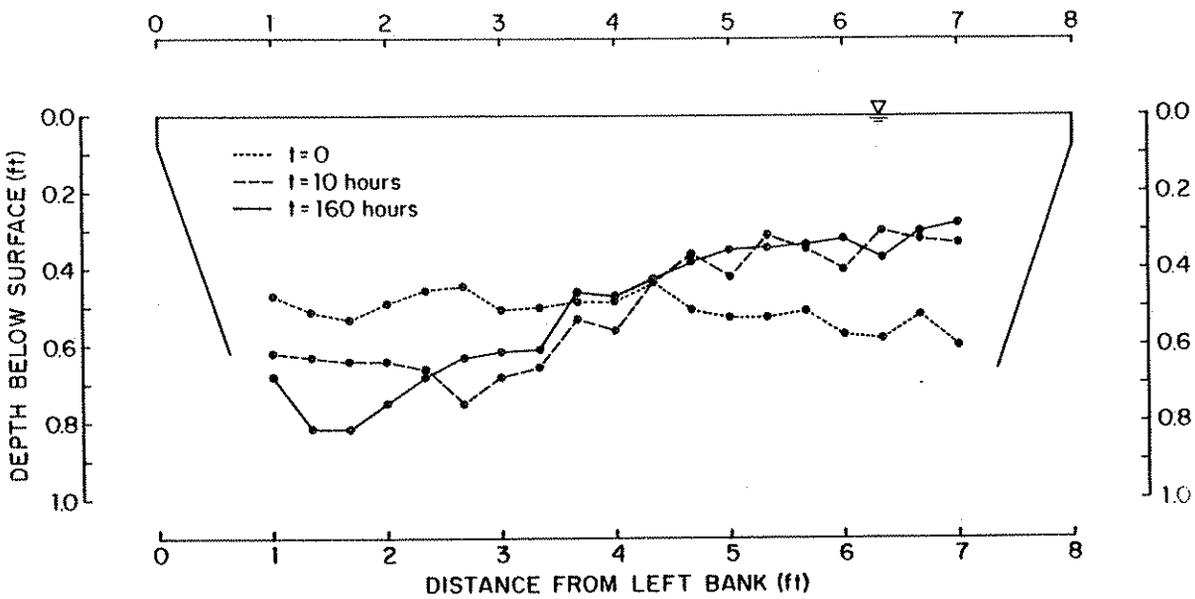
Figure 12. Development of Bed Profile at Section 112, Test Series No. 1

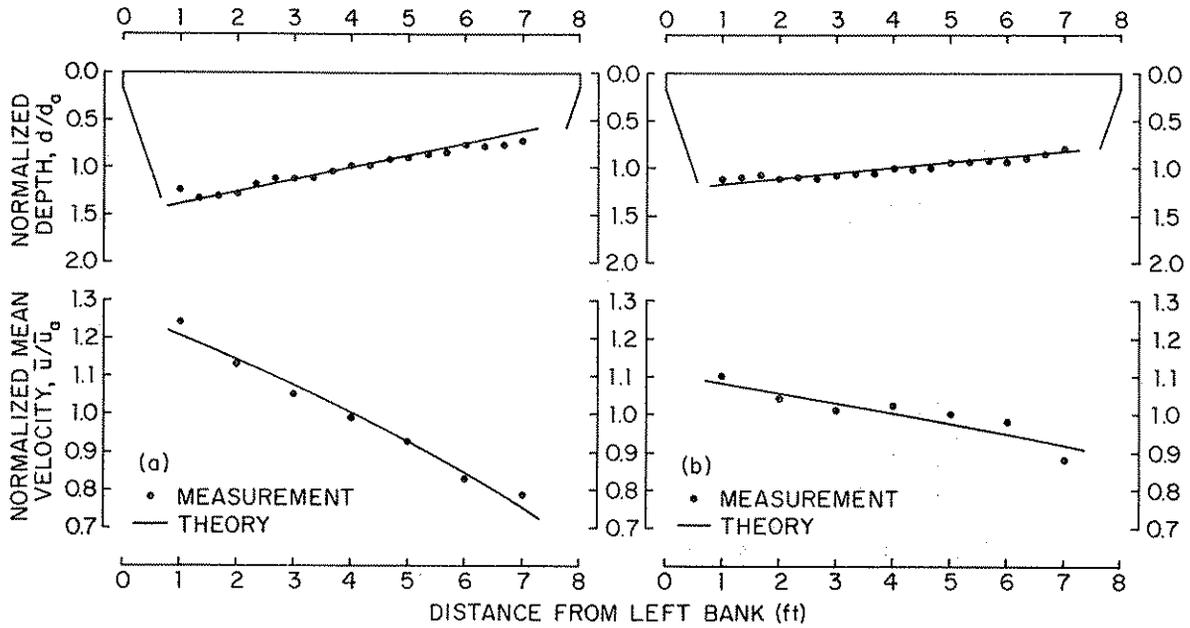
Figure 13. Test Series 1: Measured Radial Average-Distribution of Depth and Depth-Averaged Mean Velocity Compared with the Predicted Distributions; (a) Before Installation of Vanes; (b) After Installation of Vanes

total of 15.7 ft³ of sand was moved from the inner half of the channel to the outer half. In other words, the vane system caused 52% of the sand that was originally moved (during the initial bed-forming process) from the outer half to the inner half to return to the outer half of the channel. As Fig. 13b shows, the average distributions of depth and velocity are in good agreement with those predicted by the design procedure. In Fig. 15 it is seen that the vane system performed better over the first half of the bend than over the second half. This may have been due to the fact that the reach between Sections 64 and 104 was furnished with 28 vanes (in double-array) whereas the remaining part of the bend had only 14 vanes (in single array), or 30 percent fewer vanes than called for by the design calculations (which were done after the completion of the tests).

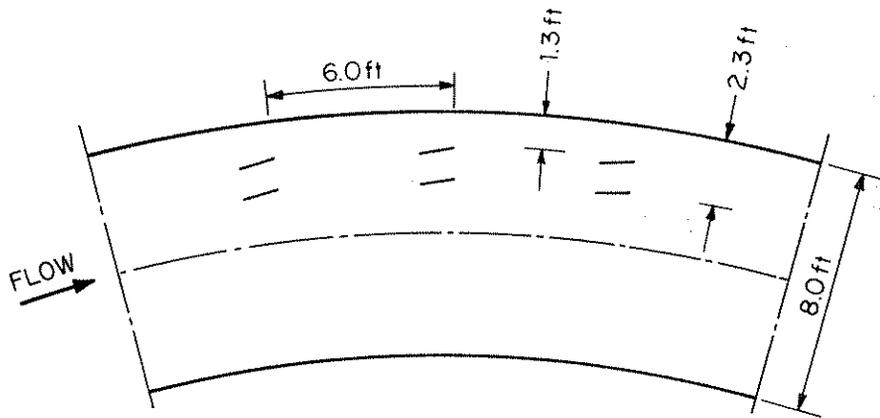
Figure 14. Test Series 1 Vane Emplacement

The vanes were installed in a two-row array up until Section 104, and a one-row array beyond Section 104. The emplacement of the two-row array is sketched in Fig. 14. The emplacement of the one-row array was the same as that of the outer row in Fig. 14. The vanes were installed on the dry 5.2-cfs channel bed such that their top edge was 0.4 ft under the 5.2-cfs water surface. The flow rate was then gently increased to 5.2 cfs, and maintained at this rate for a period of 160 hours. The bed topography was measured after 10, 20, 40, 80, and 160 hours. The transverse bed slope was observed to change very rapidly within the first 10 hours after the start of the flow, as Figs. 15, 16, and 17 indicate. Over the 160-hour period, a

The vane-design formula was tested with a system of 42 14-in. vanes in the Fig. 14 configuration. The design calculations (Tables 3 and 4) show that this system corresponds with the design objective of obtaining a reduction of the transverse bed slope from 0.07 to 0.03, which is seen to be in very good agreement with that measured. The vane system is seen to have performed with about the same efficiency as in the case of uniform sand (Table 5).

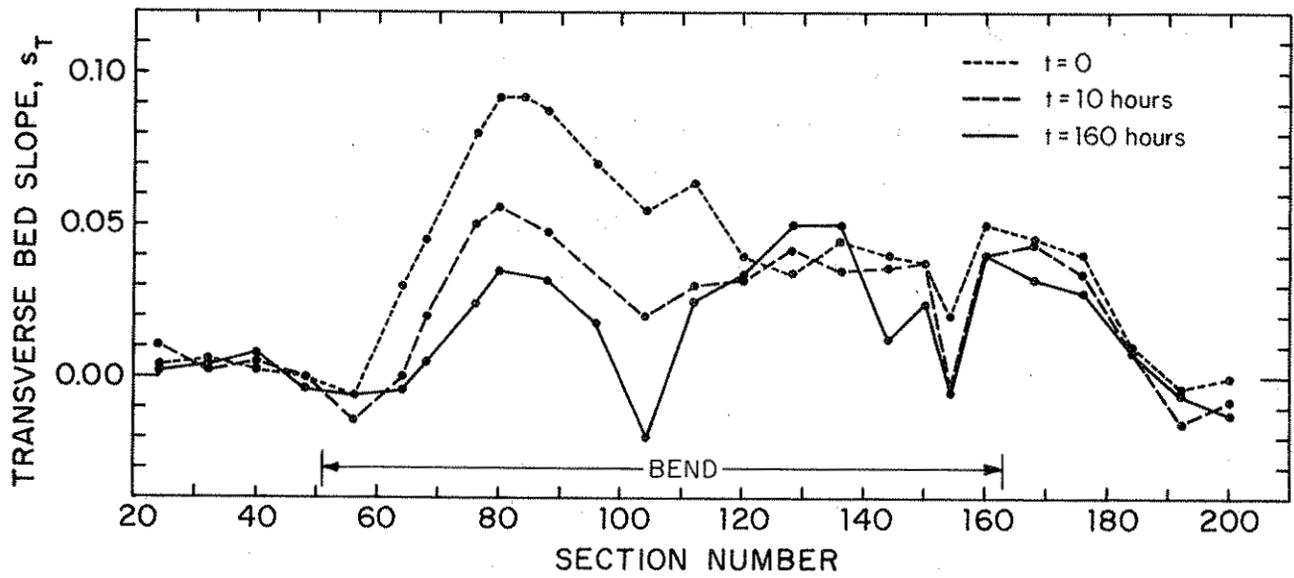
Figure 15. Streamwise Variation of Transverse Bed Slope Development after Installation of Vanes; Test Series No. 1

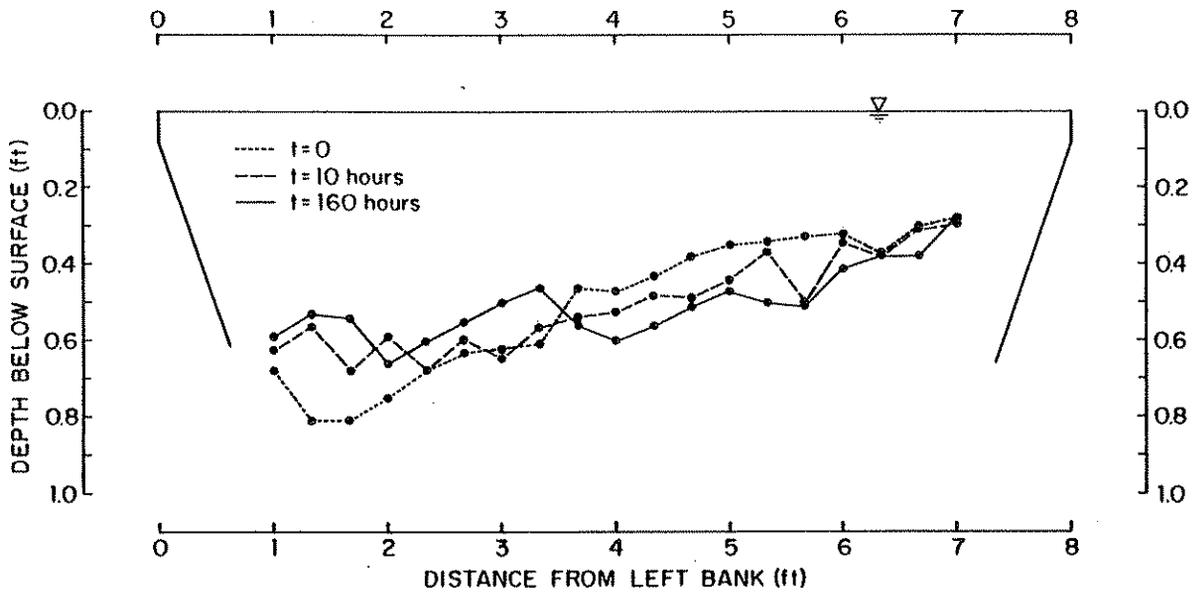
Figure 16. Development of Bed Profiles at Section 80 after Installation of Vanes; Test Series No. 1

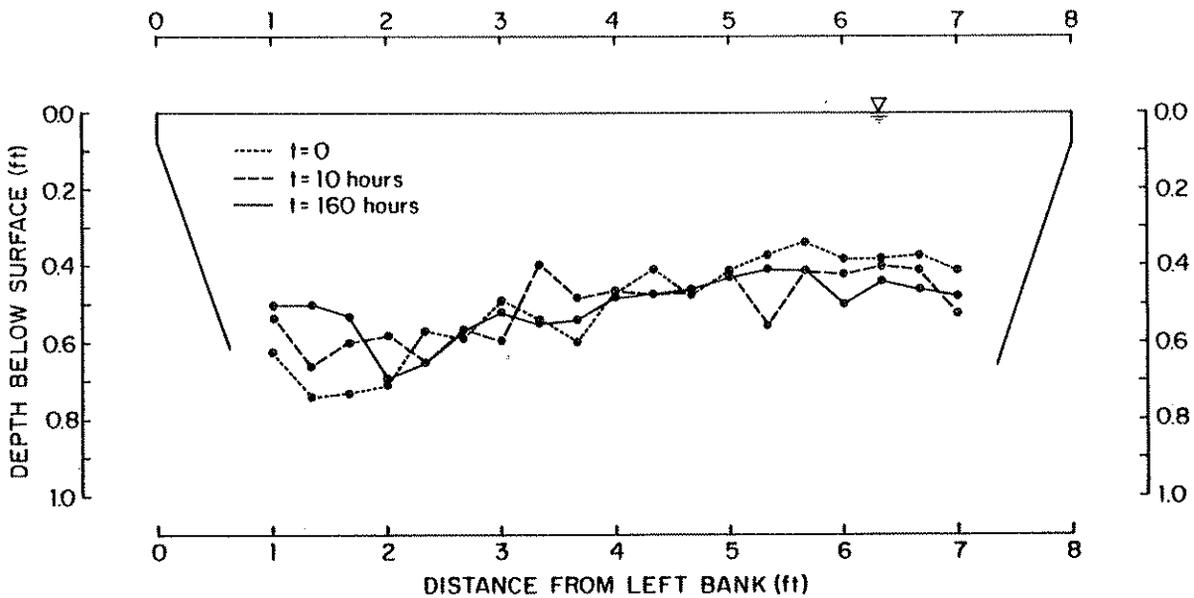
Figure 17. Development of Bed Profiles at Section 112 after Installation of Vanes; Test Series No. 1

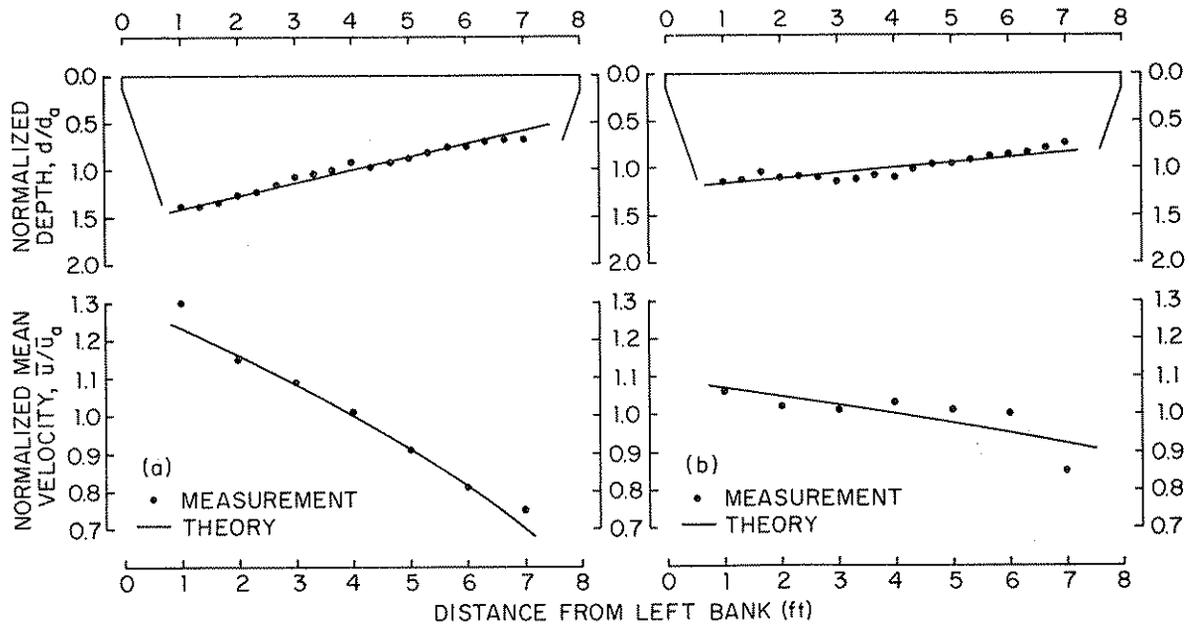
Figure 18. Test Series 2: Measured Radial Average-Distributions of Depth and Depth-Averaged Mean Velocity Compared with the Predicted Distributions; (a) Before Installation of Vanes; (b) After Installation of Vanes

Test Series No. 2 was conducted with the same grade of sediment in the flume as Test Series No. 1. The maximum flow rate was 6.0 cfs. At fully developed flow and bed topography, the longitudinal slope of the water surface and the cross-sectional average values of depth and velocity were 0.00146, 0.54 ft, and 1.40 ft/sec, respectively. Thus, $F_D = 6.11$, $n = 3.5$, $u_* = 0.16$ ft/sec, and $\theta = 0.04$. Based on these flow data, Eq. 12 predicts a transverse bed slope of $S_T = 0.074$, which is in good agreement with those measured (Fig. 18a).
