SUBMERGED VANES FOR FLOW CONTROL AND BANK PROTECTION IN STREAMS

A. Jacob Odgaard and Hong-Yuan E. Lee

the Highway Division of the Iowa Department of Transportation
and
the Iowa Highway Research Board
Project HR-255

IHR Report No. 279

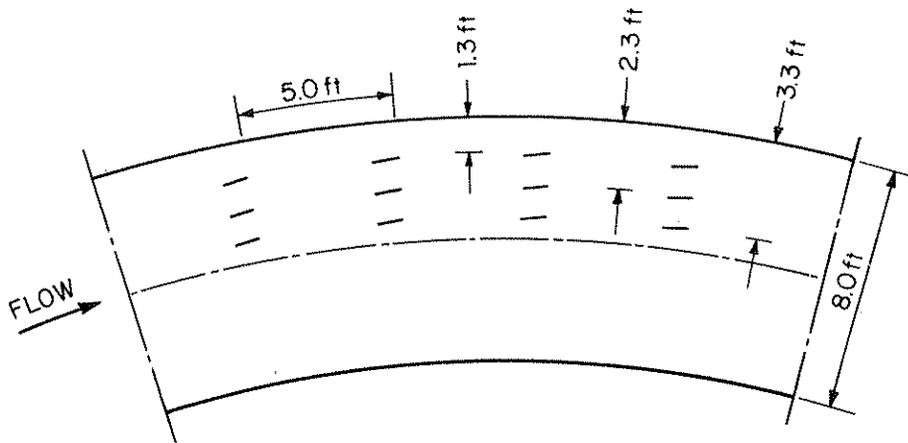
Figure 19. Test Series 2 Vane and Vane Emplacements

In Test Series No. 2, the vane-design formula was tested with a system of 84 9-in. long, slightly curved vanes (Fig. 19). These tests were conducted specifically to verify that the lift force, and therefore the torque T_v , produced by a given lift-surface area increases when the aspect ratio increases. As the design calculations, summarized in Tables 3 and 4, show, the number $N = 84$ corresponds with the design objective of obtaining a reduction of the transverse bed slope to approximately 0.03, the same objective as in Test Series No. 1. By reducing the vane length from 14 in. to 9 in., the aspect ratio goes up from 0.2 to 0.3, and, according to Fig. 6, the lift coefficient becomes 0.6 as opposed to 0.4 with 14-in. vanes. Hence, with 9-in. vanes, the required lifting surface is 33% lower than if 14-in. vanes were used. The calculations summarized in Table 5 show that the effectiveness of the 9-in. vane system is as good as that of the 14-in. system as far as recovery of sediment volume, near-bank depth and near-bank velocity are concerned. The 9-

The most encouraging result was obtained in an experiment in which 12 24-in. long windrows of marble-filled baskets were installed between Sections 72 and 112 at 15° with the mean-flow direction (Fig. 27), with the remaining part of the bend furnished with 40 9-in. sheet-metal vanes in the Fig. 19 configuration. The bed sediment was that used in Test Series No. 2. The marble vanes were installed on the Run 2-1 channel bed, as developed by the 84 9-in. vanes, by replacing the 9-in. vanes between Sections 72 and 112 with marble vanes. Fig. 26 shows the average distributions of depth and velocity between Sections 72 and 112 before any vanes were installed (Fig. 26a); after the 9-in. vanes were installed (dotted curves in Fig. 26b); and after the 9-in. vanes were replaced by the marble vanes (solid curves in Fig. 26b). Approximately 50% of the sand that the 9-in. vanes recovered in the outer half of this channel portion was lost again when the 9-in. vanes were replaced by the marble vanes. The marble vanes reduced the near-bank velocity to the cross-sectional average value for this portion of the bend, as indicated in Fig. 26b; however, this reduction was accompanied (and explained) by a very significant decrease of the slope of the water surface over this reach. Despite that this experiment was by far the most successful of the rock-vane experiments, Fig. 28 clearly show that more development work is needed before "rock vanes" can be considered to be an efficient alternative to sheet-pile vanes.

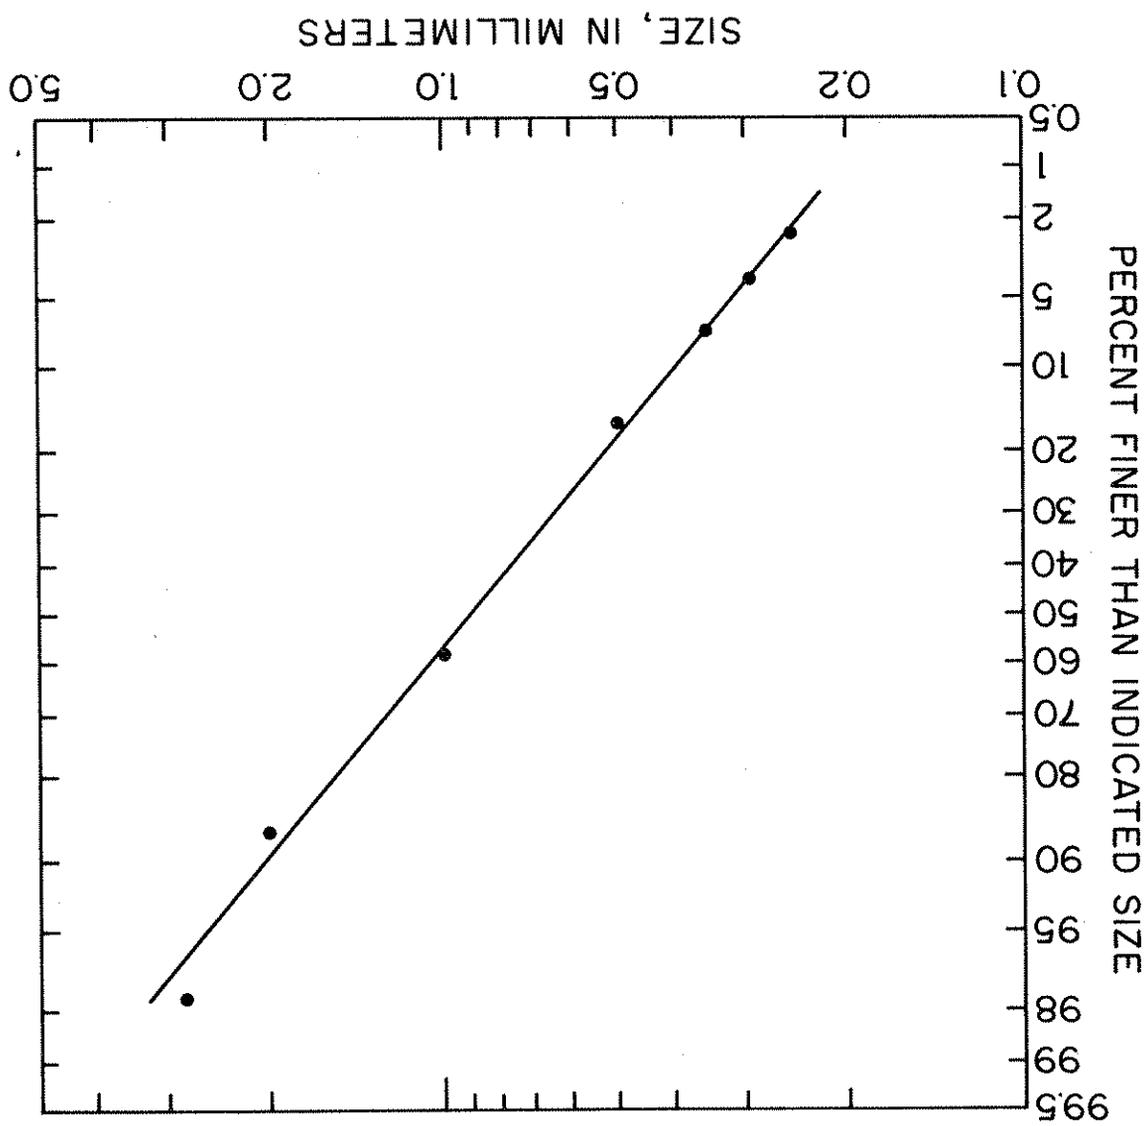
Figure 20. Grain-Size Distribution for Nonuniform Bed Sediment;
Test Series No. 3

2. Nonuniform Bed Sediment - In Test Series No. 3, the sediment was sand with a log normal grain-size distribution with a median diameter of 0.90 mm and a geometric standard deviation of 1.90 (Fig. 20). The discharge was 5.8 cfs. Initially, the sand was distributed uniformly throughout the flume. As the water-sediment mixture was then propelled through the flume, grain sorting took place. The smaller fractions tended to accumulate near the inside of the bend leaving the larger fractions along the outside. When steady-state conditions were obtained, water-surface elevations, and distributions of depth, velocity, and grain size, were measured. Notable features of the bed topography were a point bar along the inner bank between Sections 88 and 104; and an attendant relatively deep scour hole at Section 80. Deep scour holes occurred also at the outer bend at Sections 136 and 170. It is noteworthy also that the sediment in the surface layer of the bed was generally finer than that below the surface. The coarser fractions only surfaced within a distance of about 2 ft from the outer flume wall. Bed-material samples taken below the surface of the bed throughout the bend showed that the original sand mixture was found at a depth of three to five inches below the bed surface, indicating that grain sorting was limited to the upper three to five inches of the sediment layer. Bed armoring did not occur. The overall median diameter of the sediment in the surface layer of the bed was determined to be $D_a = 0.50$ mm. The longitudinal slope of the water surface, and cross-sectional average values of depth and mean velocity were measured to be 0.00063, 0.47 ft, and 1.56 ft/sec, respectively, yielding $F_D = 5.27$, $n = 6.5$, $u_* = 0.10$ ft/sec, and $\theta = 0.04$. Based on these flow data, Eq. 12 predicts a transverse bed slope of $S_T = 0.055$, which is in reasonable agreement with those measured (Fig. 21). The overall average transverse bed slope was measured to be 0.07.

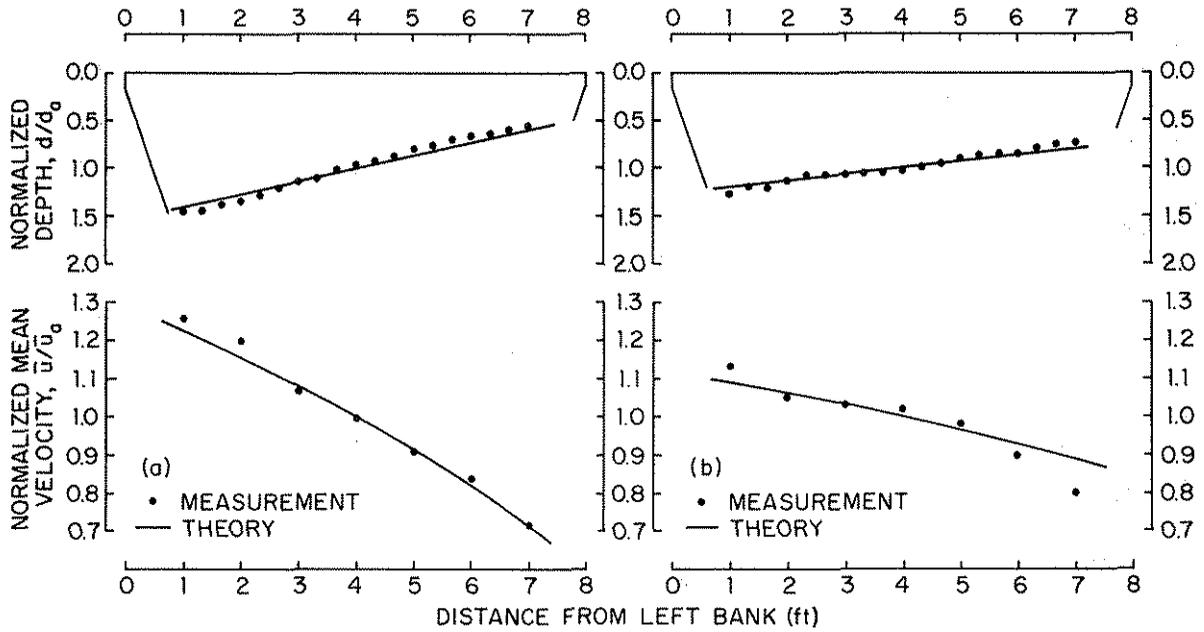
Figure 21. Test Series 3: Measured Radial Average-Distributions of Depth and Depth-Averaged Mean Velocity Compared with the Predicted Distributions: (a) Before Installation of Vanes; (b) After Installation of Vanes

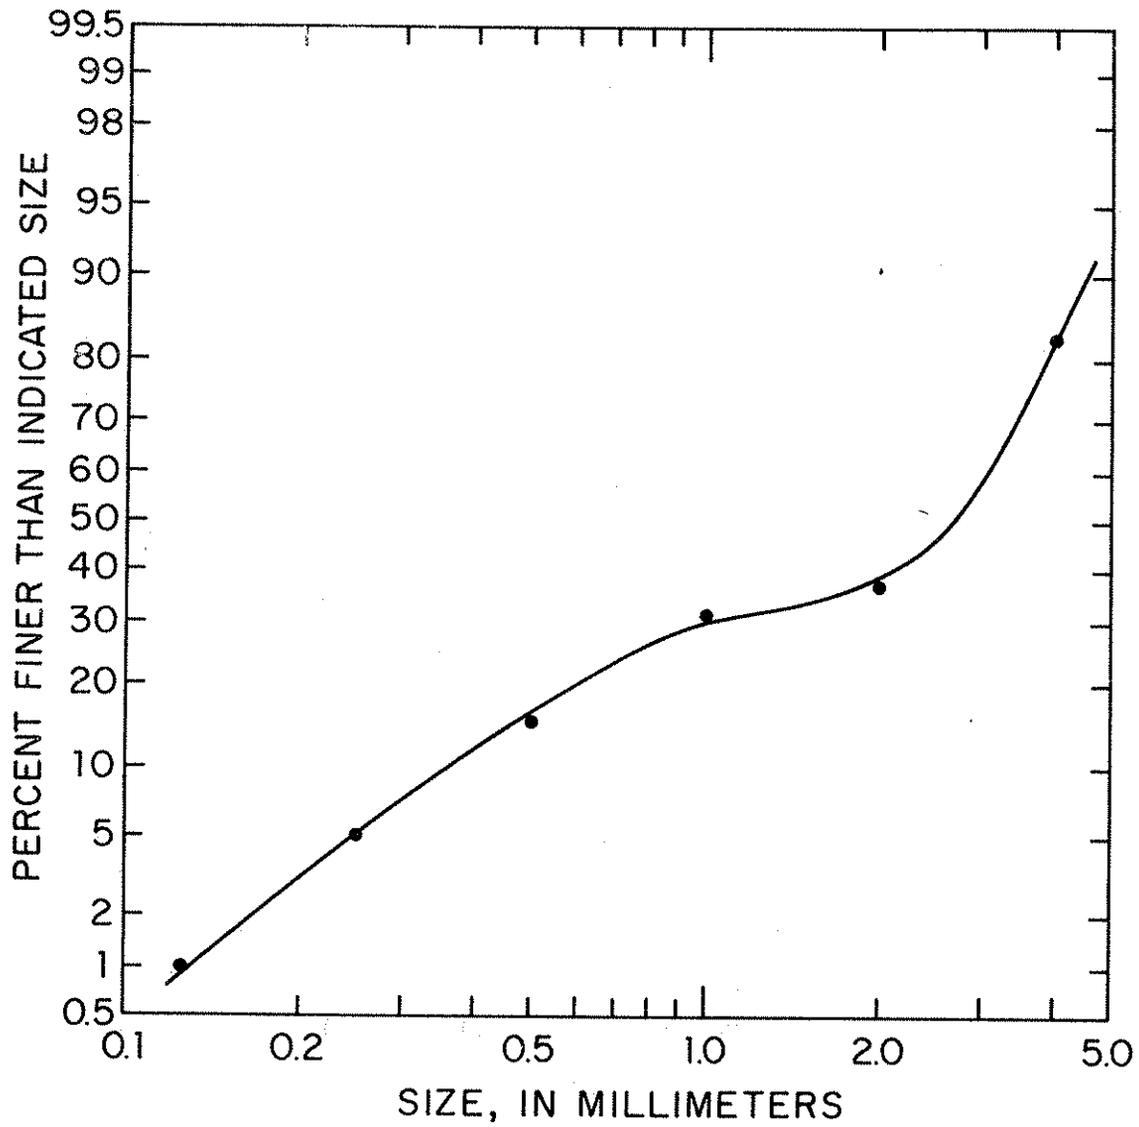
Figure 22. Grain-Size Distributions for Nonuniform Bed Sediment;
Test Series No. 4

The bed material in this test series was that of Test Series No. 3 supplemented with coarse sand to give the grain-size distribution shown in Fig. 22 (several different mixtures were tested before one was found that armored over a significant part of the bend). During the process of bed armoring, the bed level was observed to increase in the straight approach section causing the overall longitudinal bed slope to be somewhat larger than the slope of the water surface. Grain sorting took place both laterally and longitudinally. The bed became fully armored in the entire approach section and in the beginning of the bend up till Section 88. Between Sections 88 and 172 the bed material near the outer bank was coarse sand with a median diameter of about 3.2 mm and a geometric standard deviation of less than 1.4. Armoring occurred over most of the point bar within a distance of 4 to 5 ft from the inner flume wall. At full development, the overall average distributions of depth, velocity, and median-grain size were as shown in Fig. 23a. As was expected, Eq. 12 could not predict the transverse bed slope in this case. So

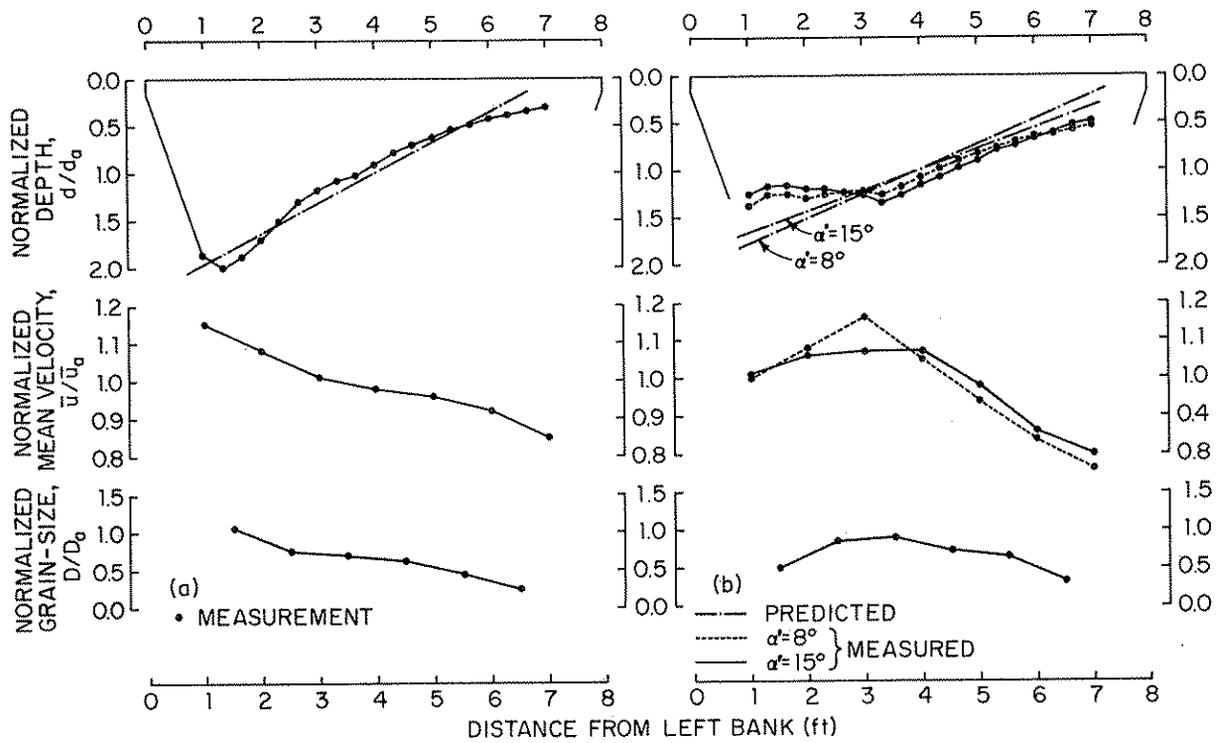
Figure 23. Test Series No. 4: Radial Average-Distributions of Depth, Depth-Averaged Mean Velocity, and Median-Grain Diameter; (a) Before Installation of Vanes; (b) After Installation of Vanes

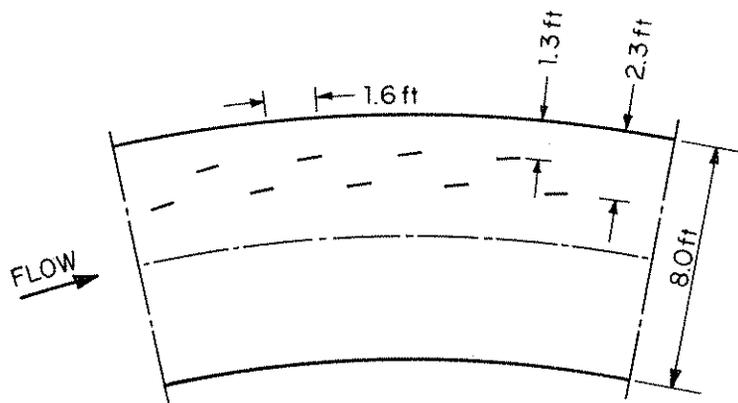
Figure 24. Test Series No. 4 Run 3 Vane Emplacement

In Run 4-3, the performance of 70 9-in. long vanes, installed at an angle of $\alpha' = 15^\circ$ in the Fig. 24 configuration, were tested. The objective was the same as that of Run 2-1 with uniform sand; i.e., to verify that the efficiency of a system with given lift-surface area increases when the aspect ratio of each individual vane increases. As the design calculations, summarized in Tables 3 and 4, show, the system of 70 9-in. long vanes at $\alpha' = 15^\circ$ corresponds with the design objective of obtaining a reduction of the transverse bed slope from 0.16 to 0.09. The predicted improvement over the 14-in. vane system is not apparent from the test results (Fig. 25); in fact, the performance is seen to have been slightly lower than that of the 14-in. system as far as near-bank depth recovery is concerned. However, it is noteworthy that the lift surface of the 9-in. system was about 10% smaller than that of the 14-in. system, and that the 9-in. system did not produce any measureable change of the slope of the water surface.

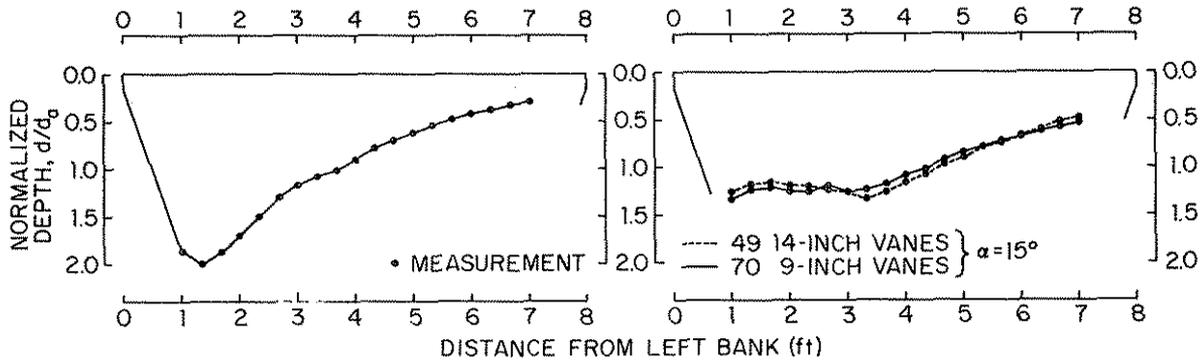
Figure 25. Test Series No. 4: Radial Average-Distributions of Depth; (a) Before Installation of Vanes; (b) After Installation of Vanes

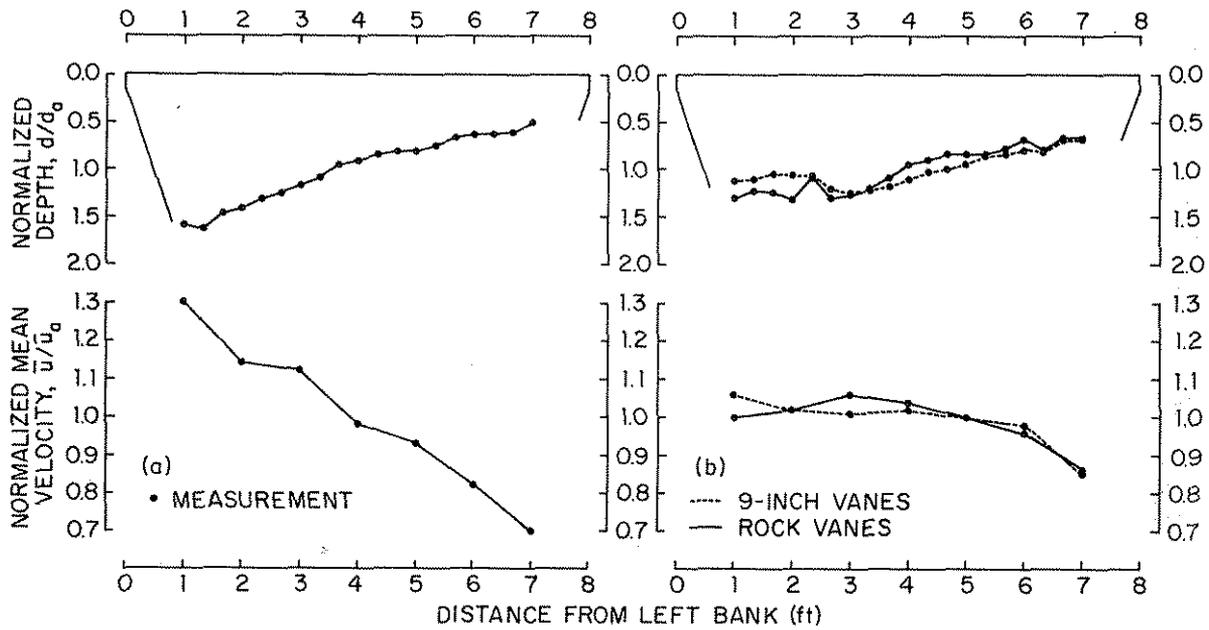
Figure 26. Test Series No. 5: Radial Average-Distributions of Depth, and Depth-Averaged Mean Velocity between Sections 72 and 112; (a) Before Installation of Vanes; (b) After Installation of Vanes

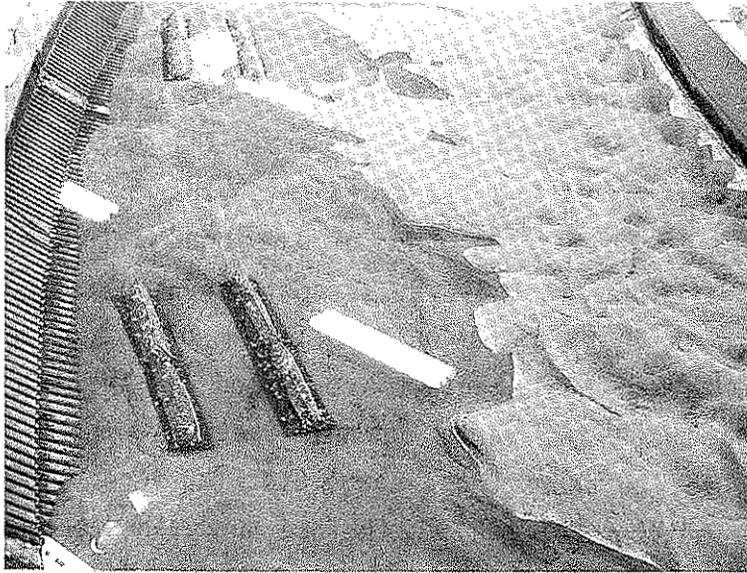
Figure 27. Test Series No. 5: Rock Vanes before Admission of Flow

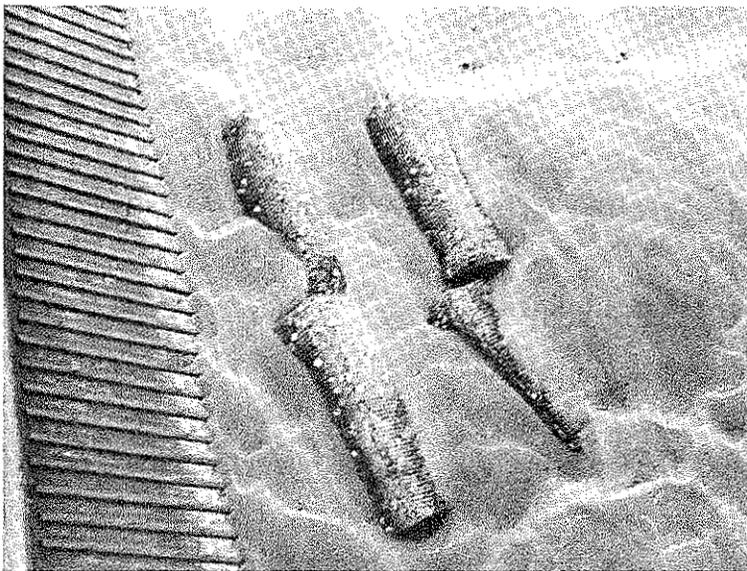
Figure 28. Test Series No. 5: Rock Vanes after Admission of Flow

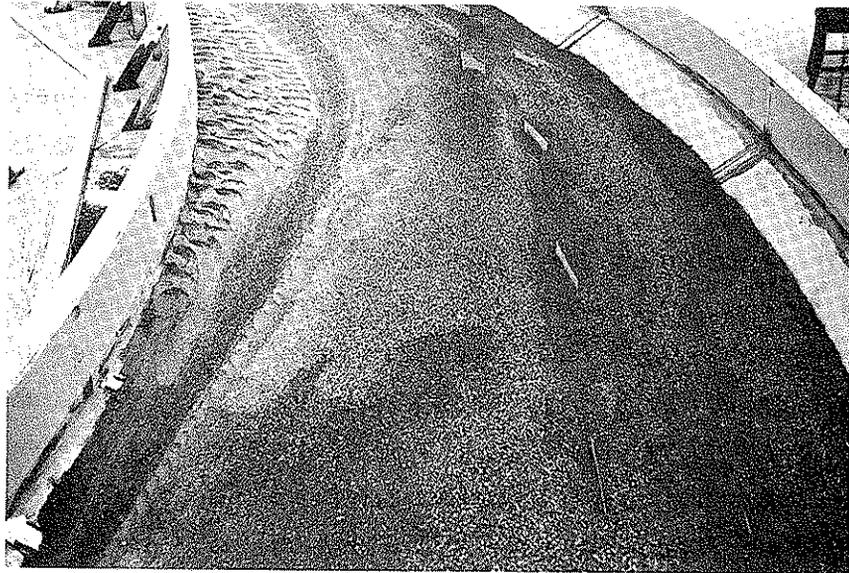
Figure 29. Naturally Formed Bed Topography in Test Series No. 4 (Looking Upstream)

The performance of the various sheet metal vanes is illustrated on the photographs in Figs. 29 through 36. Fig. 29 shows a naturally formed bed topography with partial armoring (from Test Series No. 4). Notable features are the flat point bar and the steep slope at the edge of it. Fig. 29 also shows the 14-in vanes installed in a two-row array up to Section 98 (at the top of the picture) and a one-

row array over the rest of the bend. The two-row array was later extended up to Section 112 (at the lower edge of Fig. 29). After 160 hours with a discharge of 5.8 cfs through the flume, most of the point bar had disappeared (Fig. 30). Note in Fig. 30 that some of the vanes in the outer row had become completely covered with sand. The depth distribution at Section 112 is indicated in Figs. 31 (before installation of vanes) and 32 (after installation of vanes). For visualization, a string was extended horizontally at the water level, and 5 thin staffs with 1/10-ft marks were driven into the sand bed (after draining of the flume) at 1 ft intervals. The outer staff was 2 ft from the outer flume wall. The depth at this staff is seen to have been 0.8 ft before vanes were installed. After the vanes were installed the depth here was reduced to 0.4 ft (Figs. 32 and 33). Downstream from 112, where only one row of vanes were installed, the result was also very satisfactory, as Fig. 34 clearly shows. The bed recovery at Section 112 with 9-in. vanes is shown in Figs. 35 (Test Series No. 4-3) and 36 (Test Series No. 2-1).

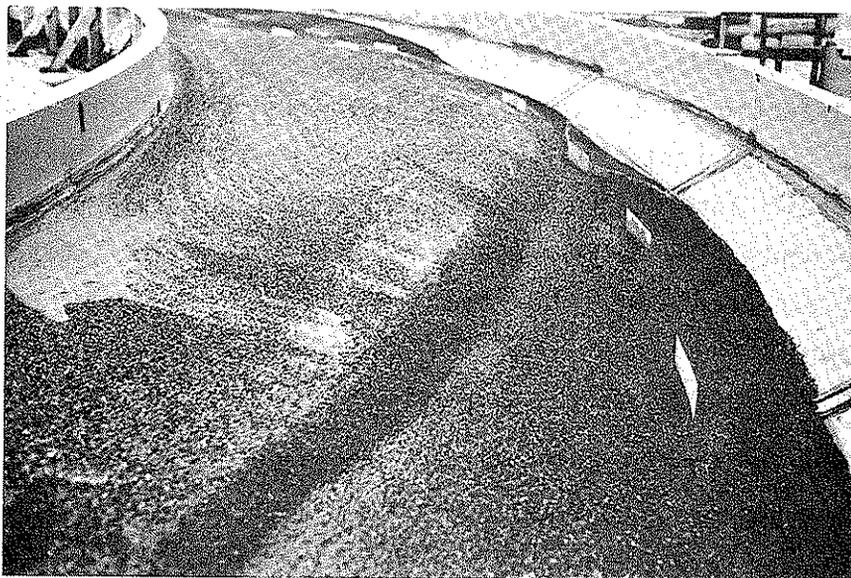
Figure 30. Bed Topography in Test Series No. 4 (Looking Upstream) after Installation of 14-in. Vanes

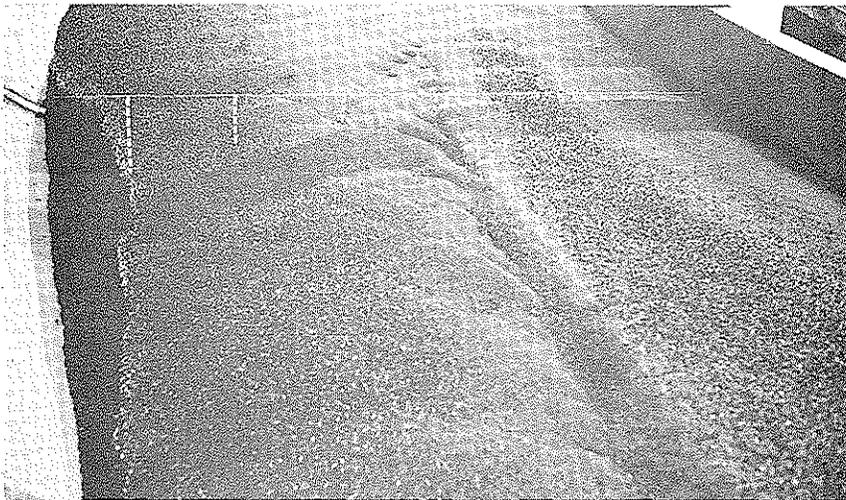
Figure 31. Depth Distribution at Section 112 in Test Series No. 4
Before Installation of Vanes

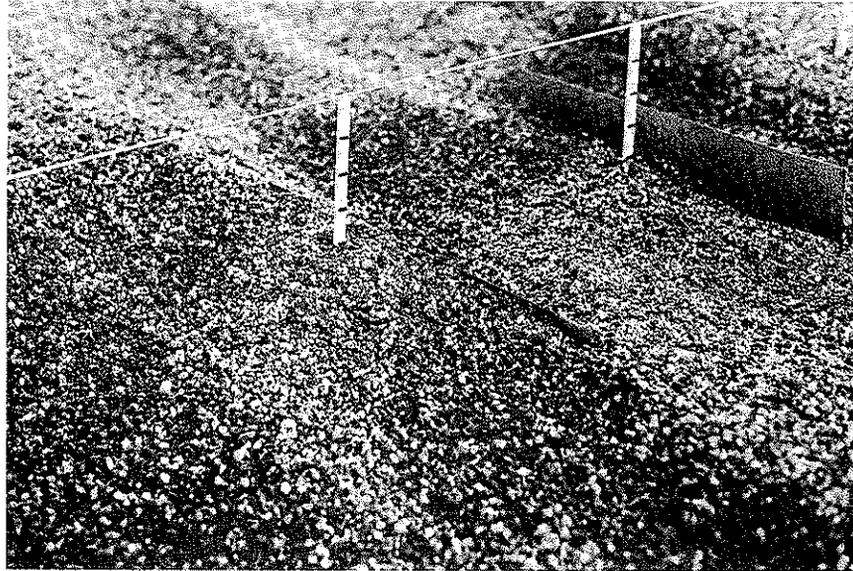
Figure 33] Close-up of Bed with 14-in. Vanes (one barely visible)
at Section 112 in Test Series No. 4

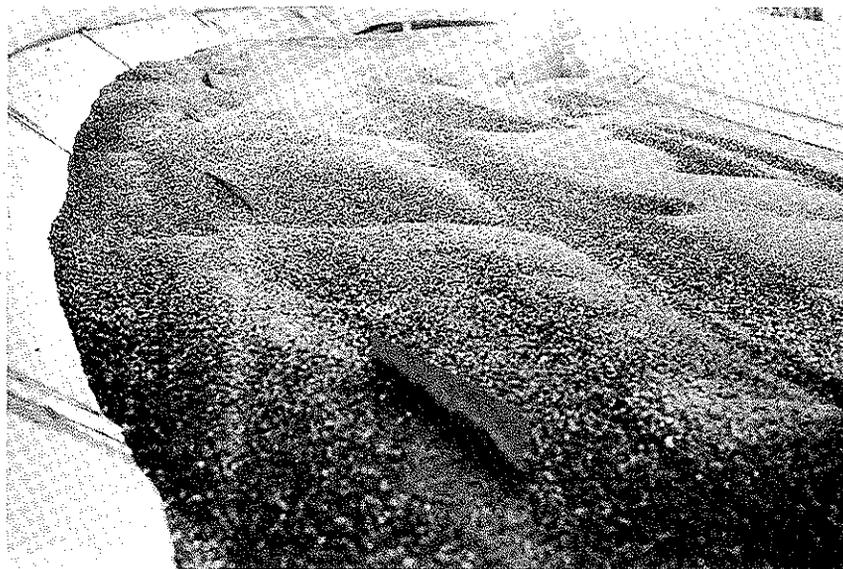
Figure 34. Bed Topography Downstream from Section 112 in Test Series
No. 4 with 14-in Vanes

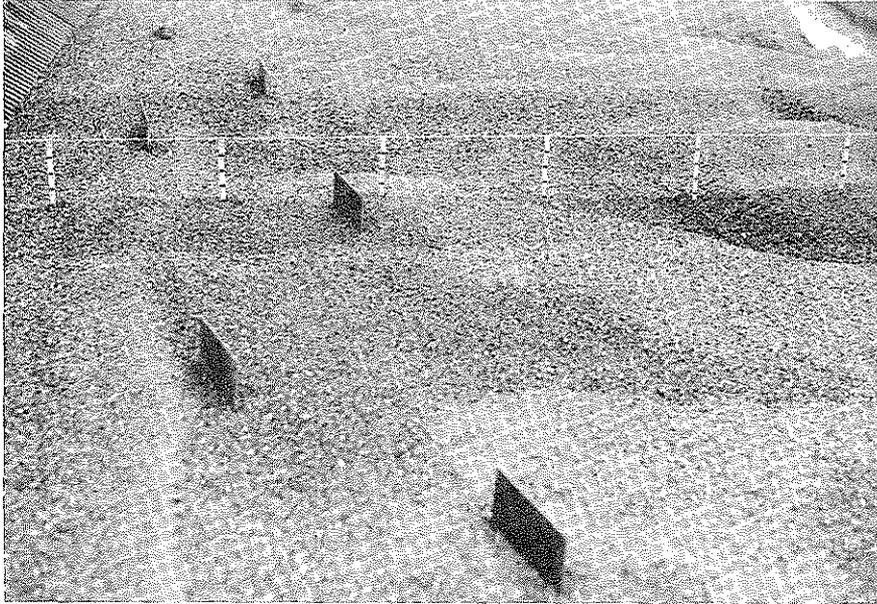
Figure 35. Depth Distribution at Section 112 in Test Series No. 4
After Installation of 9-in. Vanes

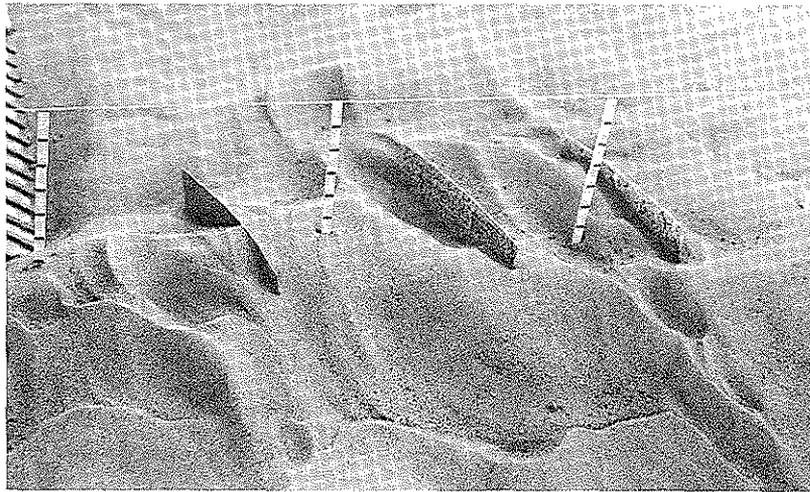
Figure 36. Depth Distribution at Section 112 in Test Series No. 2
After Installation of 9-in. Vanes

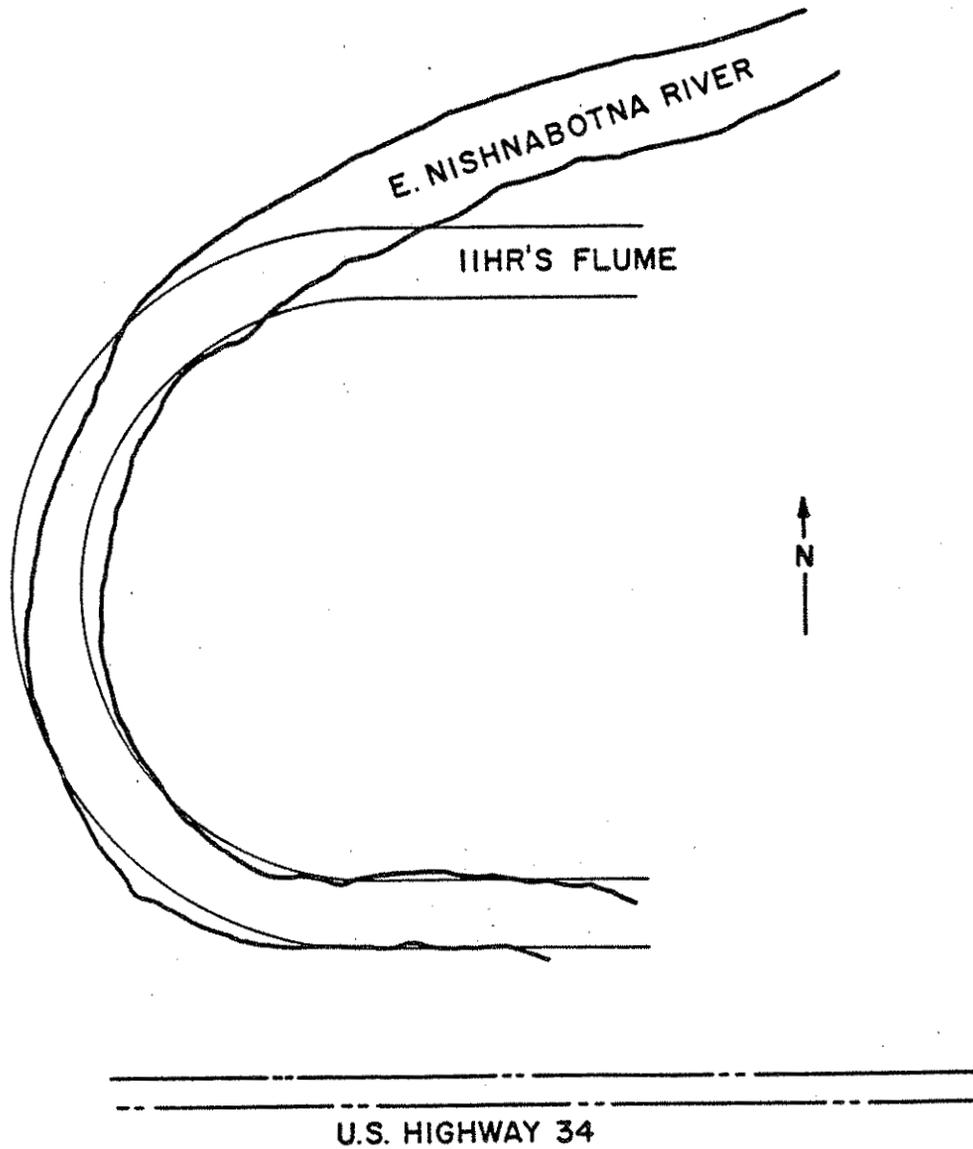
Figure 37. Plan-View of IIHR's Sediment Flume Overlaid the East Nishnabotna River Bend at Red Oak, Using a Scale Ratio of 1:10

The results of the theoretical analysis and the laboratory-model experiments were used for the design of a vane structure for the meander bend in Fig. 3 for the protection of U.S. Highway 34 and its bridge over East Nishnabotna River. The flume in which the aforementioned experiments were conducted, models, with some idealization, this meander bend at an undistorted scale of approximately 1:10. Fig. 37 shows the IIHR flume overlaid the prototype bend, using the scale ratio 1:10.

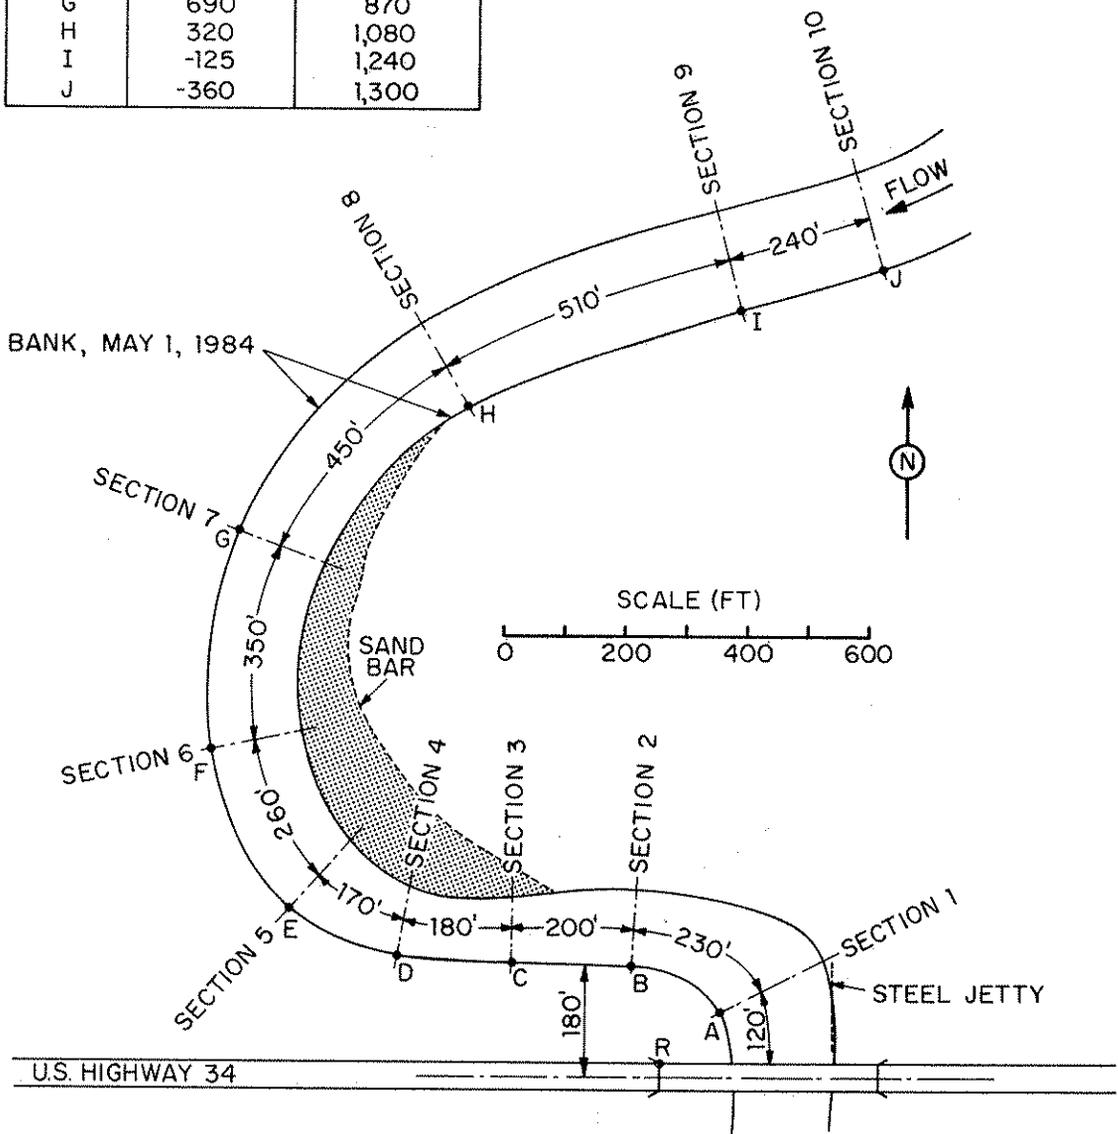
Figure 38. Plan-View Sketch of the East Nishnabotna River Bend at Red Oak, Iowa

Cross sections of the river bend (of which a plan view is shown in Fig. 38) were surveyed October 6-7, 1983 (eight cross sections), and April 30 through May 2, 1984 (ten cross sections) to define the channel geometry at two different times for two different flow rates

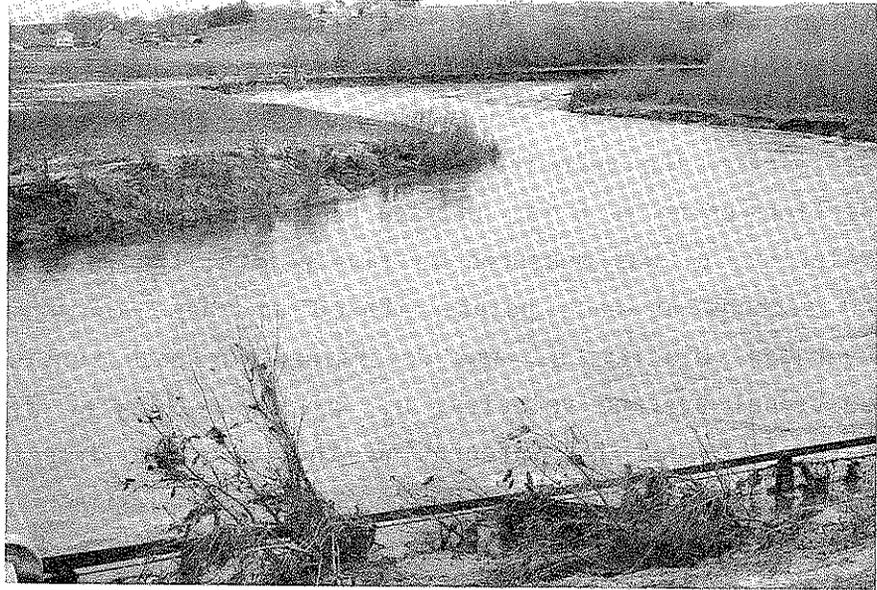
Figure 39. East Nishnabotna River on May 2, 1984,
Looking Upstream from the U.S. Highway 34
Bridge

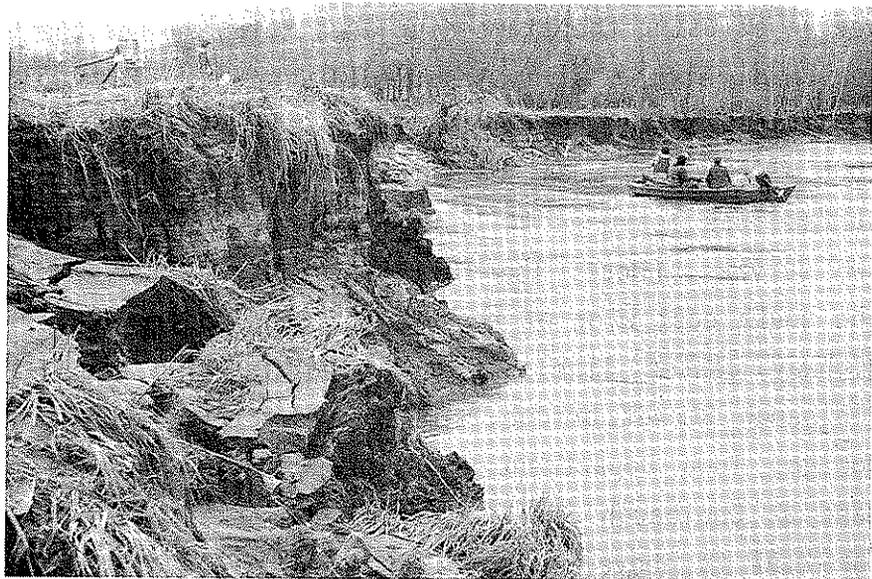
Figure 40. Survey at Section 4, May 2, 1984

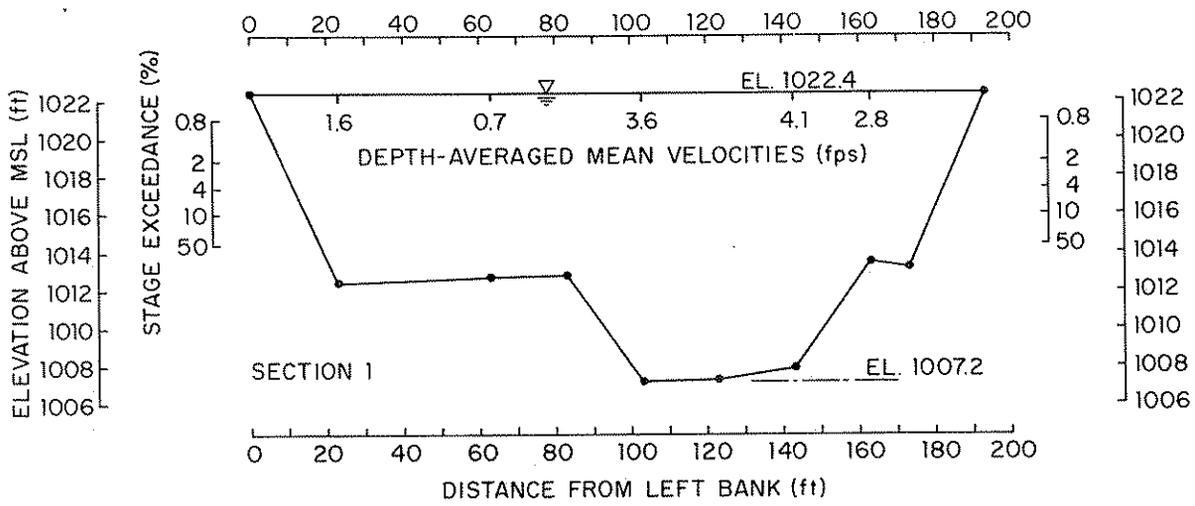
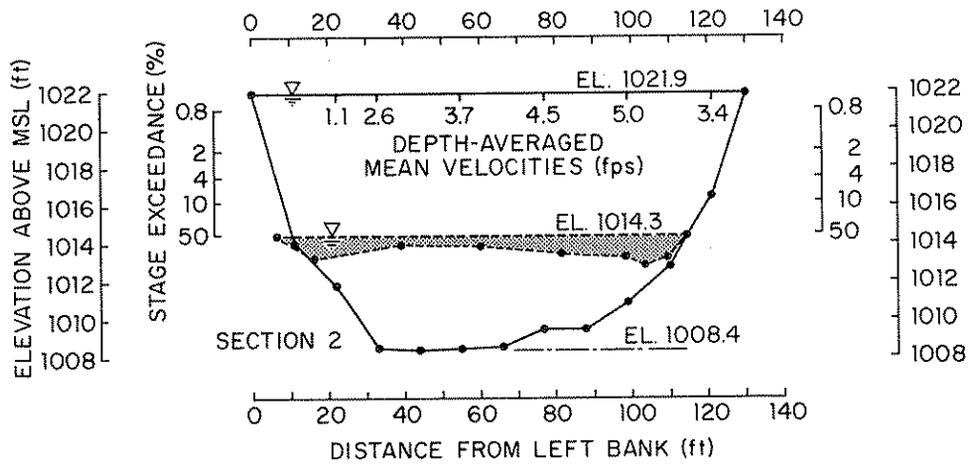
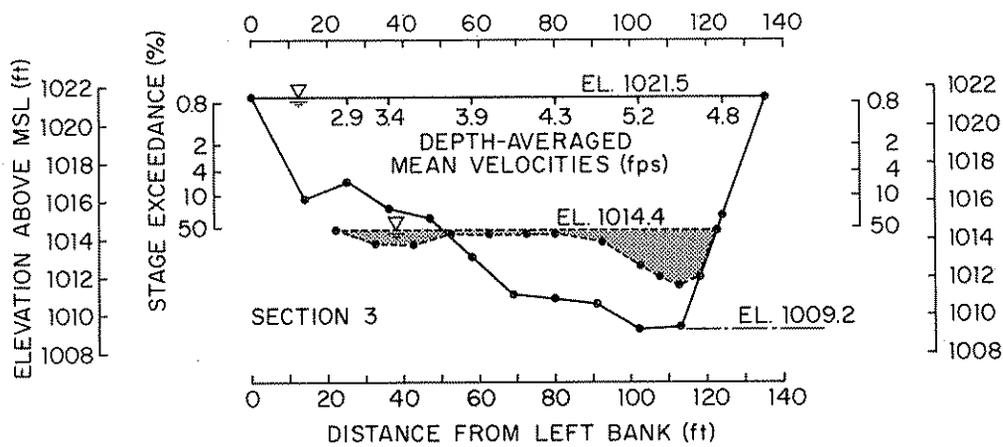
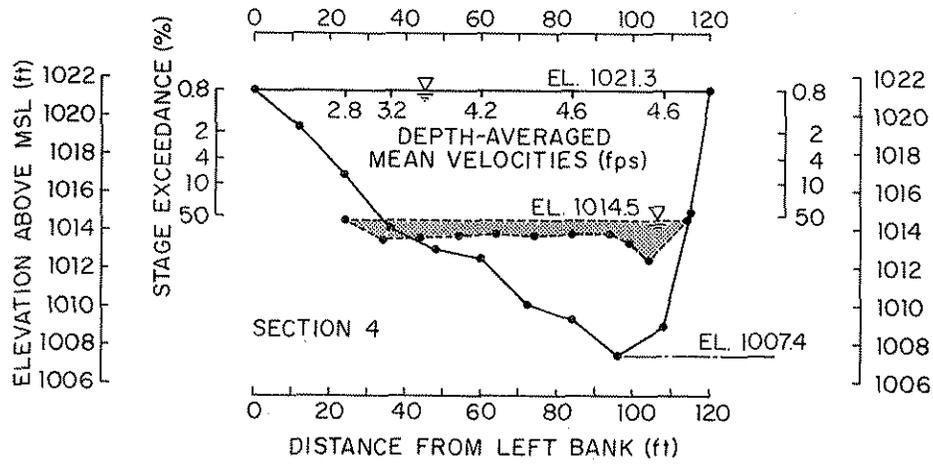
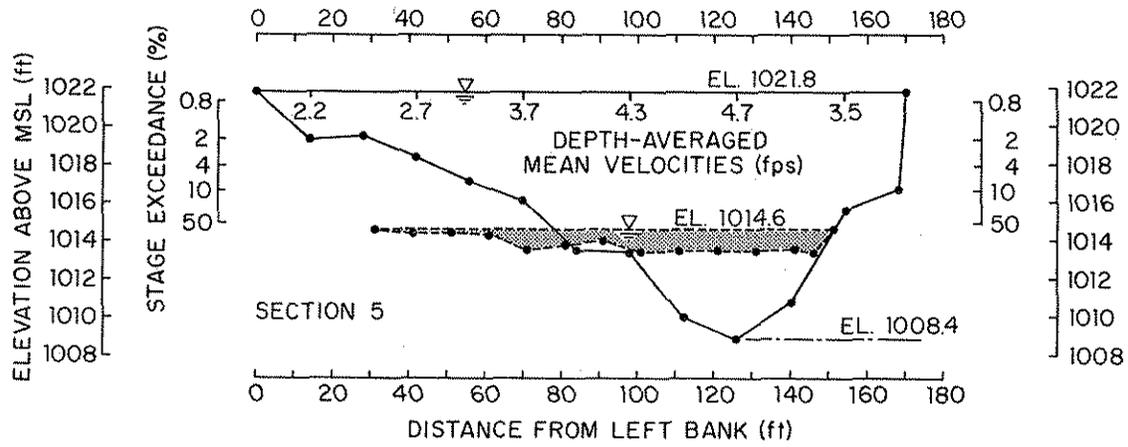
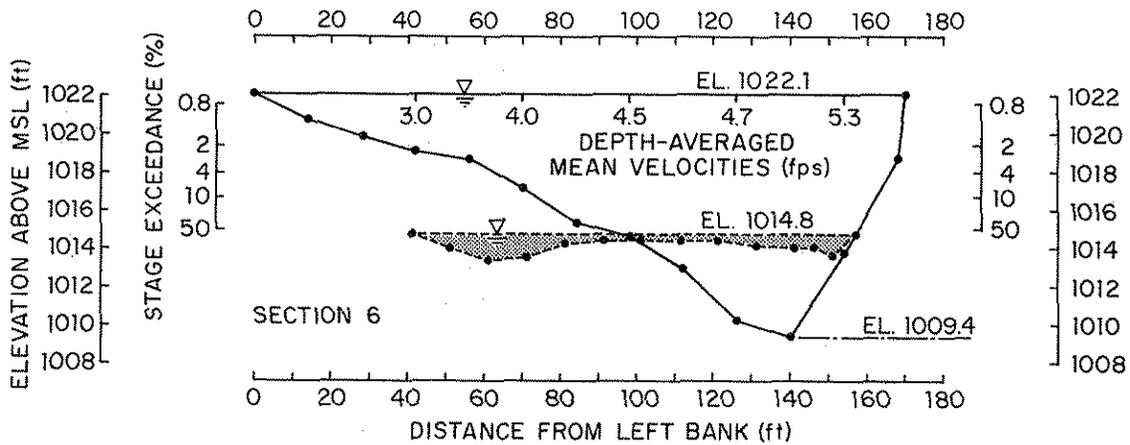
Figure 41. Sections 1 through 10 of the East Nishnabotna River Bend

Figs. 41 show the ten cross sections measured in the April-May survey with the eight October cross sections superimposed (dotted) for comparison. (The lateral position of the October cross sections relative to the April-May sections is only approximate). It is seen that for most sections the elevation of the bed in the October channel is very close to that of the average depth in the April-May channel. This indicates that the increase in transverse bed slope due to increase of flow rate is accomplished basically by a tilting of the October bed about the April-May channel centerline. At Section 2, the April-May high flow is seen to have caused an overall lowering of the October low flow channel bed by 5-6 ft. Note also that the deepest point in Section 1 (130 ft upstream from the bridge) is at elevation 1007.2 ft, which is about 5 ft lower than the stream-bed elevation for which the bridge foundation was designed (Iowa State Highway Commission, Design No. 262, Montgomery County, File No. 21400, July, 1963). The cause of this overall lowering of the stream bed may be related to the presence of the 600-ft rock protection on the right bank near the bridge (Fig. 43). According to Jansen et al. (1979), fixation of an outer bank which is being eroded induces a steeper slope in the cross section and a greater depth at the toe of the fixation structure.

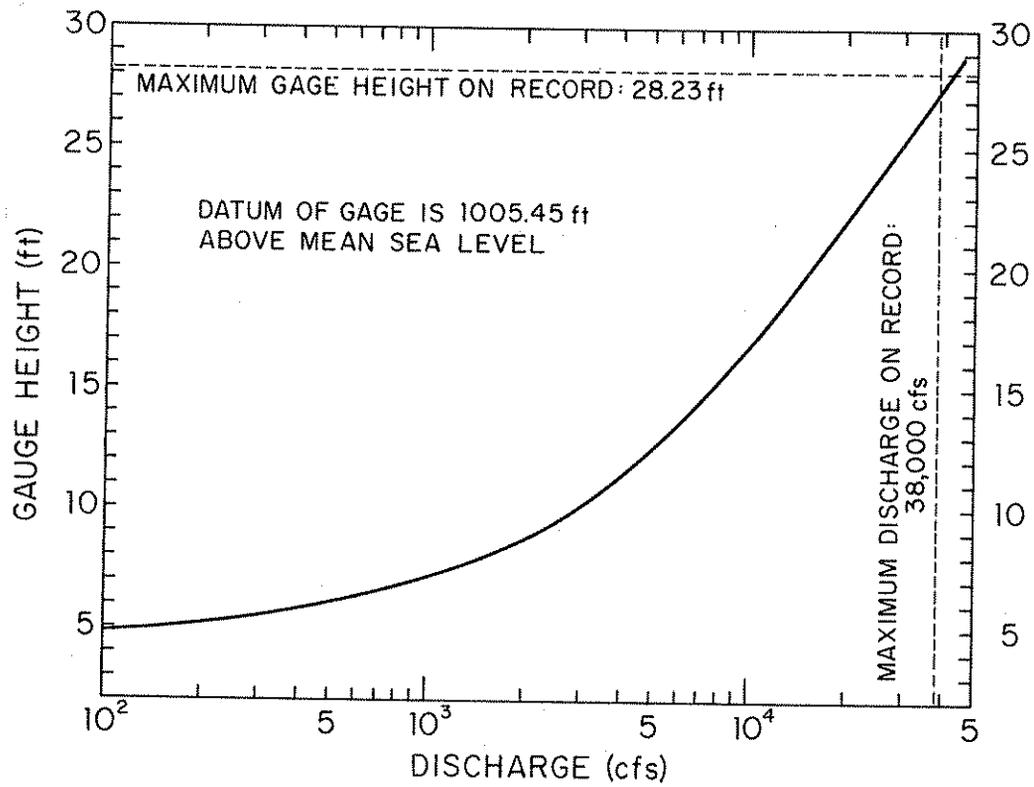
Figure 42. Rating Curve for the U.S.G.S. Water-Stage Recorder on East Nishnabotna River at Red Oak (at Coolbaugh Street Bridge)

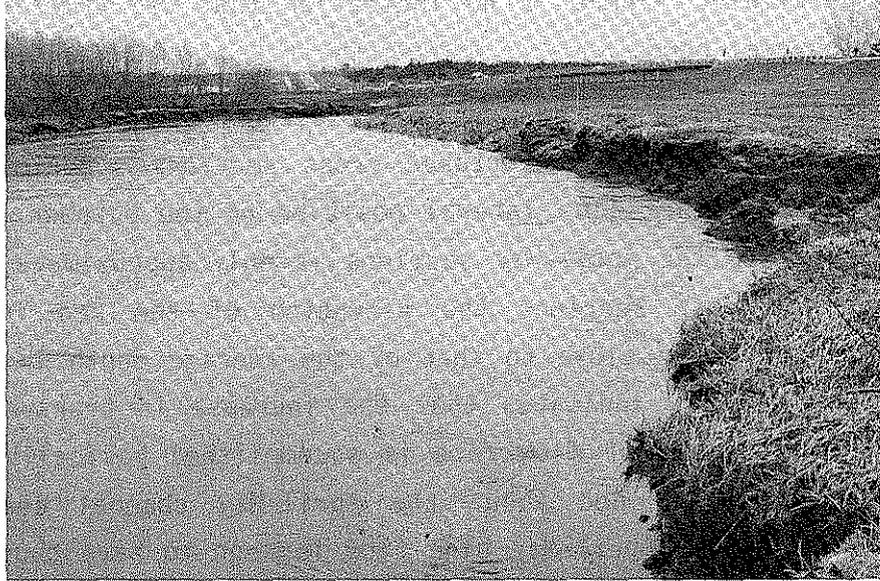
Figure 43. East Nishnabotna River on May 2, 1984, Looking Downstream toward the Highway 34 Bridge (The rock protection is along the right bank in the upper-center portion of the picture)
