SUBMERGED VANES FOR FLOW CONTROL AND BANK PROTECTION IN STREAMS

A. Jacob Odgaard and Hong-Yuan E. Lee

the Highway Division of the Iowa Department of Transportation
and
the Iowa Highway Research Board
Project HR-255

IHR Report No. 279

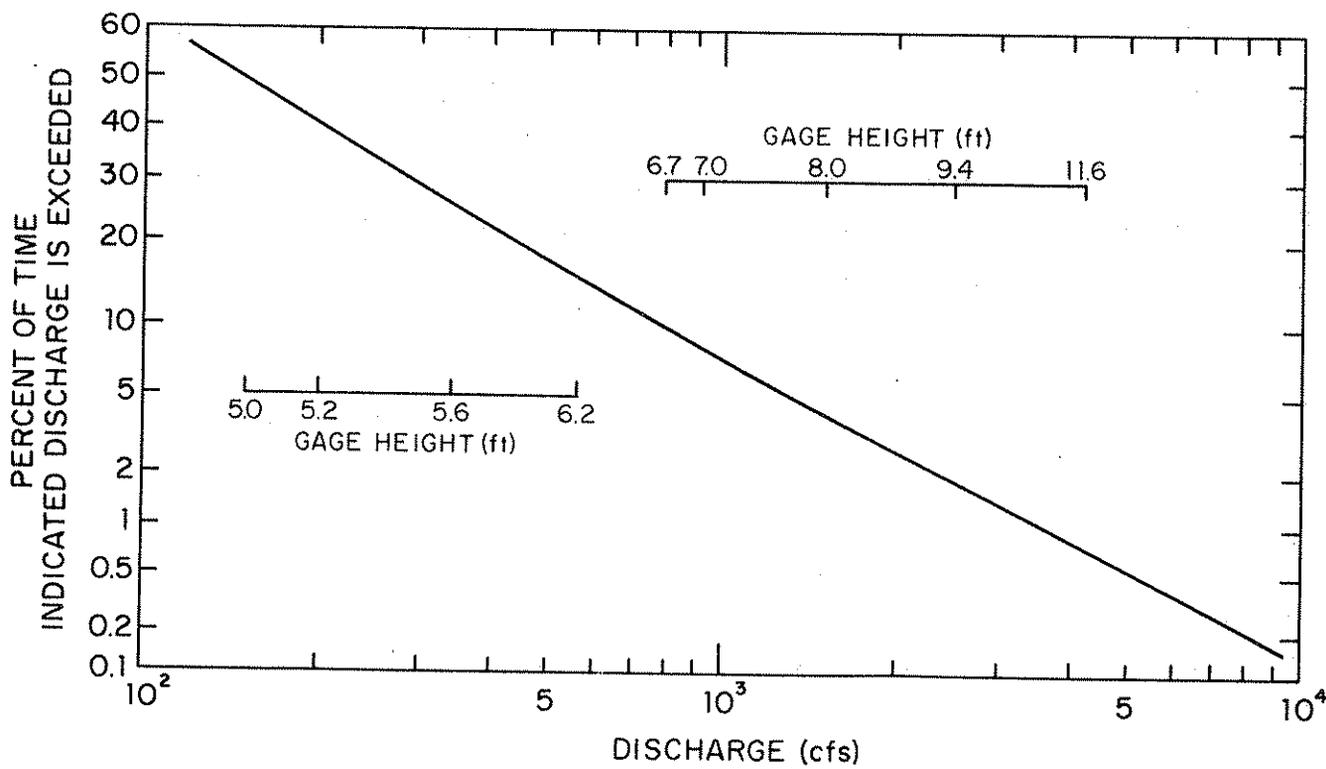
Figure 44. Frequency Distribution for Discharge in East Nishnabotna River at Red Oak

of Reclamation for the design of a stable, firm-loam channel carrying water with colloidal silts.) According to the U.S. Geological Survey, this flow rate is exceeded on the average (based on 60 years of records) 4% of the time, or approximately 15 days per year (Fig. 44). The 1500-cfs river stages are obtained from the U.S.G.S stage-discharge relation for the gage in Red Oak using a longitudinal water-surface slope of 0.00064. The 1500-cfs average water depth is estimated to be approximately 5 ft. Therefore, the top of the vanes should be more than 2.5 ft under the 1500-cfs stage to be erosion preventive at this and higher stages. From Fig. 41 follows that if the vanes are installed at low flow with their top edge 2.5 ft below the 1500-cfs stage and can maintain the present low-flow bed profile, the H/d-value will be optimum (of the order of 0.2-0.3) at the extreme high flow when most erosion losses would occur. For this situation to occur, the vane height must be of the order of 3 ft. In the model, the best performing vane was four times as long as it was high. A 3-ft high prototype vane should then be 12 ft long. If the vane is much longer than that it may generate two (or more) secondary flow cells downstream rather than one, which reduces the overall performance. Using $H/L = 0.3$, and $\alpha = 20^\circ$; the lift coefficient as given by Fig. 6 is $c_L = 0.5$. The value of F selected for the design was the minimum value, F_{min} , corresponding to the n -value for the section. The lifting surface per unit surface area of the channel, $NHL/(r_c \phi b)$, required to maintain a horizontal "low flow" bed is then readily calculated, and so is the required number of vanes.

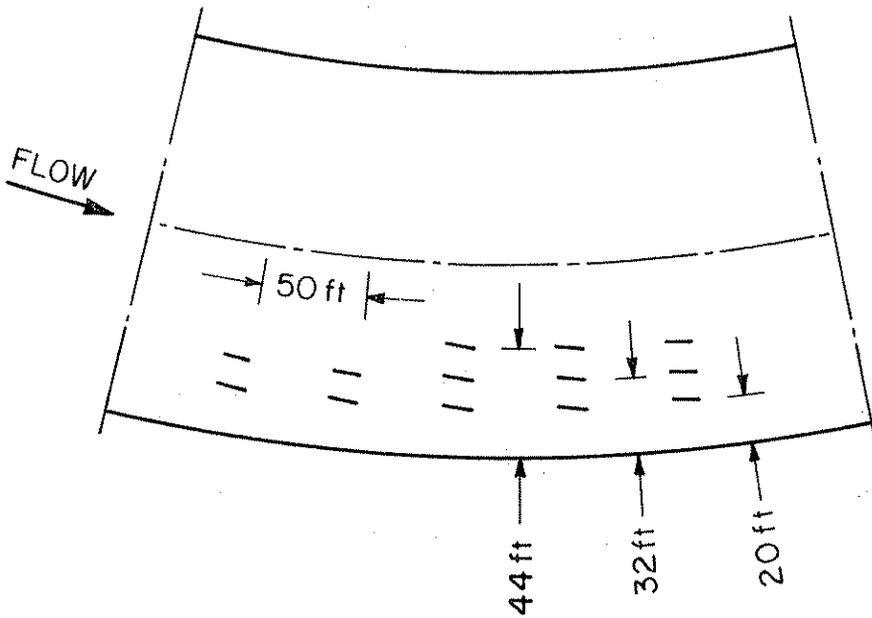
Figure 45. Proposed Emplcaement of Vane System for the East Nishnabotna River Bend

The positioning of the vanes on the stream-bed requires careful planning. In order that the vane system as a whole function at optimum efficiency, the longitudinal and lateral spacing of the vanes must be such that a single-cell circulation is induced in the flow section. If the vanes are spaced too far apart laterally, two or more secondary flow cells are induced. Dye and float studies in the laboratory model indicated that the lateral distance between two vanes should be less than or equal to two times the water depth. The optimum distance, which undoubtedly is a function of L and α , was not identified in the model studies. Satisfactory results were obtained in the model with a lateral vane distance of two times the water depth. Based on a 4,000 cfs river flow, the prototype vanes should then be spaced about 12 ft apart in the lateral direction. The proposed emplacement of the vanes is detailed in Fig. 45, and Table 9.

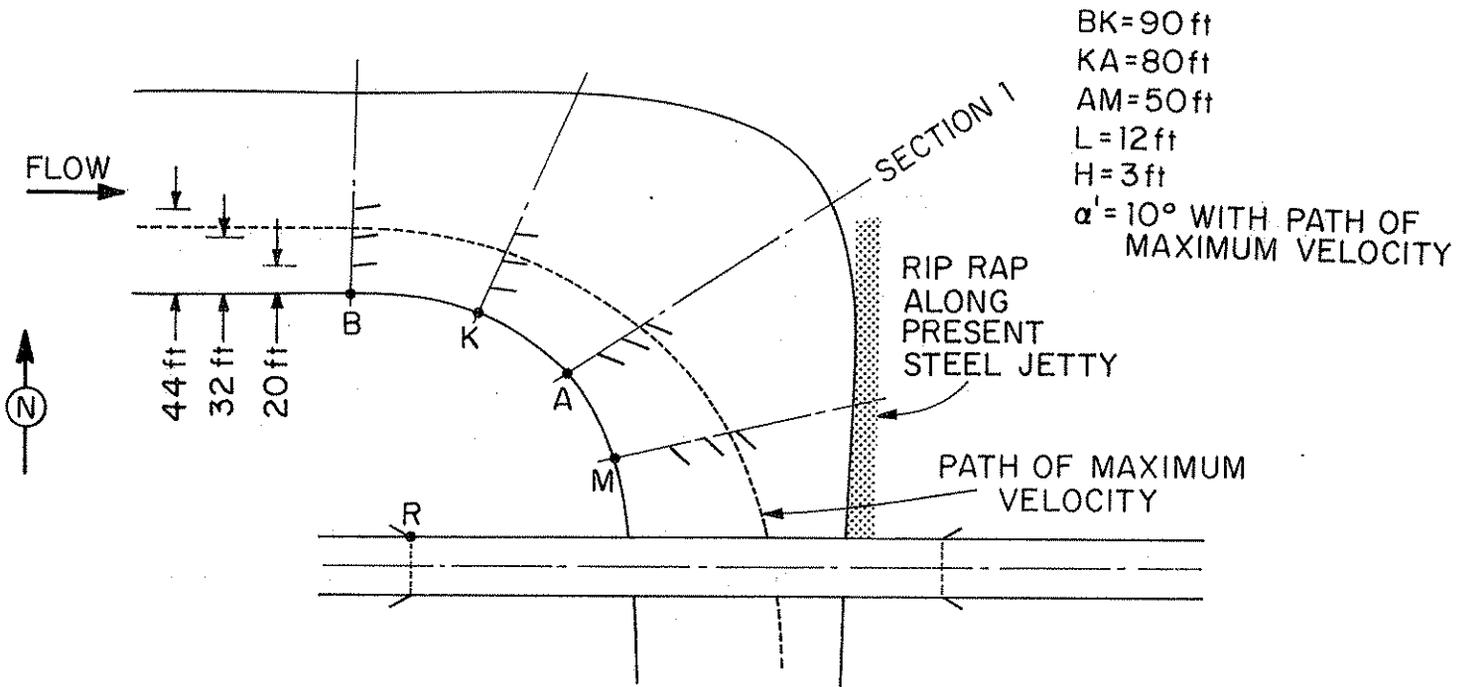
Figure 46. Proposed Combination of Vanes and Rock Rip Rap at the Highway 34 Bridge.

The above emplacement applies to the reach between Sections 2 and 9. However, it is equally important that measures be taken to guide the flow through the bridge section. The effective width of the channel at the bridge section is presently less than half the width for which the bridge was designed. There is obviously a need for measures that can: (1) Turn the river flow southward (90°) over a short distance (less than 300 ft) without endangering the left bridge abutment; and (2) generate a widening of the effective channel width at the bridge section. It is uncertain to what extent Iowa Vanes can accomplish such a task. The most logical solution would be to use a combination of bank rip rap and vanes as sketched in Fig. 46. Note that bank rip rap alone would not produce a widening of the river channel.
