**FIELD EVALUATION
OF
THE LANE-WELLS ROAD LOGGER**

IOWA HIGHWAY RESEARCH BOARD PROJECT HR-113

SEPTEMBER 1966

Investigation of the Lane-Wells Road Logger

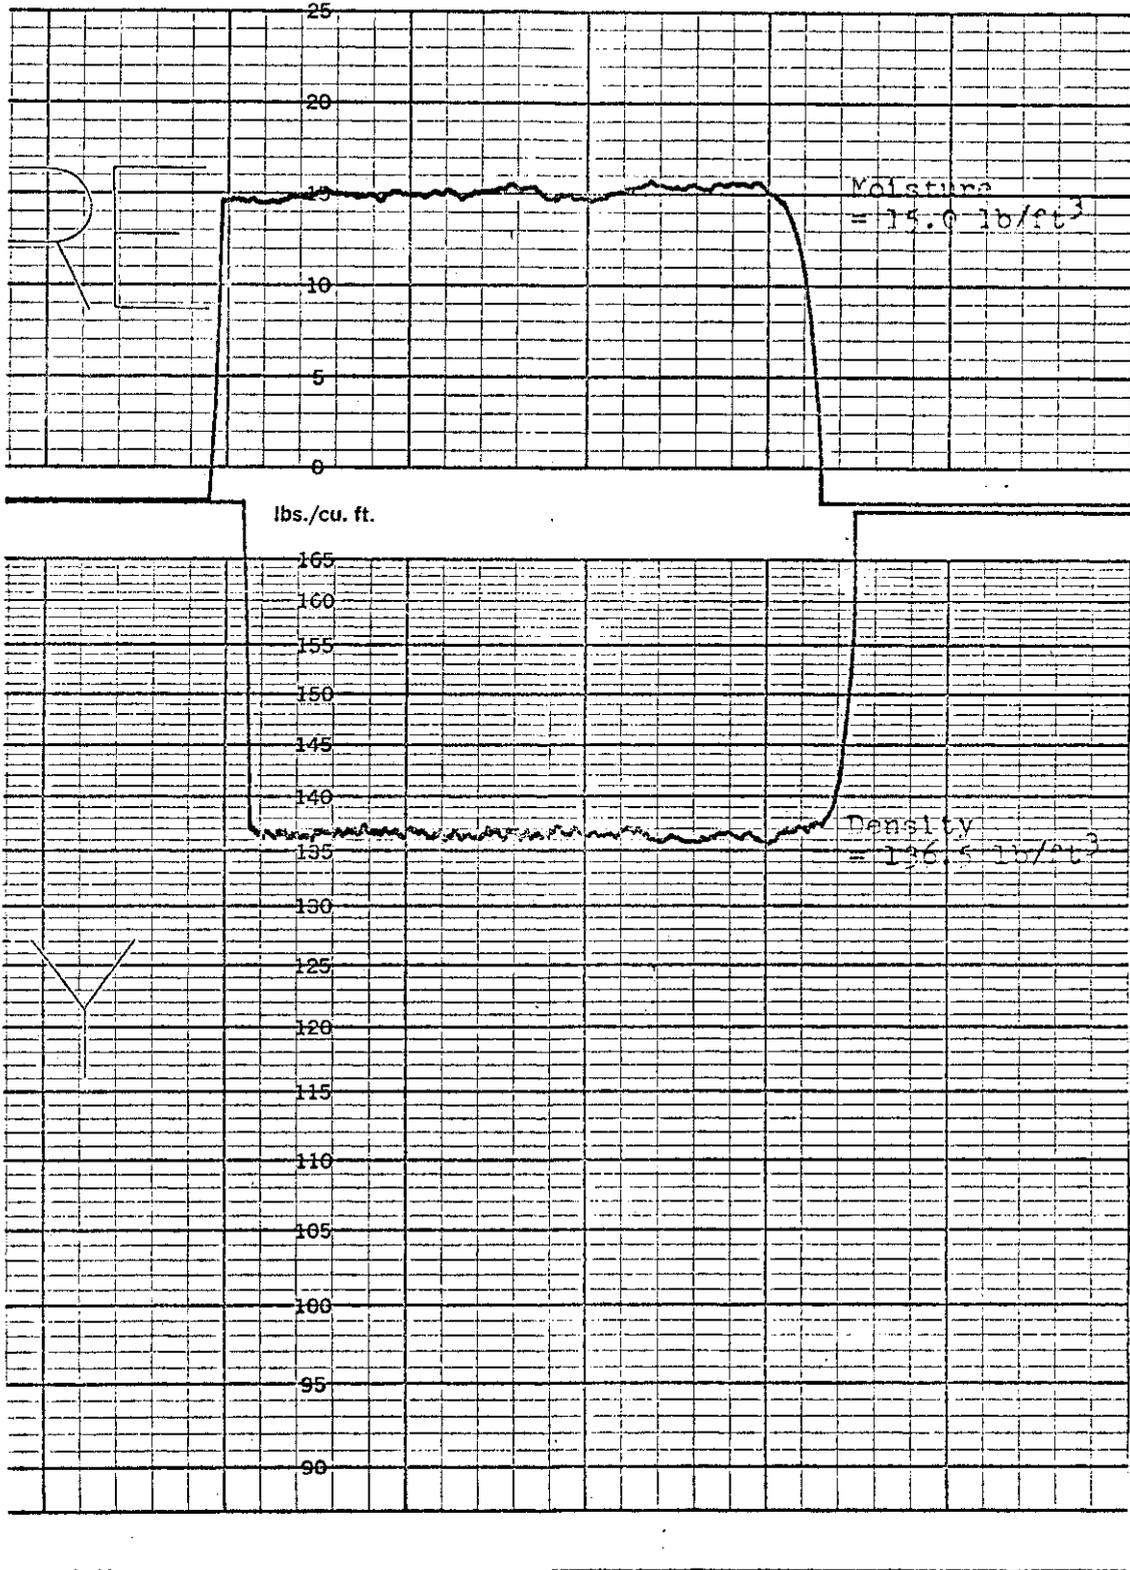
Figure 1

Typical Calibration

At the beginning of operation on almost every project, a calibration was made of the Logger's equipment. This type of calibration was quite simple and could be made in a few minutes by the operator. To make this calibration both units were raised and the calibration blocks were moved hydraulically under the units. The blocks were composed of limestone of known density for the density unit and polyethylene plastic of known hydrogen content for the moisture unit. With the units in this position, the readings on the chart for moisture and density should have been 15.0 lb/ft.³ and 136.5 lb/ft.³, respectively. If results different from these were obtained, the readings could be changed by the manipulation of the output circuit of the rate meter in the panel in the back of the cab. A sample calibration of this type is contained in this report on Figure 1.

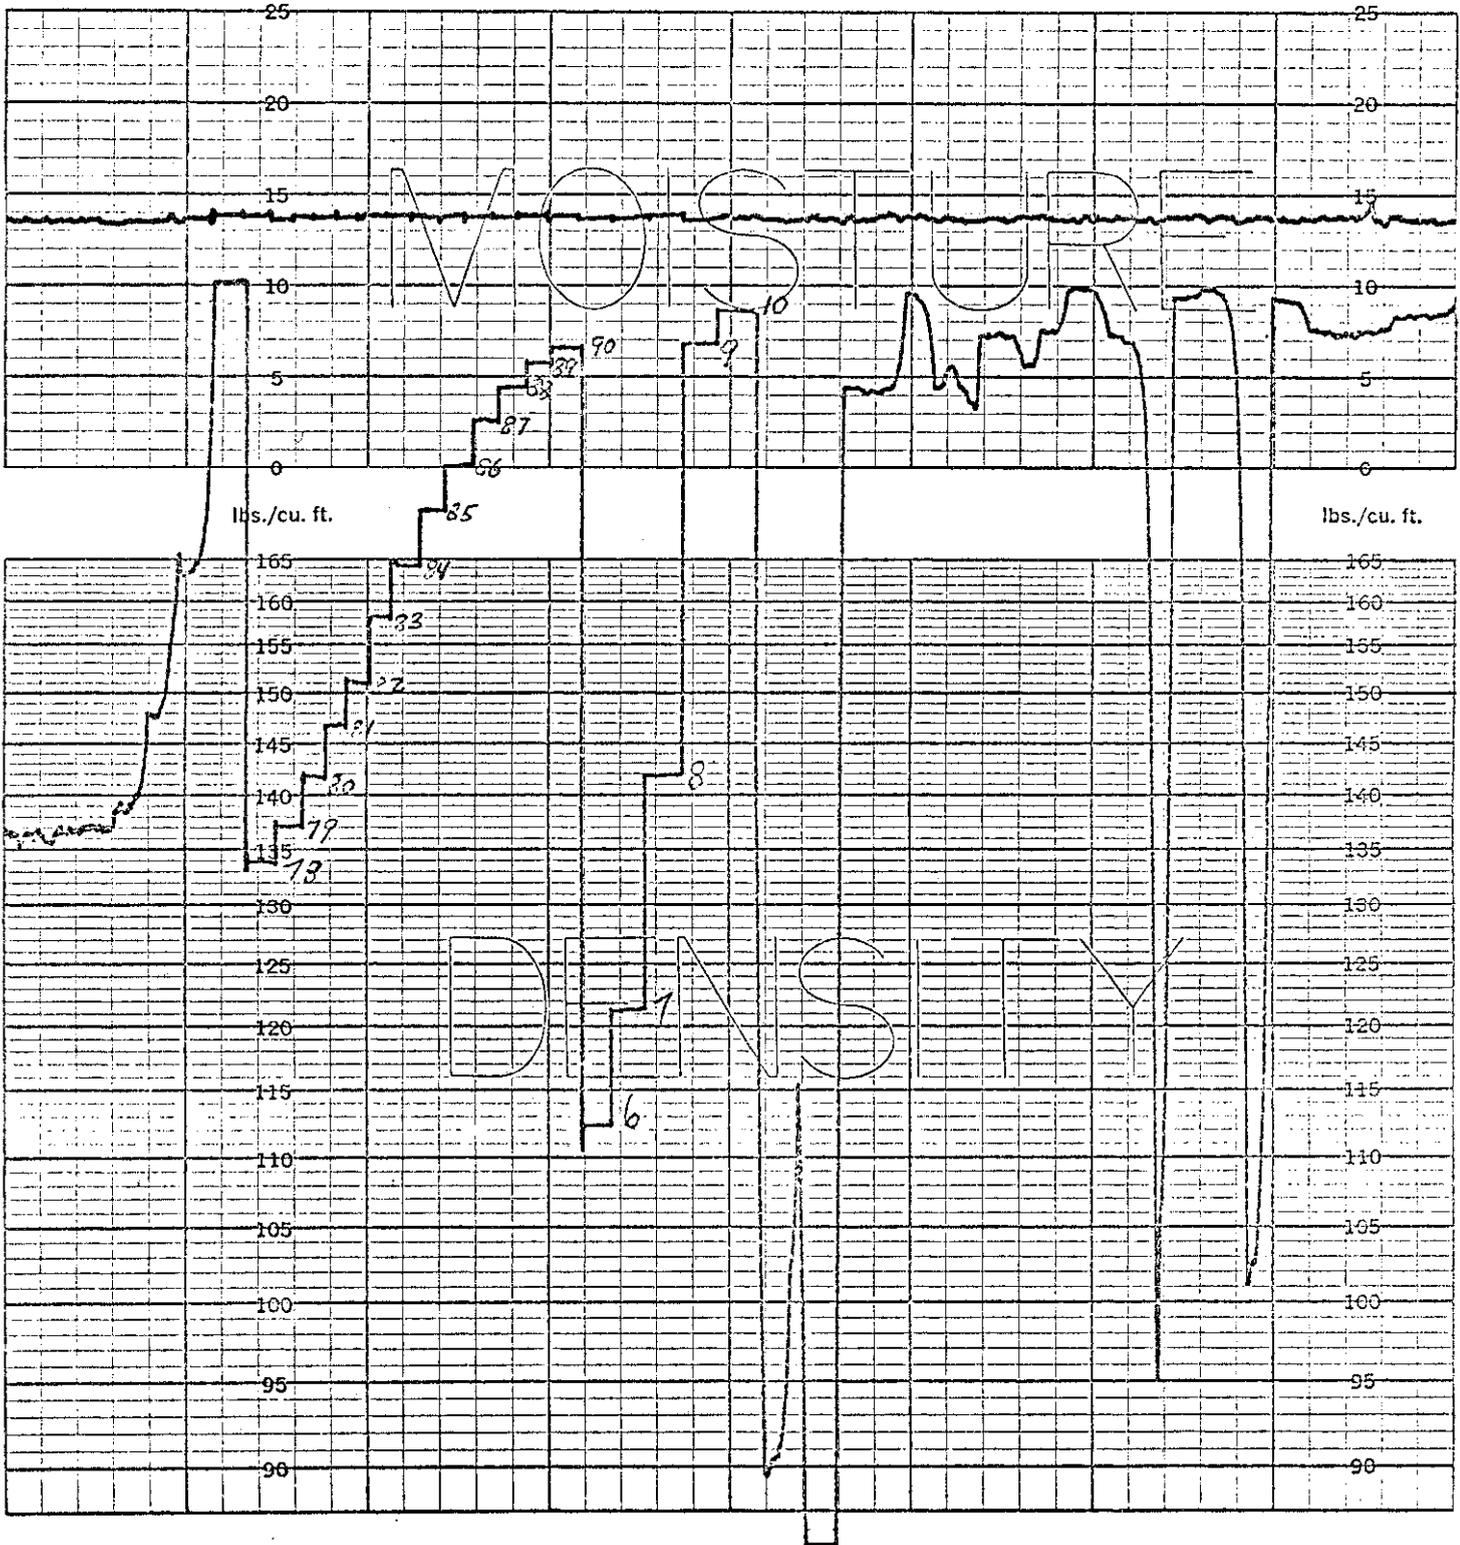
Figure 2

Typical Cesium Peak Calibration
For Density Unit

To insure against the recording of chemical sensitivity by the density unit, all signals below 150,000 volts were rejected or discriminated. In order to find the setting of the amplifier-discriminator at which all low-energy signals were rejected a calibration known as a "Cesium peak" was made. This type of calibration required more time and skill to perform than the one previously described. A Cesium source of known radiation intensity was used to perform this operation. A sample Cesium peak calibration is shown on Figure 2. This type of calibration was performed only a few times a week.

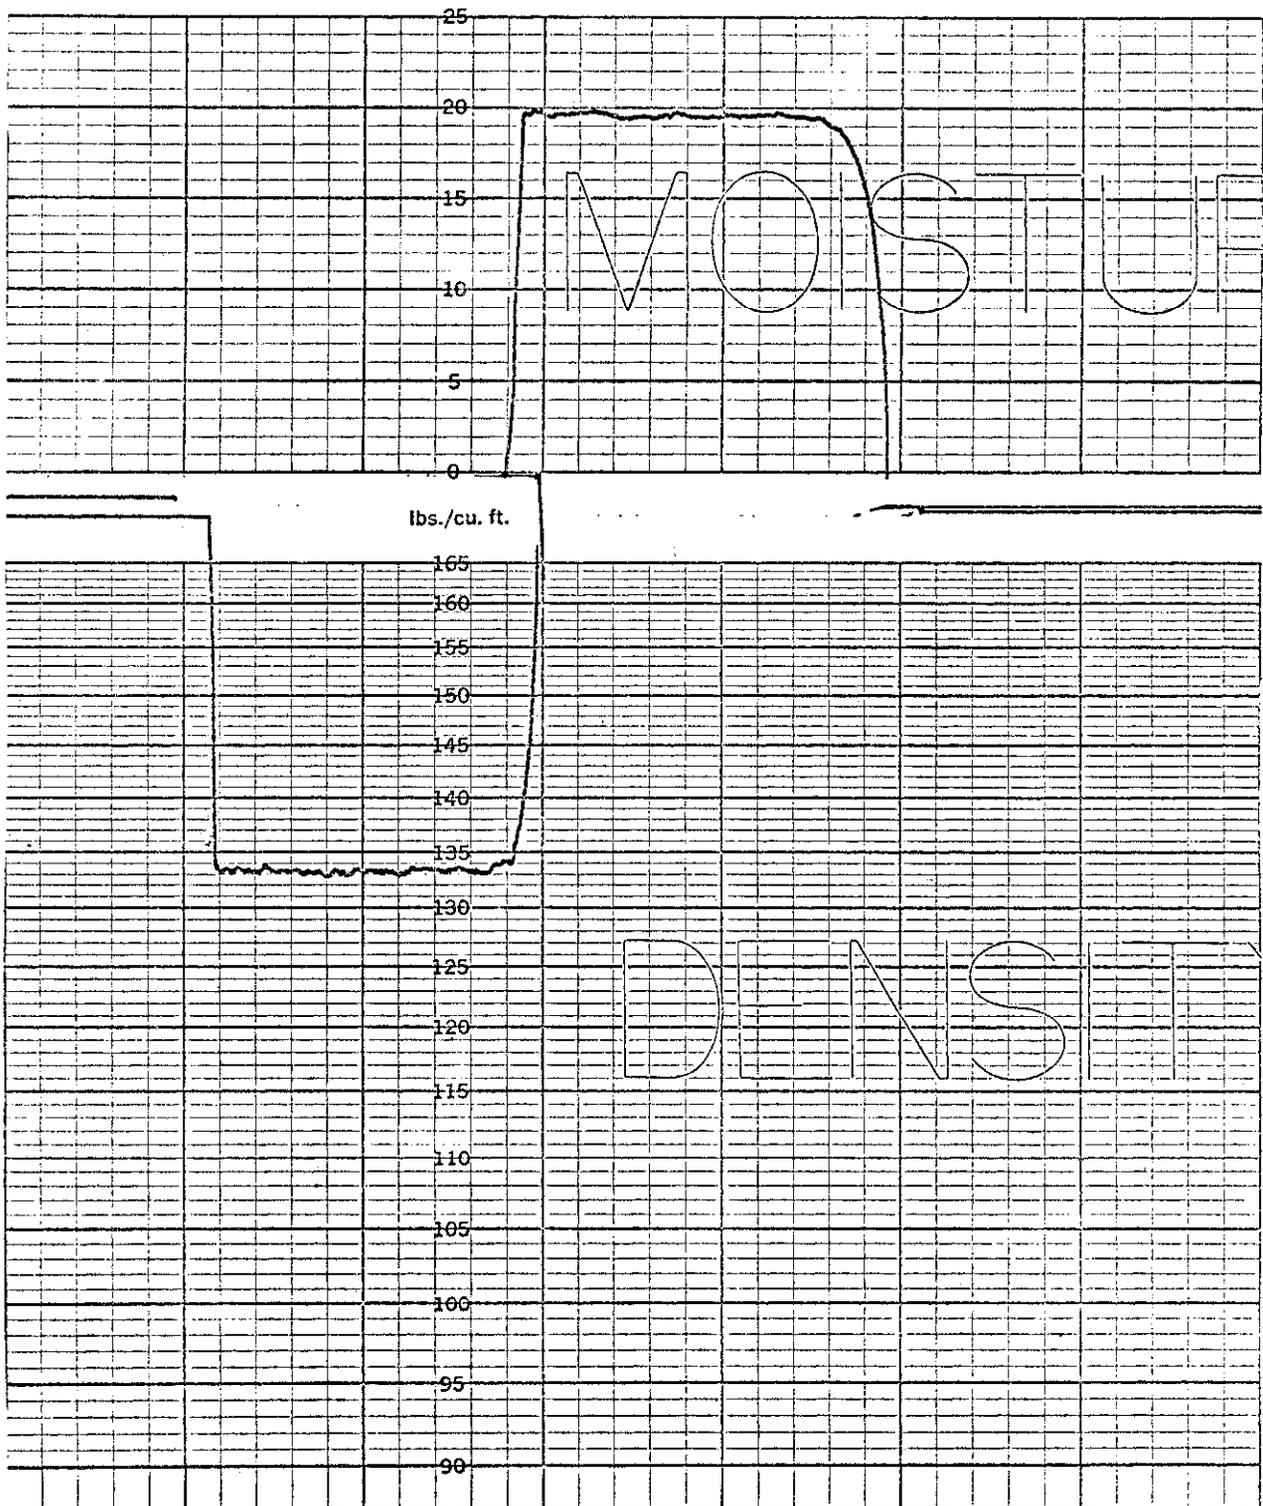
Figure 3

Typical Stationary Test

I-IG-80-1(27)33

Sta. 1090+20

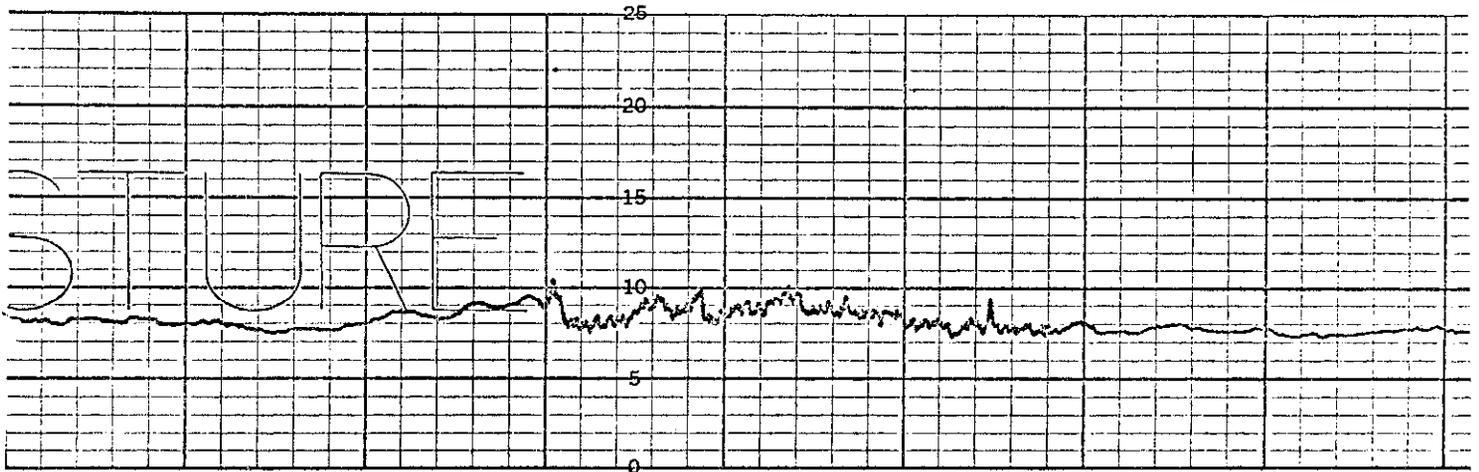
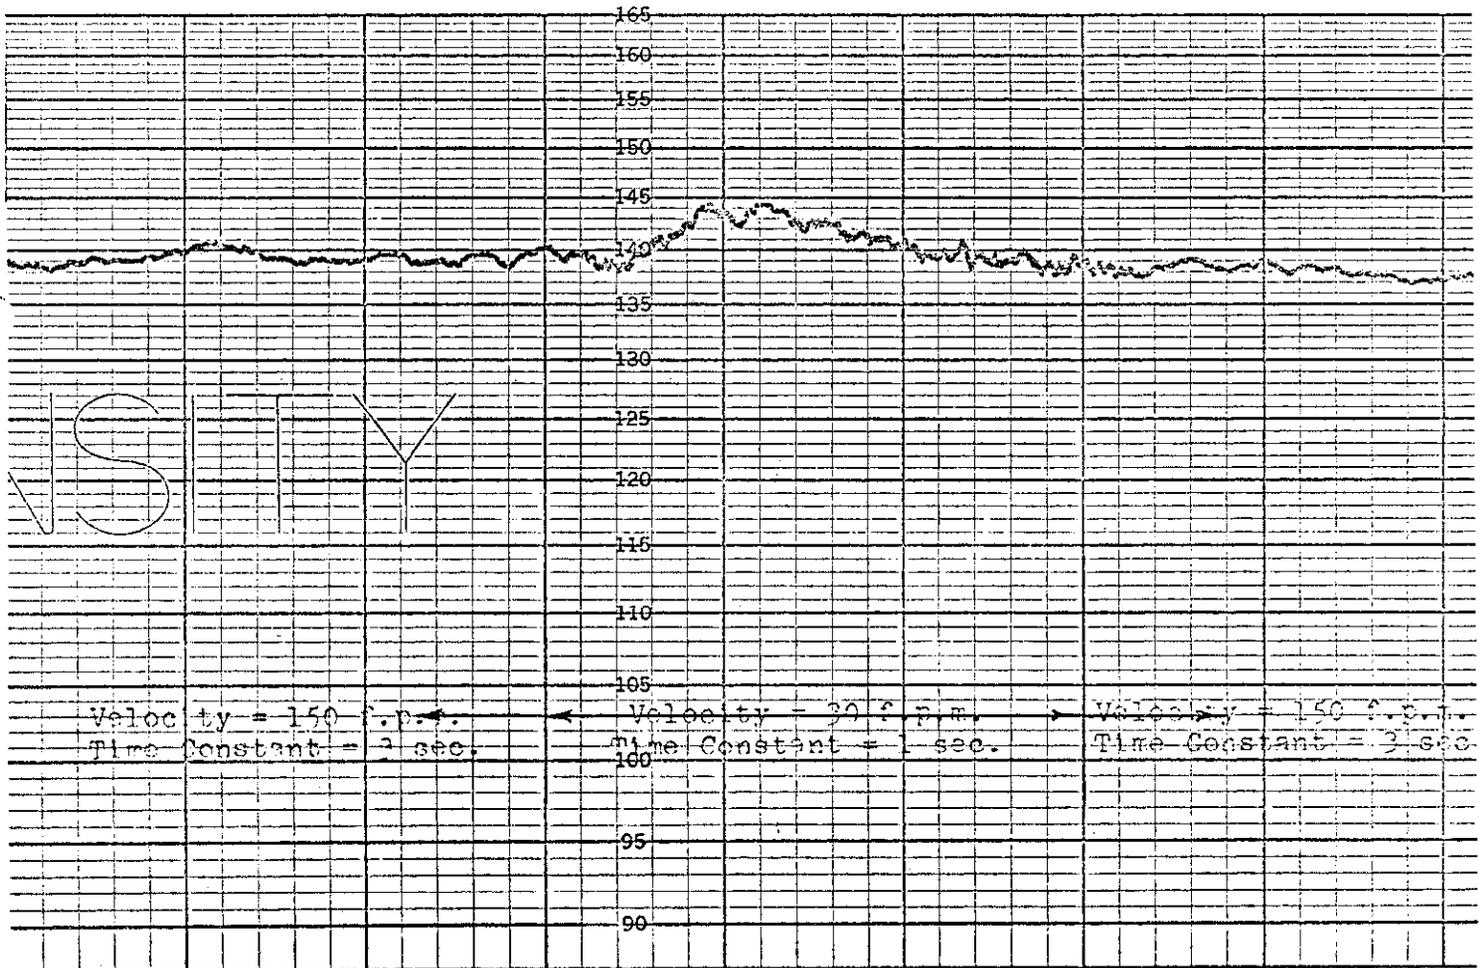
Figure 4

Typical Section Showing Effect of Varying
Vehicle Velocity and Time Constant

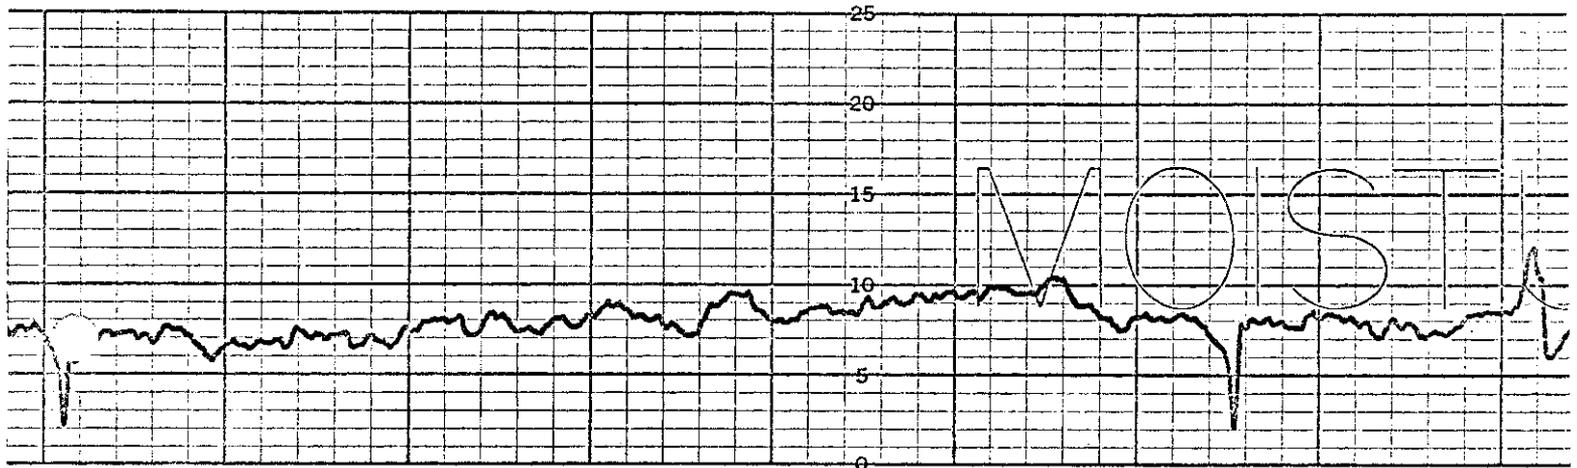
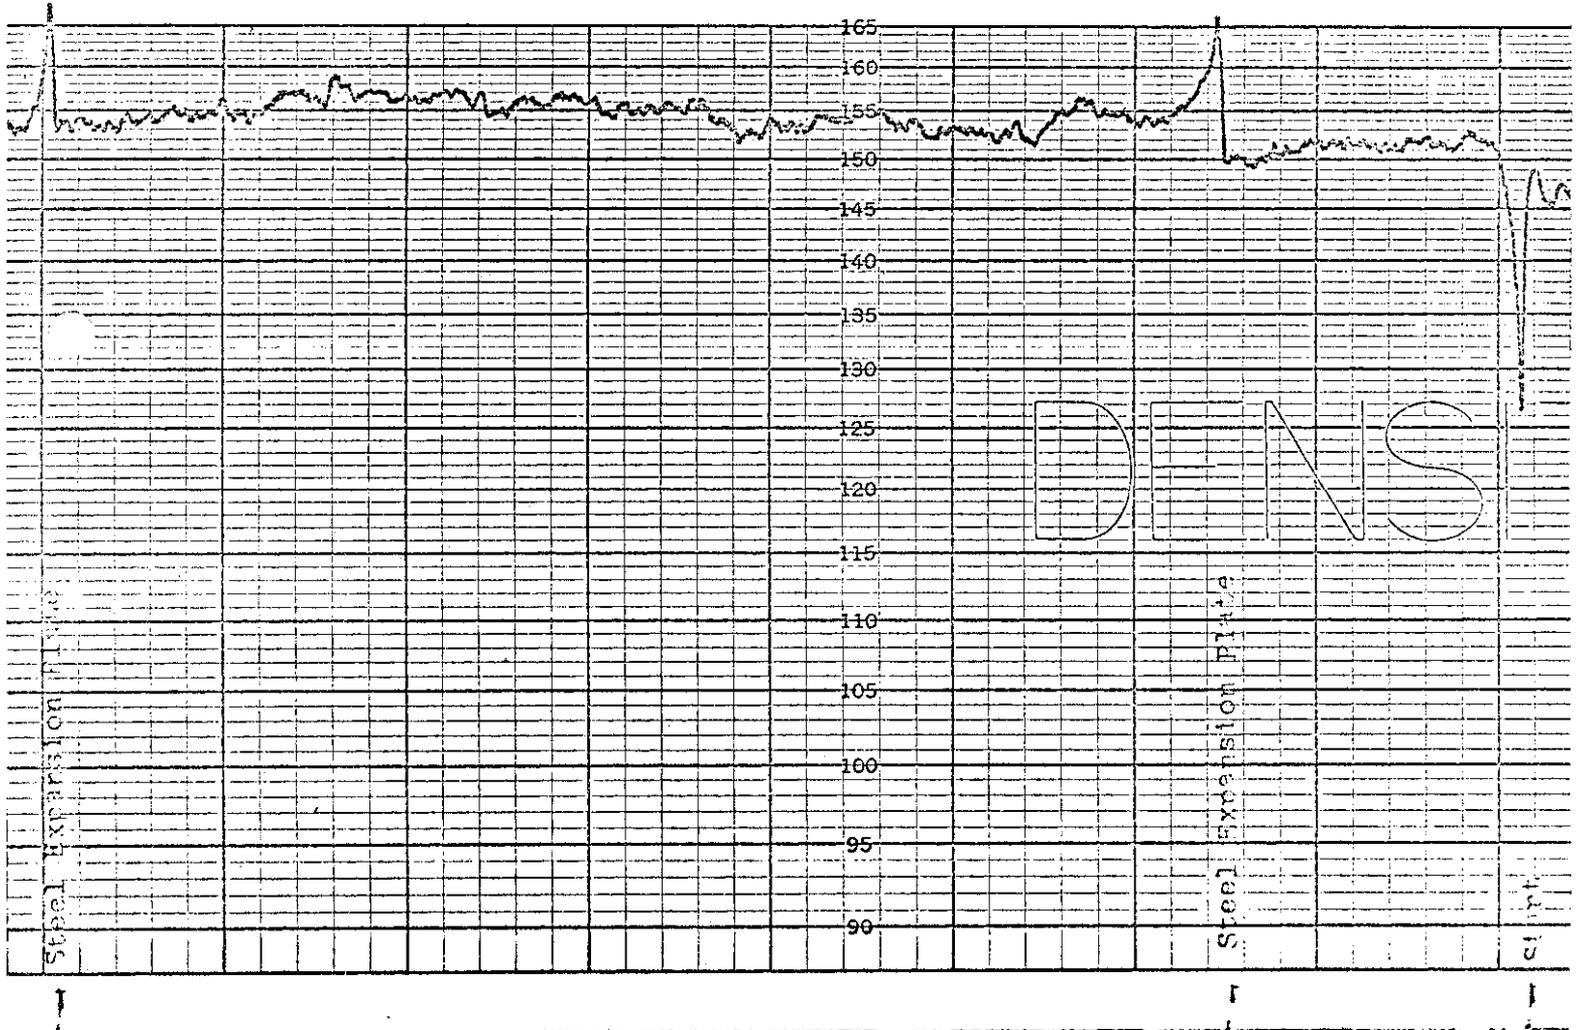
Figure 5

TYPICAL BRIDGE DECK TESTED WITH ROAD LOGGER
OVER I-80-35, NORTH OF DES MOINES, IOWA

Velocity = 30 f.p.m., Time Constant = 1 sec.

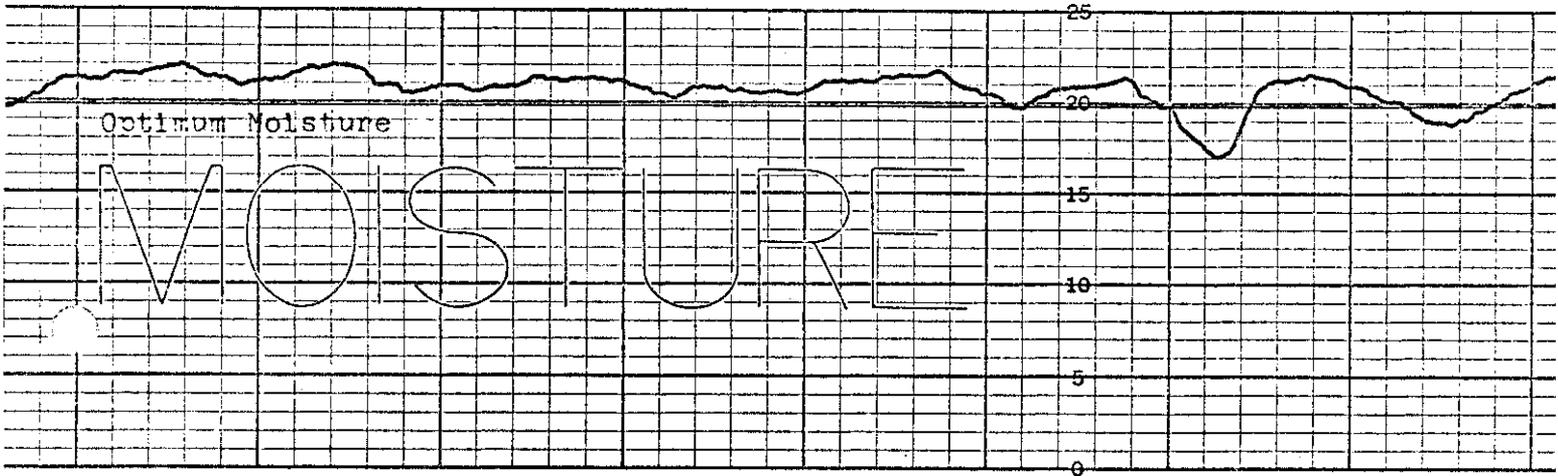
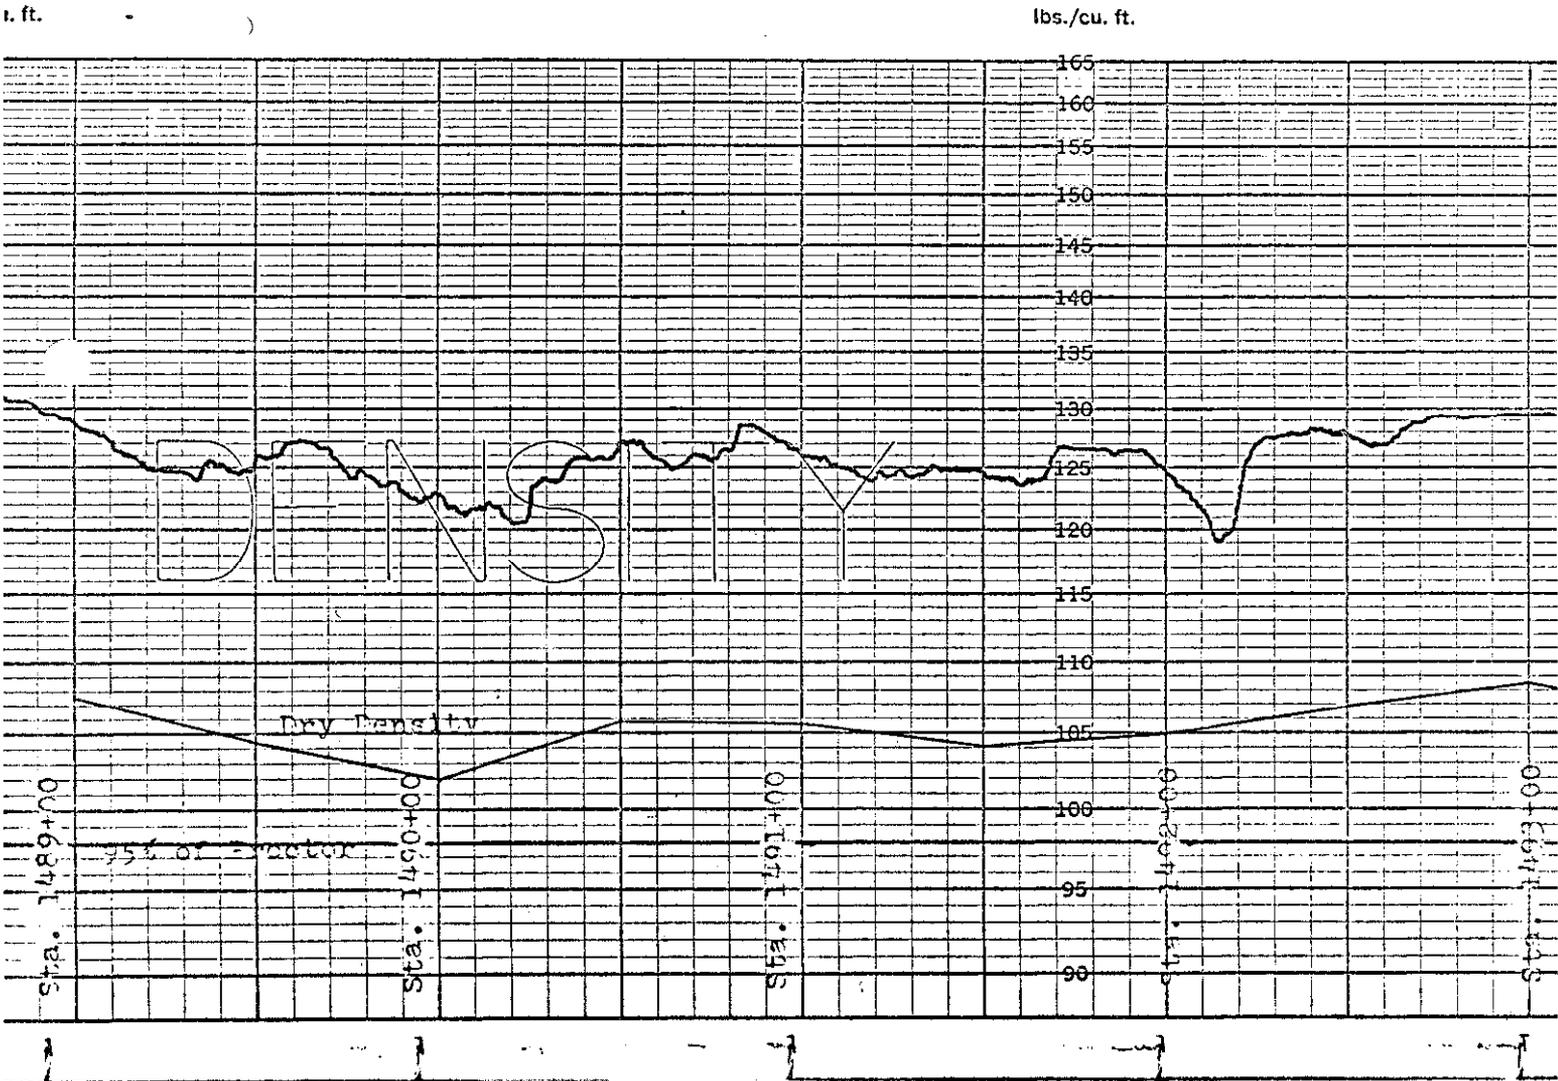
Figure 6

Pottawattamie County
 I-80-1(20)-34
 Subgrade
 Optimum Moisture = 19.9 lb/cu. ft.
 Proctor Density = 103.1 lb/cu. ft.
 Required 95% of Proctor

It is possible to evaluate a section of compacted material from the Logger's chart by comparing the densities obtained to a percent of the Proctor Density. This operation has been carried out on several charts which are included in the Appendix, on Figures 6 through 10. A dry density line was computed and plotted on these charts, together with an optimum moisture line and a line representing minimum acceptable densities which was 95% of Proctor in most cases. This was done for illustrative purposes only, and in the field such a detailed observation as this would neither be needed nor necessary. Only areas of apparent low density where the dry density fell below the minimum density line would have to be checked. With this method, however, Proctor Densities would still have to be prepared whenever a different soil type would be encountered. Also, if a strip of material was evaluated in which more than one Proctor Density was involved, different minimum densities would have to be calculated and applied.

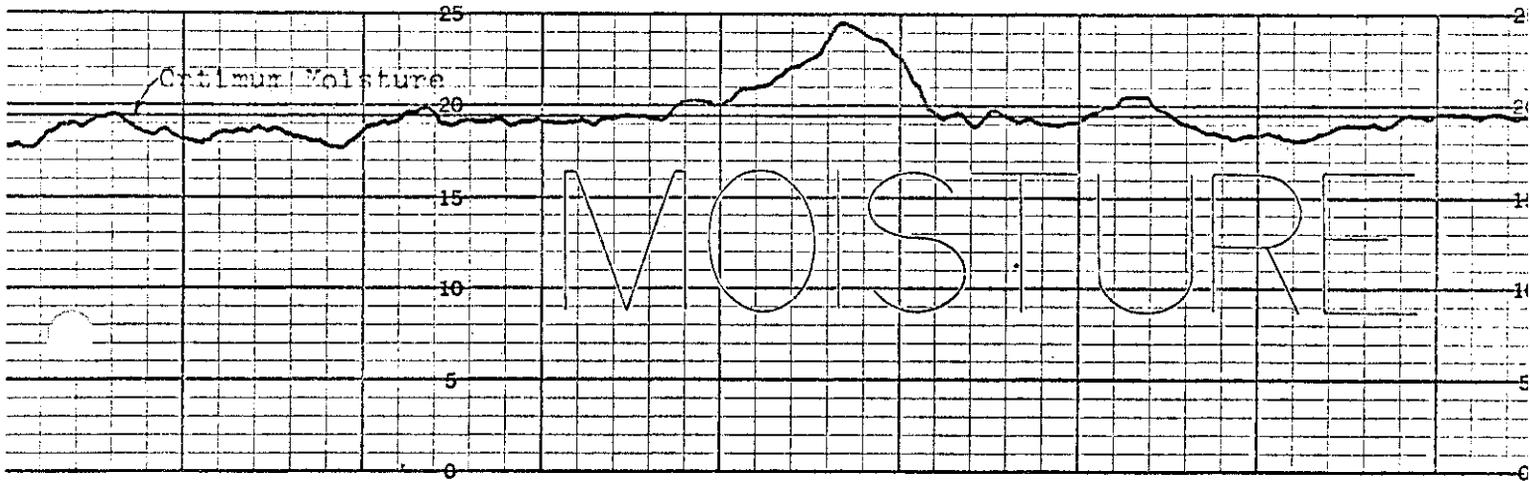
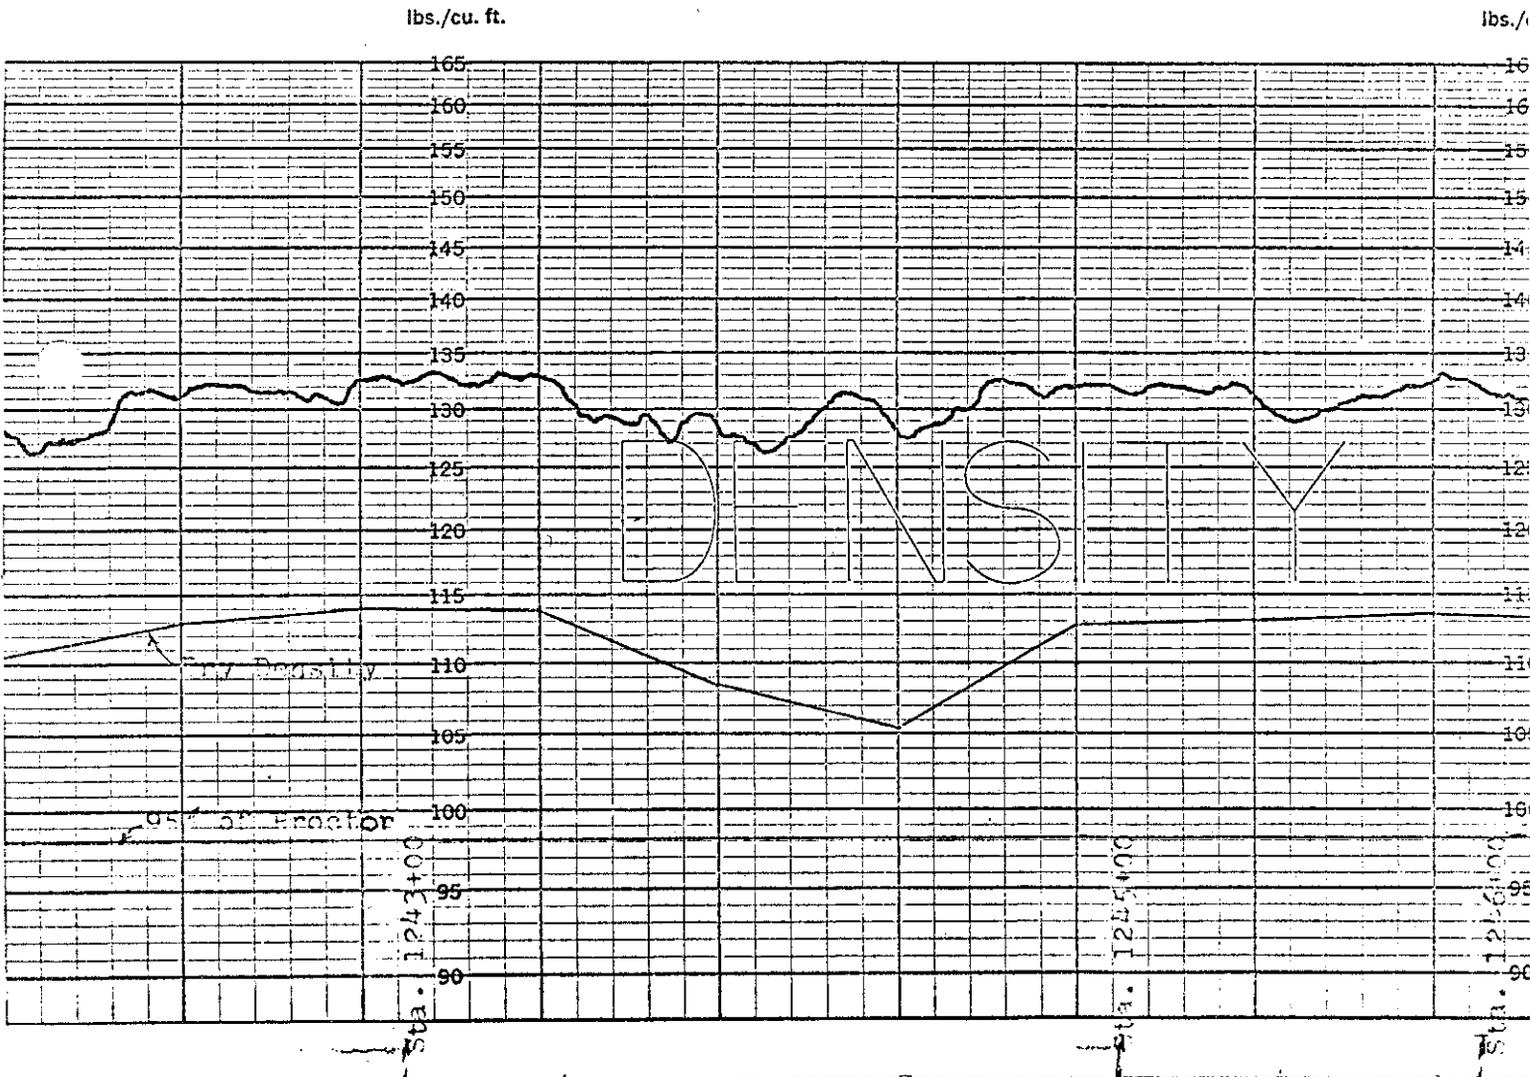
Figure 7

Optimum Moisture = 19.5 lb/cu. ft.

Proctor Density = 103.1 lb/cu. ft.

Required 95% of Proctor

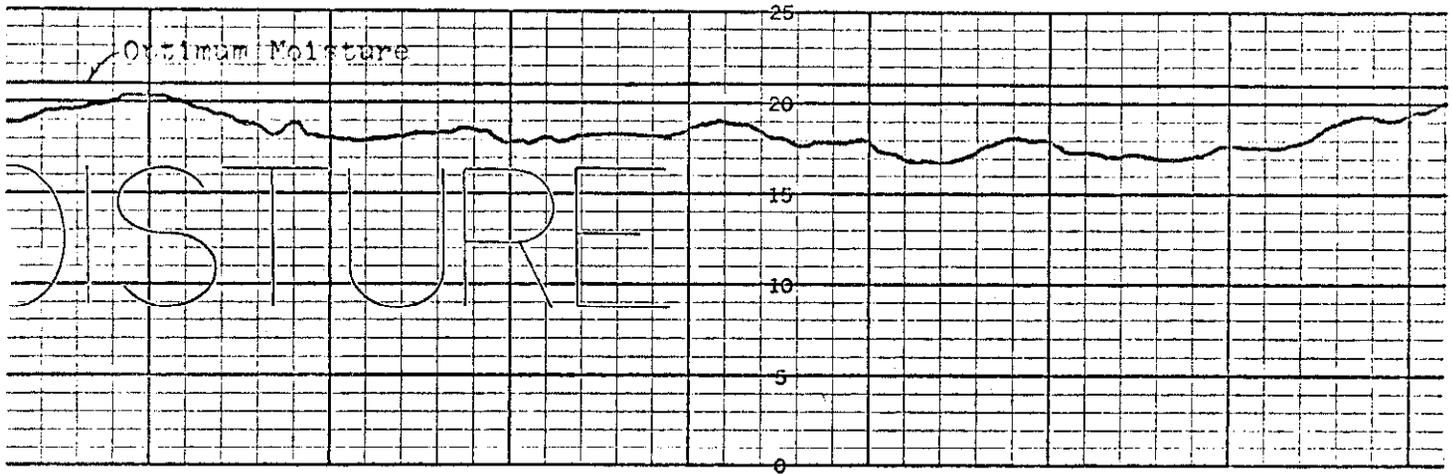
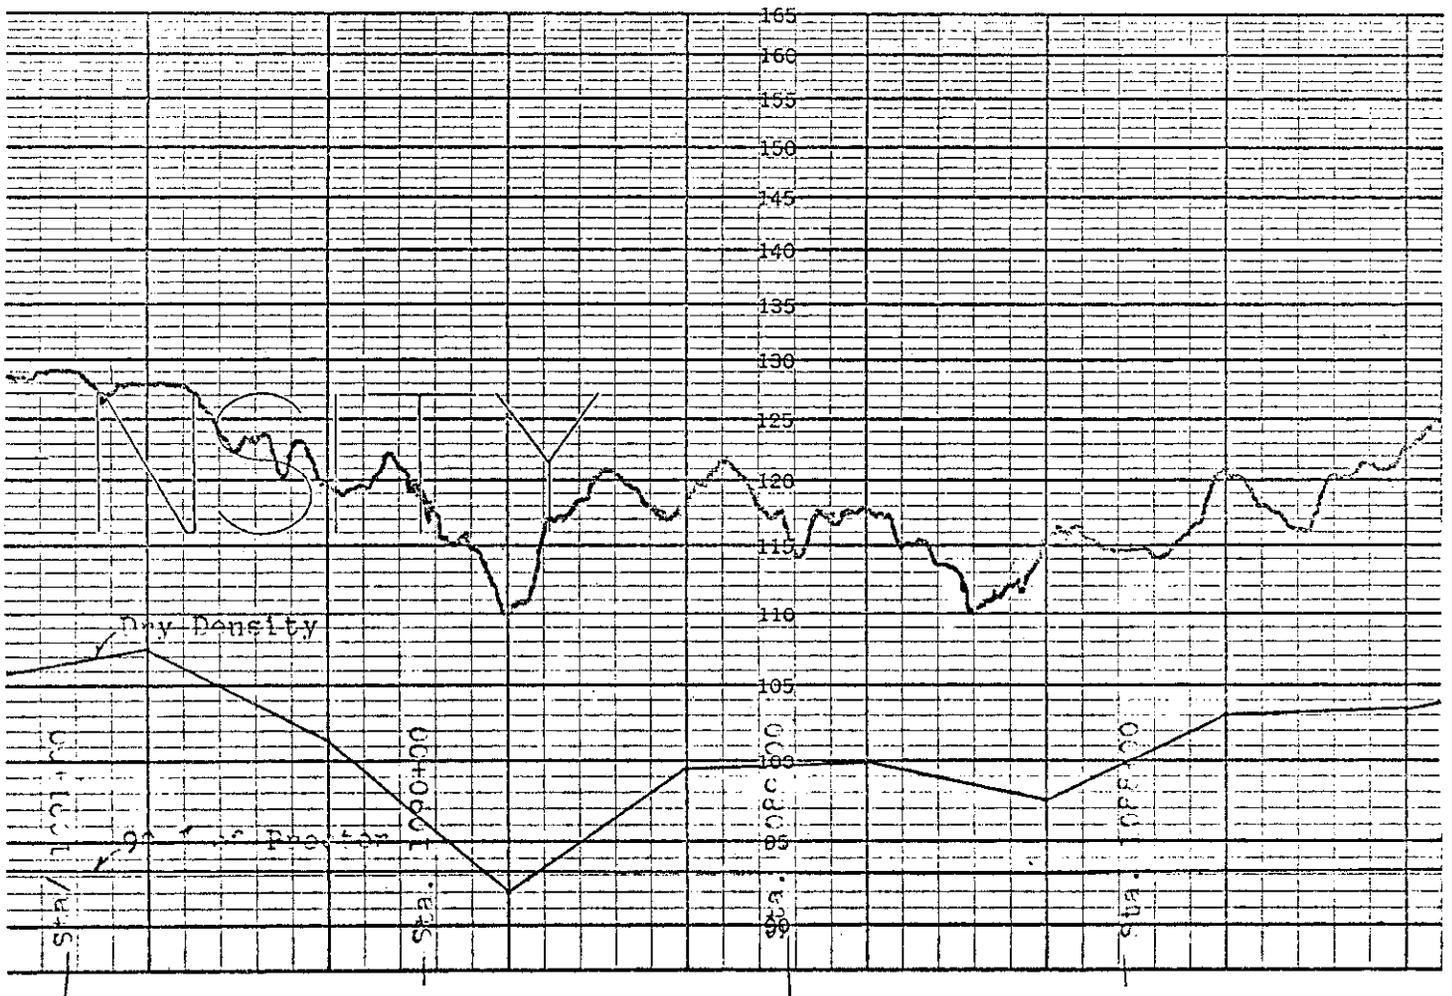
Figure 8

Pottawattamie County
 I-IG-80-1(33)27
 Subgrade

Optimum Moisture = 20.9 lb/cu. ft.
 Proctor Density = 103.6 lb/cu. ft.
 Required 90% of Proctor

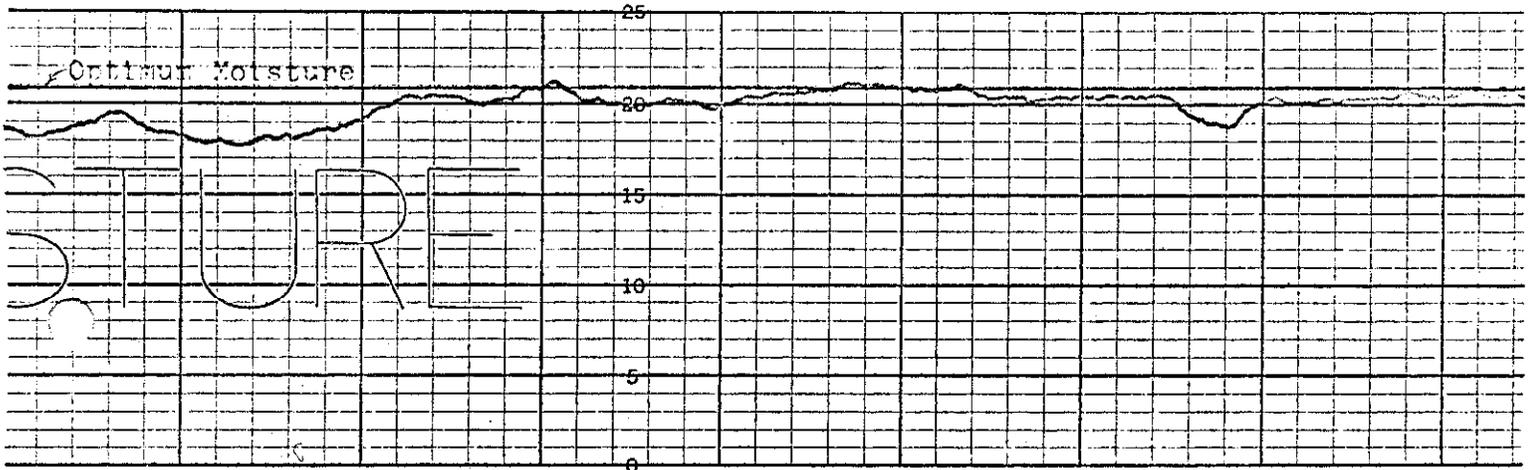
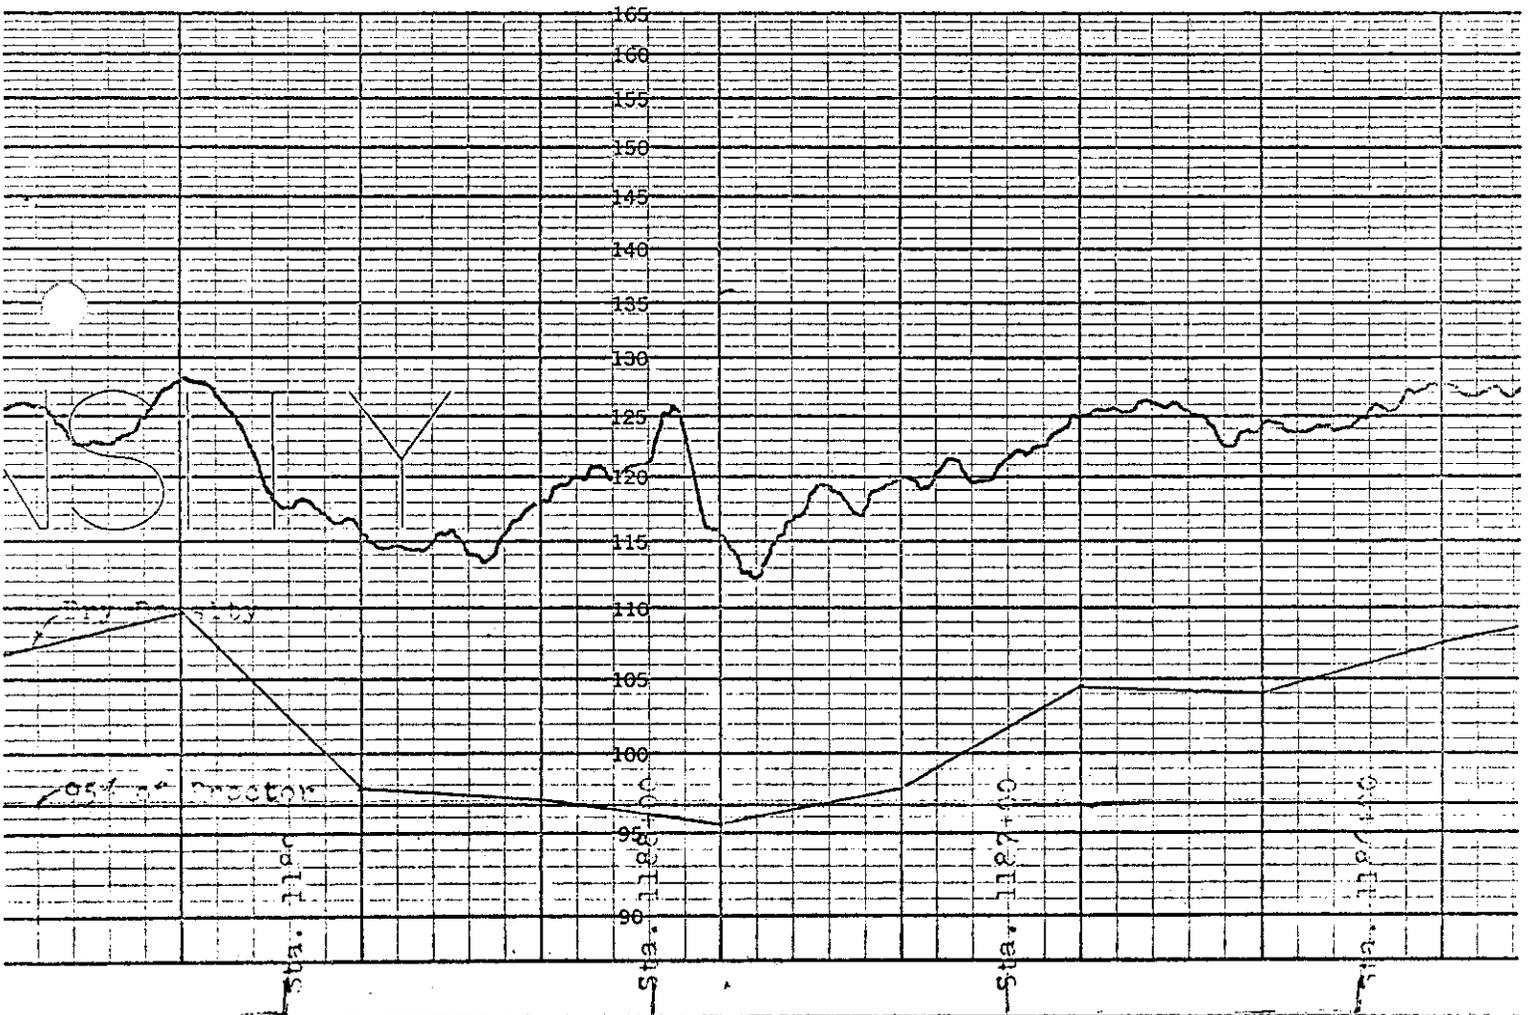
Figure 9

Optimum Moisture = 20.9 lb/cu. ft.

Proctor Density = 101.9 lb/cu. ft.

Required 95% of Proctor

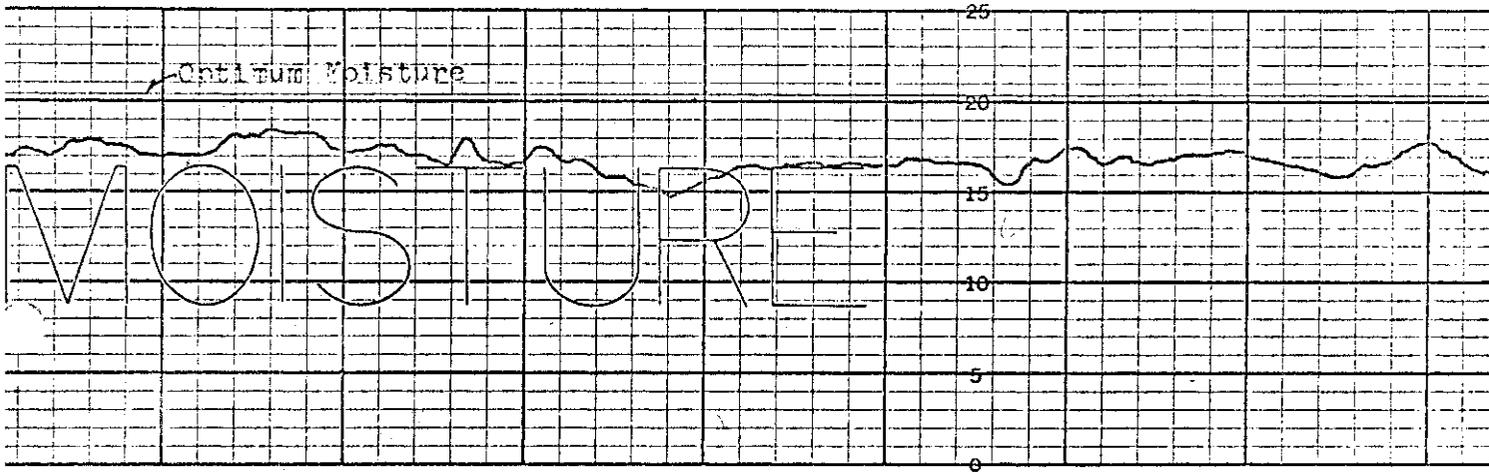
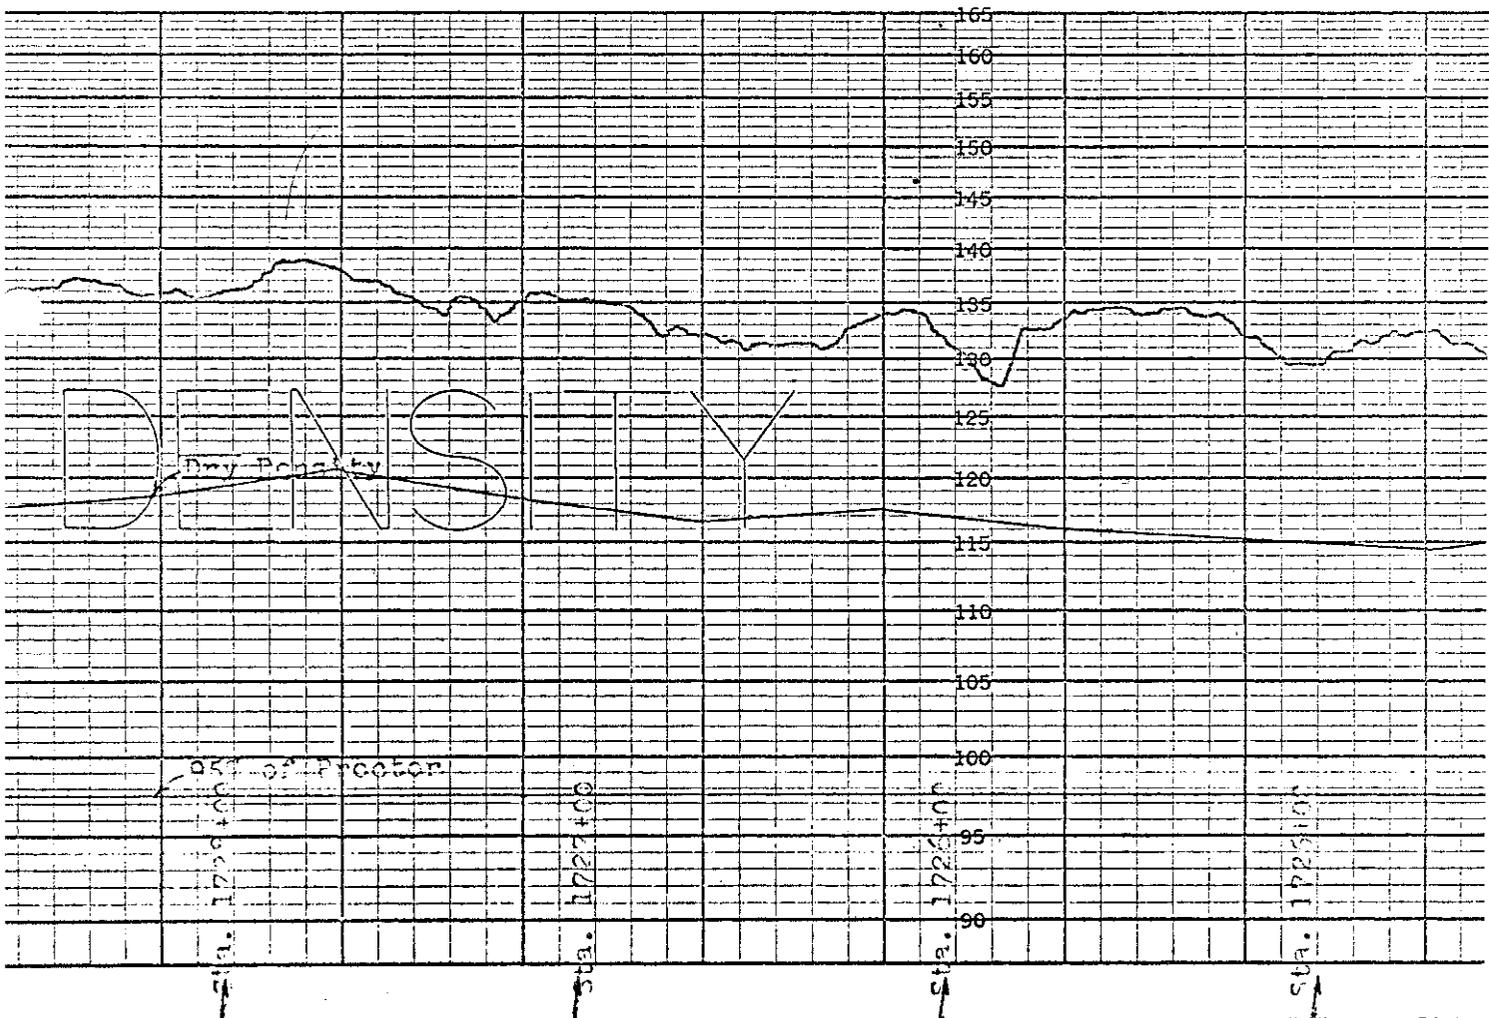
Figure 10

Optimum Moisture = 20.3 lb/cu. ft.

Proctor Density = 102.4 lb/cu. ft.

Required 95% of Proctor
