**FIELD EVALUATION
OF
THE LANE-WELLS ROAD LOGGER**

IOWA HIGHWAY RESEARCH BOARD PROJECT HR-113

SEPTEMBER 1966

Investigation of the Lane-Wells Road Logger

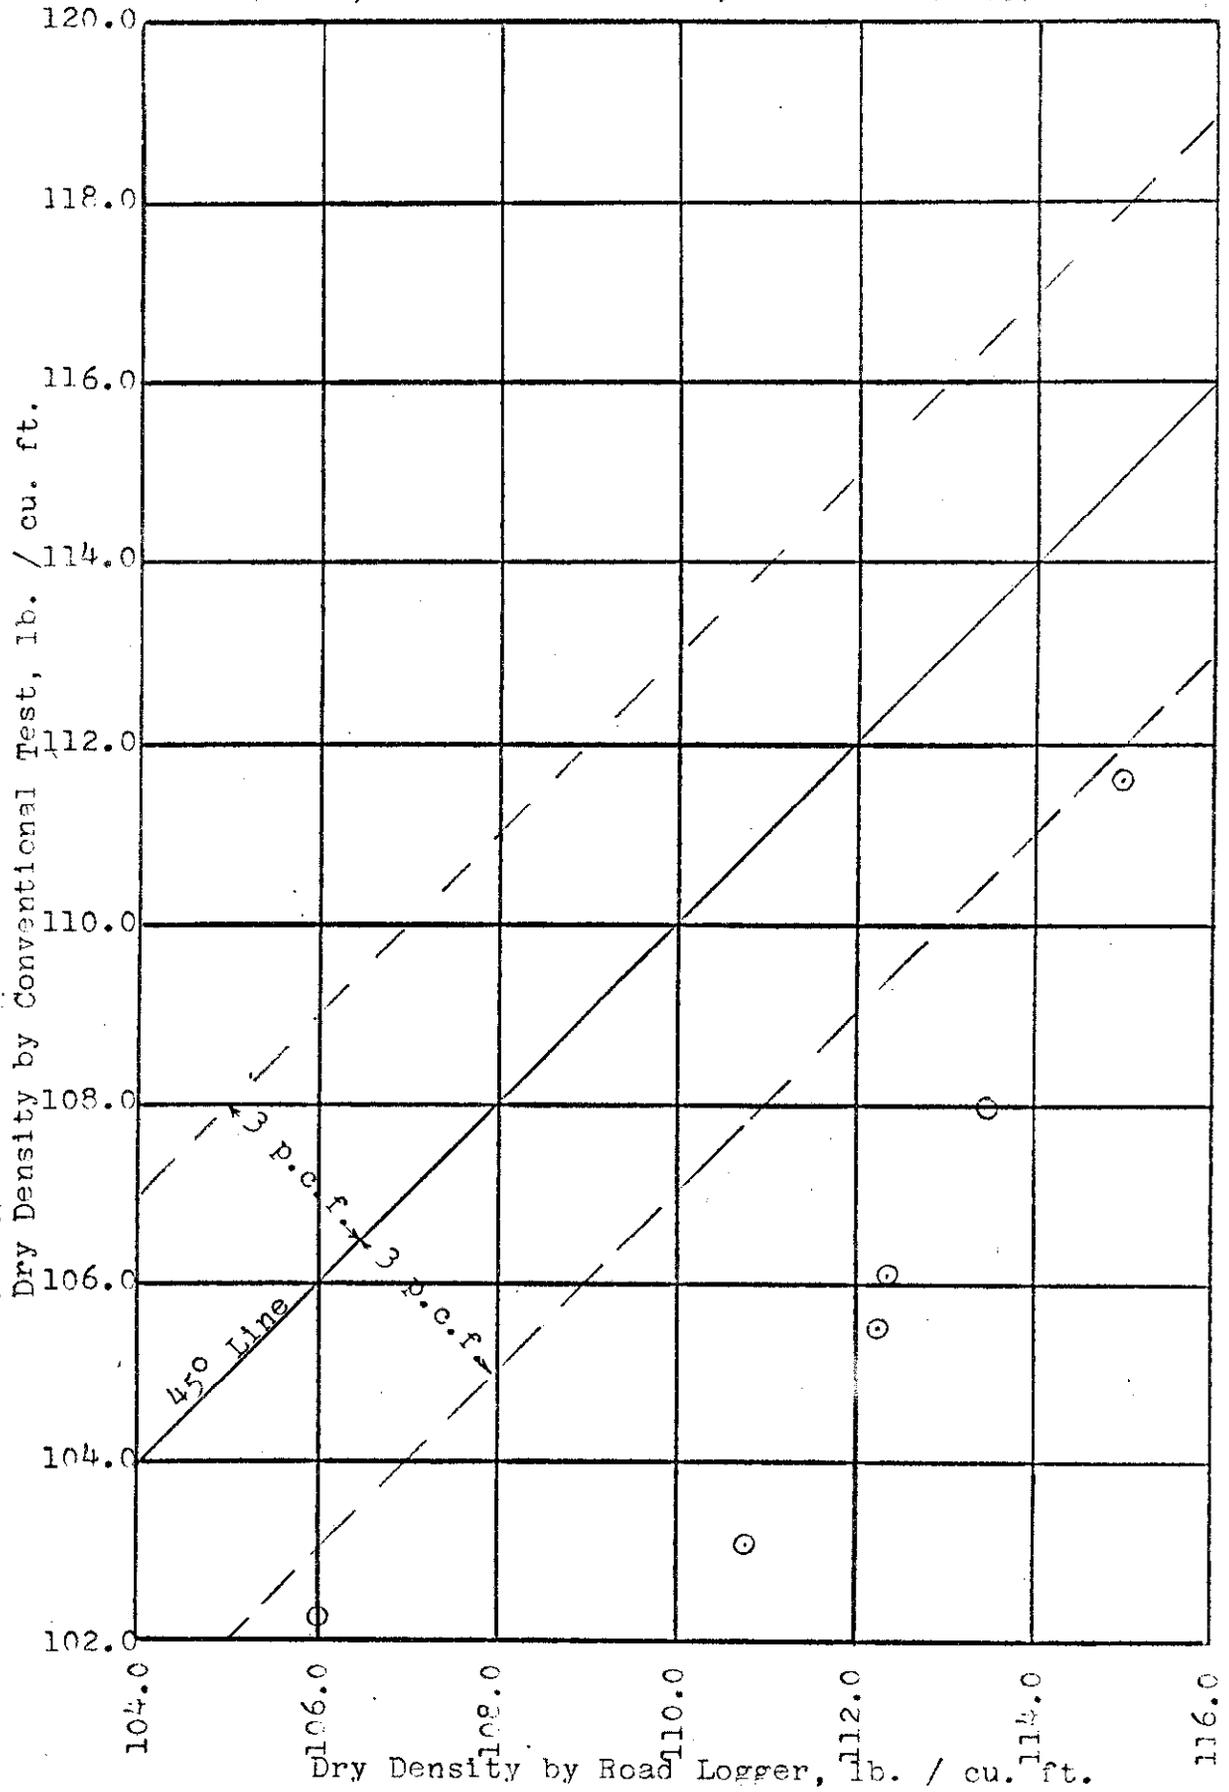
Figure 11

Static
Subgrade, Pottawattamie Co., I-IG-90-1(27)33

The majority of testing with the Road Logger was conducted on subgrade construction, much of which was subject to moisture and density control. The predominate soil type was A-7-6 although some A-6 soil was encountered in certain locations as noted below. Several stationary or static logger tests were performed in Pottawatamie County. The readings of both moisture and density were obtained and compared with conventional test results by means of graphs on Figures 11 through 15. In general, the density results of the Logger were higher than those determined by conventional testing. However, it should be noted that most of these tests follow a more or less straight line, meaning that correlation is good in most cases. The fact that the Logger readings are high could easily be alleviated by calibration changes. The moisture comparisons for the stationary tests are quite good.
