# Long-Term Structural Movement

February 1986

Iowa DOT Project HR-275  
ERI Project 1795  
ISU-ERI-Ames-86205

College of  
Engineering  
Iowa State University

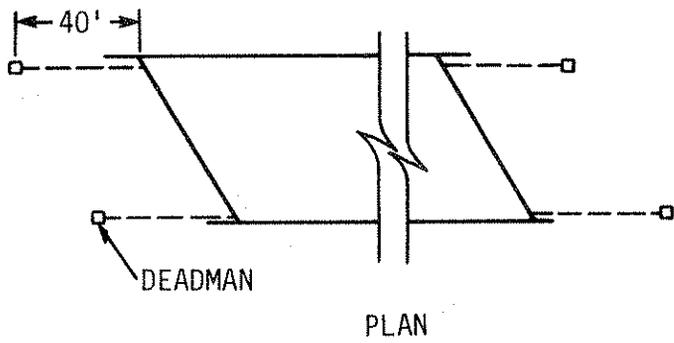
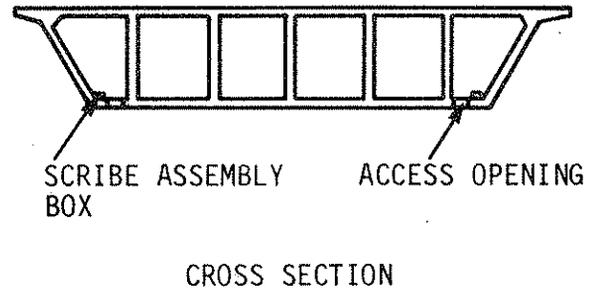
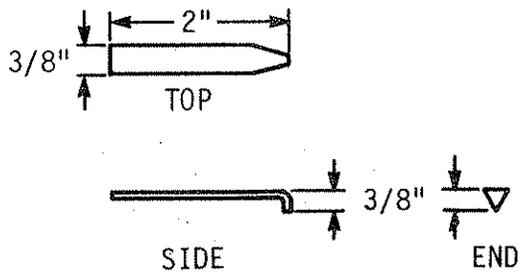
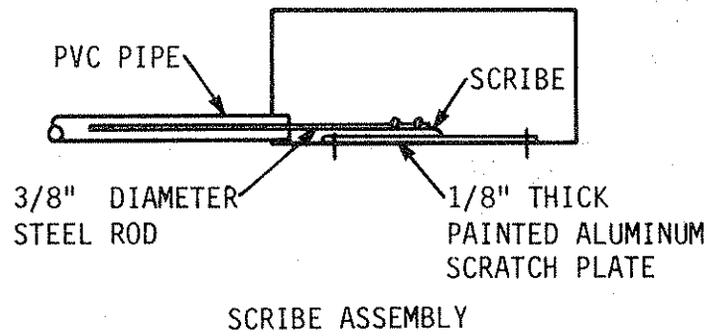
SCRIBE DETAILS

Fig. 1. Detail of assembly used in California study [5] to measure longitudinal movement because of temperature change.

In a California study [5], the longitudinal movement of 12 concrete box girder bridges was monitored using a scratching scribe assembly installed at the abutments. This technique consisted of anchoring a steel rod approximately 40 ft behind the abutment in the approach fill. It was believed that this distance was great enough so that there would be no influence from active abutment movement. The scratching scribe assembly was attached to the other end of the rod and rested on a painted plate located inside the box girder. The rod was enclosed in a plastic pipe placed between the anchorage and scribe assembly. Figure 1 shows the details of the scribe assembly. Problems with this included loose connections and settlement of approach fills that caused deflection of the rods and subsequent raising of the scribes off the plate.

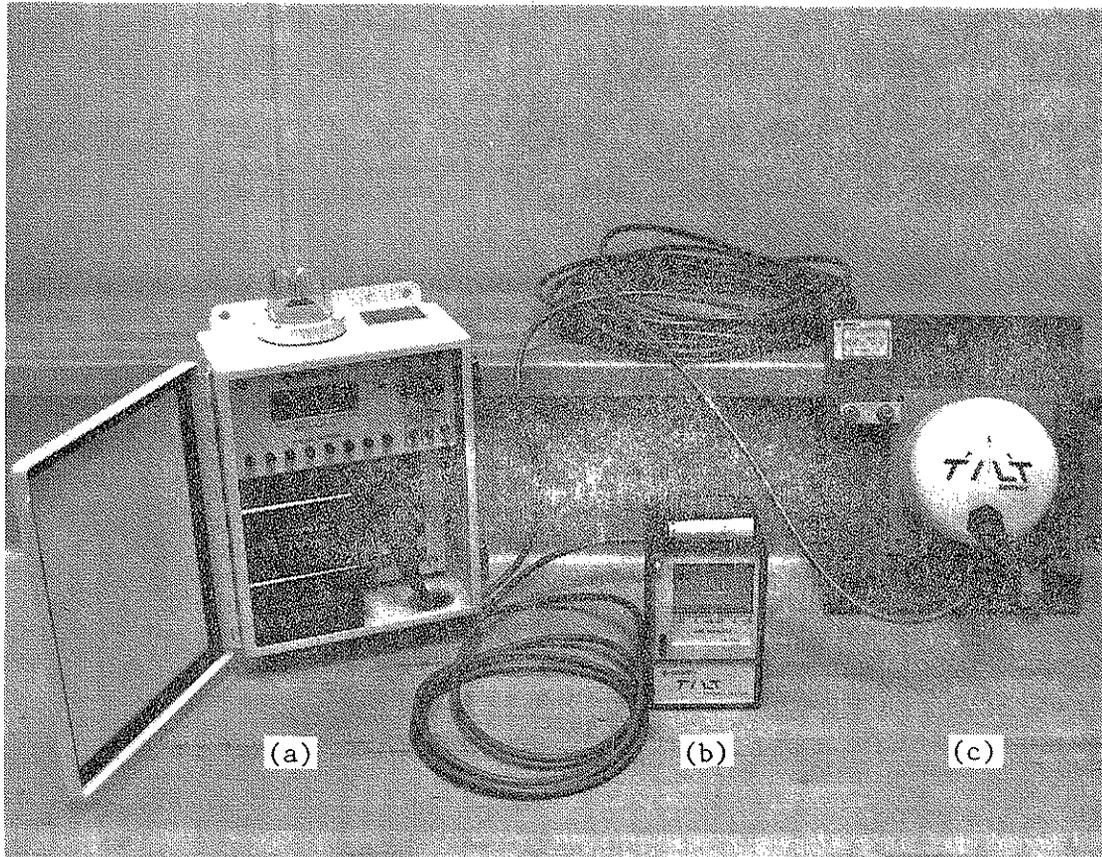
Fig. 2. Tilt sensing equipment: (a) power source, (b) recorder, and (c) tilt sensor and mounting plate.

The tilt sensors are connected to the central console unit, and readings are obtained from the liquid crystal digital readout display. The console can monitor up to four individual sensors. In addition to providing electrical power to the sensors and serving as a data source, the console also processes the electrical signals from the sensors for readout on the connected strip chart recorder. Four channels are available to record up to four tilt sensors. The central console may be battery driven or controlled by a 120 volt current.

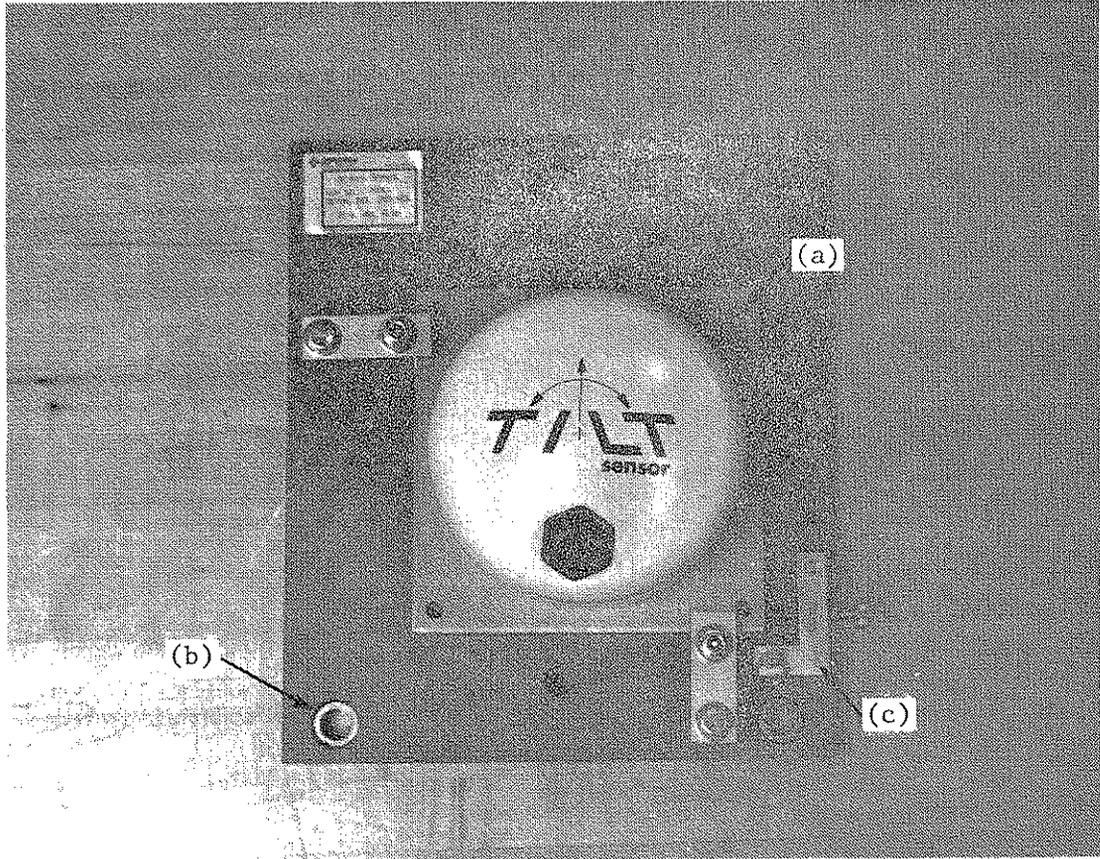
Fig. 3. Details of tilt sensor mounting to the plate: (a) pivot hole, (b) brass mounting pad, and (c) alignment mechanism.

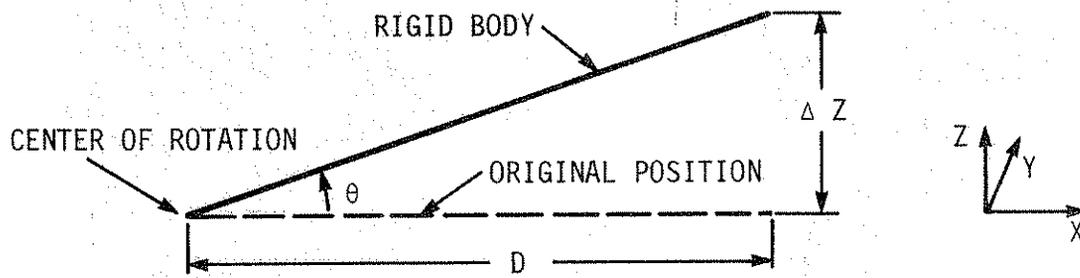
Fig. 4. Description of rigid body rotation for calculating deflections from tilt sensor data.

Use of the sensor in monitoring structural movement is made by obtaining alignment information at discrete points along the structure. From these data, calculation of deflection may be made by utilizing elementary geometrical and structural analysis principles. In the case of an angle change for rigid body rotation of a horizontal member (see Fig. 4), the movement  $\Delta Z$  may be calculated using

$$\Delta Z = D\theta \quad (1)$$

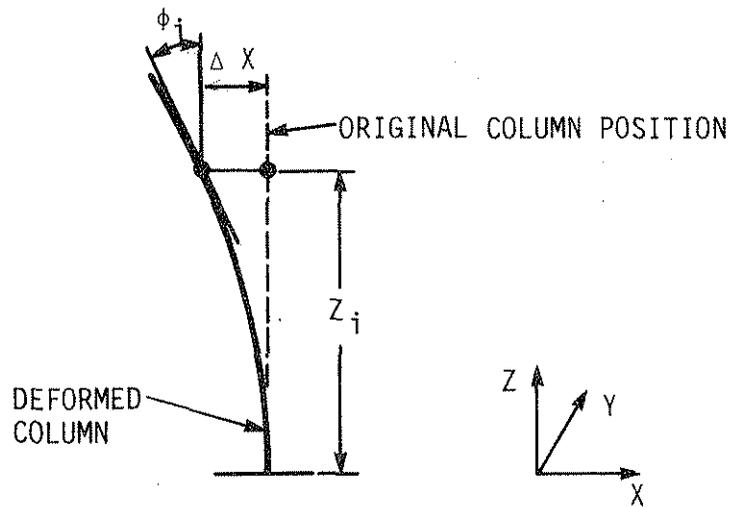
Fig. 5. Description of member curvature for calculating deflection from tilt sensor data.

$$\Delta X = \int \frac{M}{EI} Z dz \quad (2b)$$

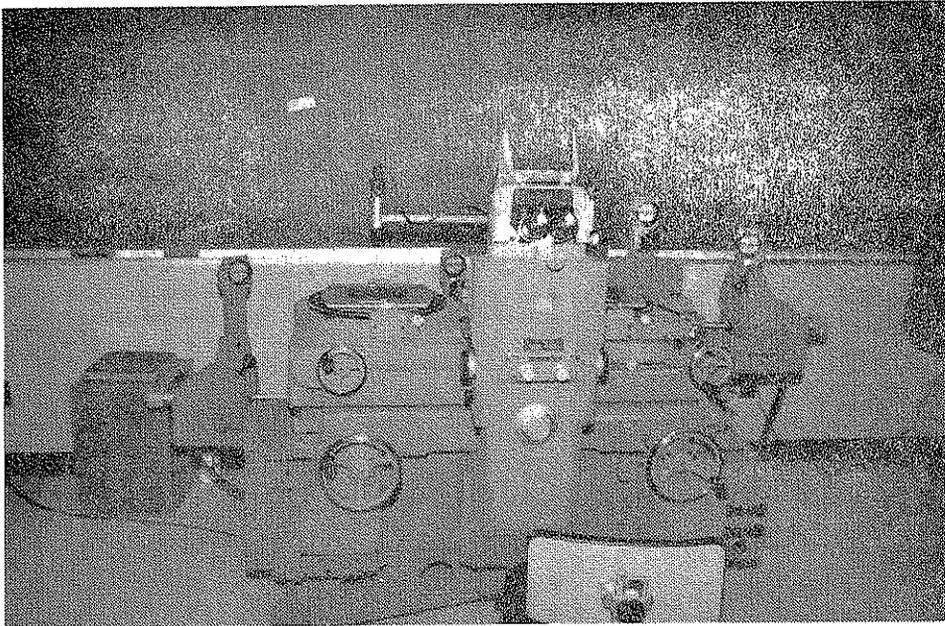
Fig. 6. Wild STK-1 stereocomparator.

Strain gauges were attached to the steel members with recommended surface preparations and adhesives. Lead wires from the strain gauges were connected to computerized data acquisition system (DAS), which read and stored the strain levels. The DCDTs utilized the DAS in a similar way by monitoring and storing deflection data. The tilt sensor readings were taken from the central console digital display and recorded by hand. Measurements observed using the dial gauges and surveying instruments were read and recorded by hand. The computerized control panel for the MTS fatigue testing equipment was used to monitor the deflections and to control the rate of displacement. Photographs, which were taken during the testing utilizing photogrammetry techniques, were processed and analyzed using a Wild STK-1 Stereocomparator.

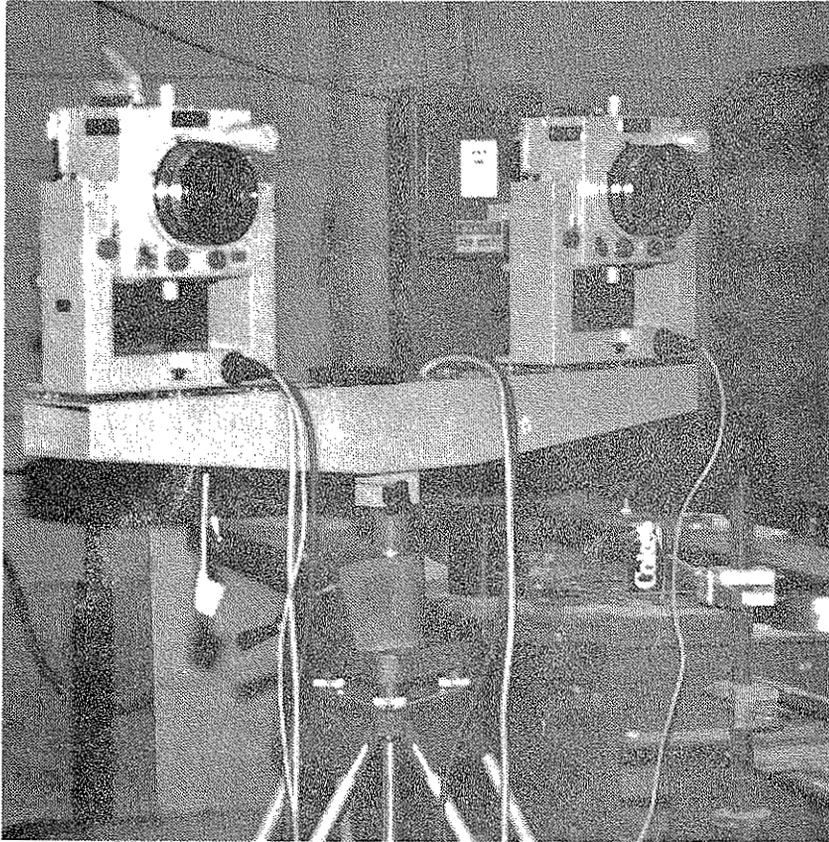
Fig. 7. Zeiss stereometric camera on a tripod.

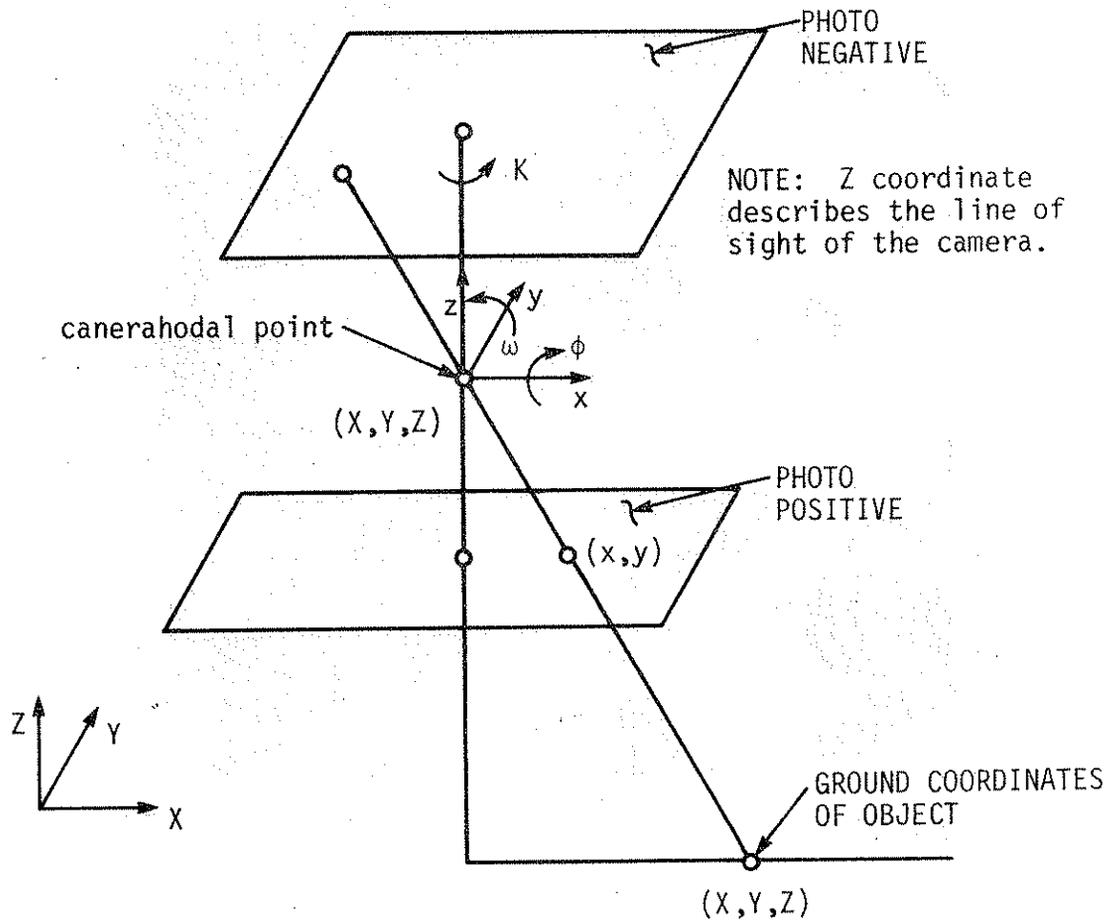
Fig. 8. Photogrammetric resection describing reduction of data for measurements from a photograph.

By measuring the photo coordinates  $(x, y)$  of three or more points, for which the ground coordinates  $(X, Y, Z)$  are known, the unknown parameters  $X_o, Y_o, Z_o, k, \phi,$  and  $w$  can be determined by an iterative least squares method using six or more equations similar to Eqs. (3) and (4).

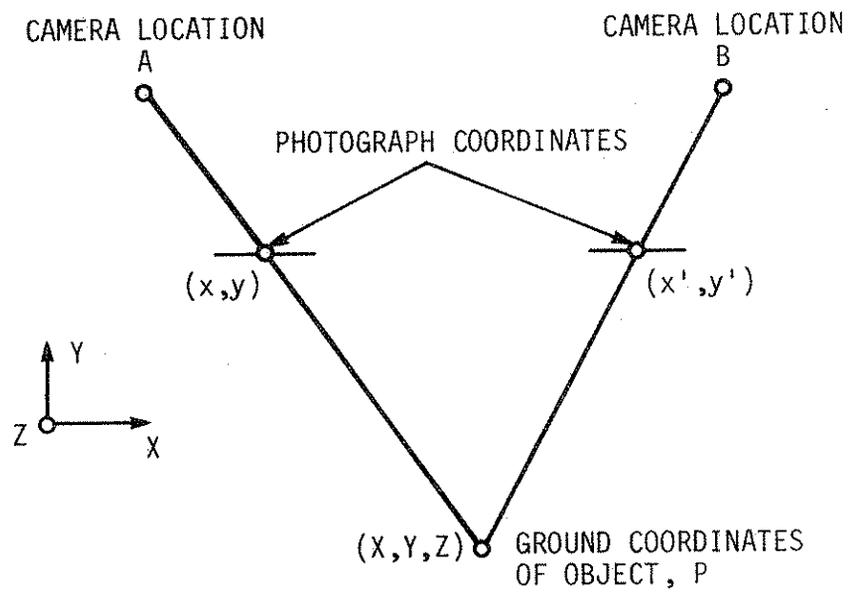
Fig. 9. Plan view of a photogrammetric intersection.

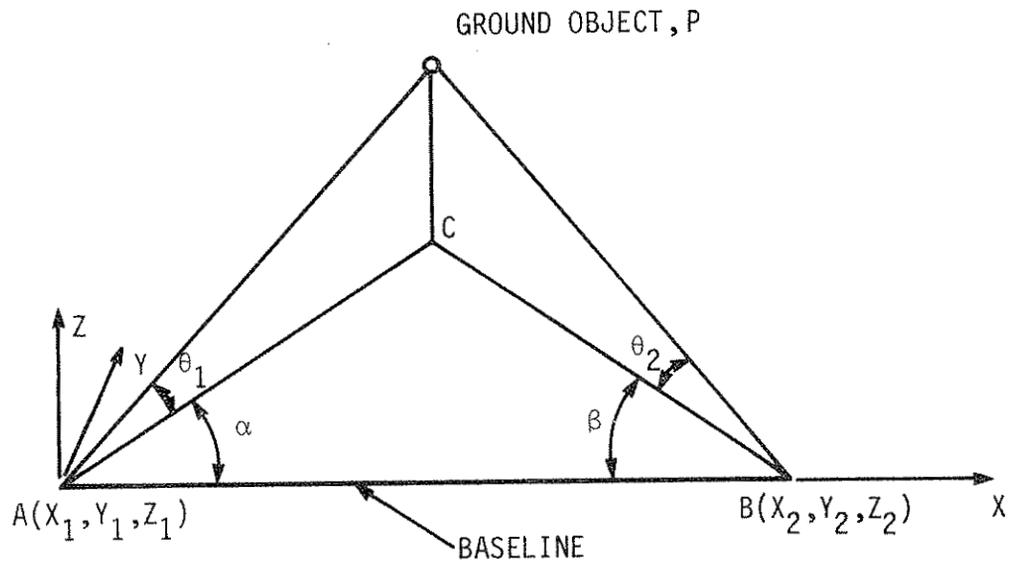
Fig. 10. Three-dimensional view illustrating the concept for making deflection calculations by the surveying method.

Application of surveying techniques in the measurement of structural movement requires the use of an instrument for making angular measurements. The measurements are taken for the points on the object being monitored from known reference points. Both Wild T2 and Kern DKM2 Theodolites were used in this study. The surveying method as applied in this study is illustrated in Fig. 10.

The horizontal angles ( $\alpha$ ,  $\beta$ ) and vertical angles ( $\theta_1$ ,  $\theta_2$ ) are measured from two stations, A and B, to a point, P. The coordinates (X, Y, Z) of P are given by

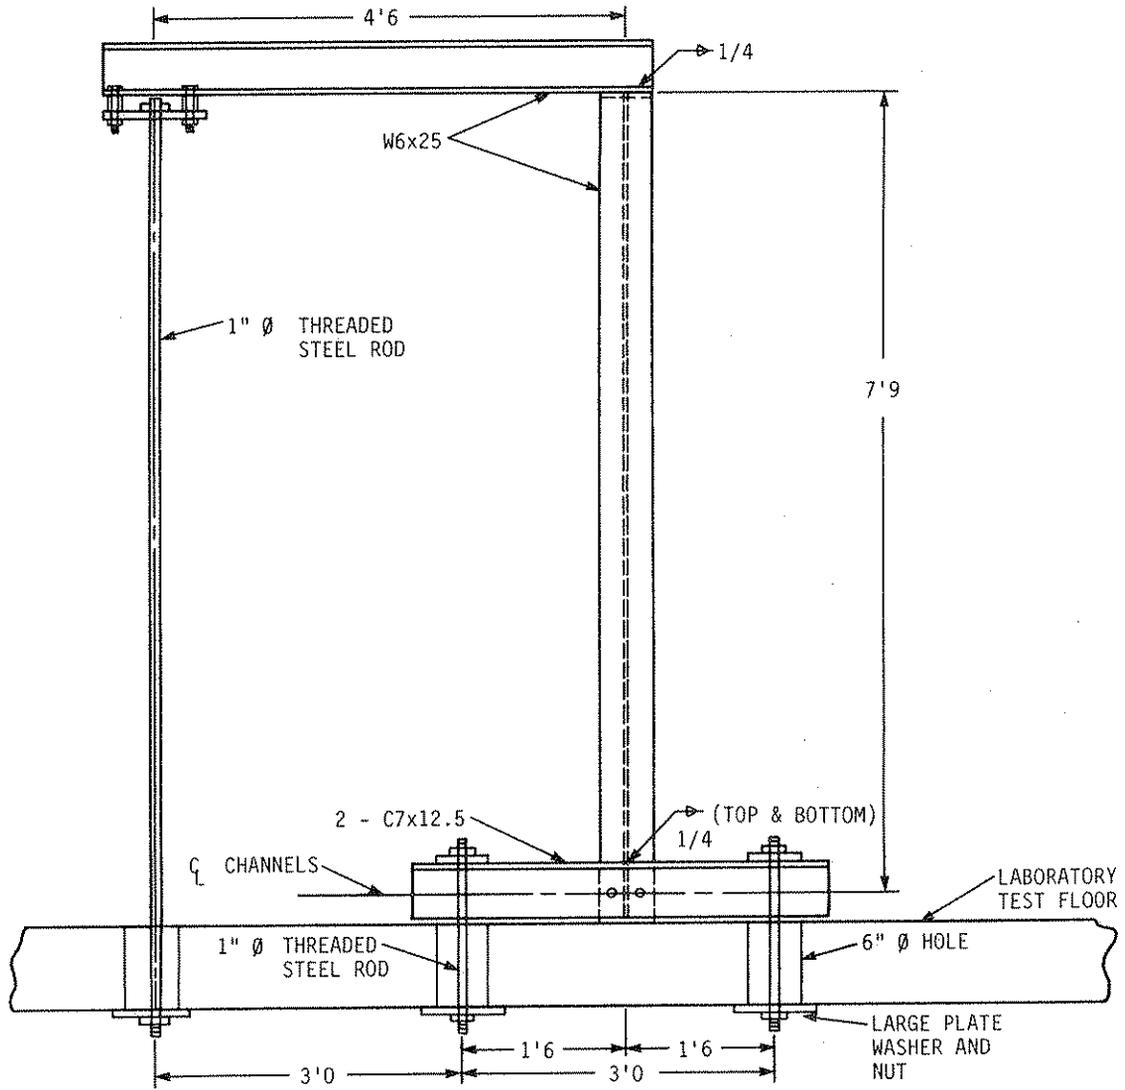
Fig. 11. Frame details for Column Tests 1 and 2.

A sketch of an elevation view of the column member is shown in Fig. 11. The column was part of a frame that allowed member curvature and deflection to be developed in the column. A wide flange A-36 steel section (W 6  $\times$  25) served as the column, which was rigidly connected at the base to two steel channel sections (C7  $\times$  12.25). As

shown in the sketch, the rigid base connection was created by welding the top and bottom flanges of the channel to the column flanges. In addition, two 1/2-in. diameter bolts were used to complete the connection. The channels were fastened to the laboratory test floor by use of a detail that allowed bearing on a large steel plate washer (attached across the top of the two channel flanges) by a one-inch diameter rod. The rod was secured to the underside of the test floor at a tie down location with a large plate washer and nut. For purposes of deflection calculation, the base of the column was assumed to be fixed.

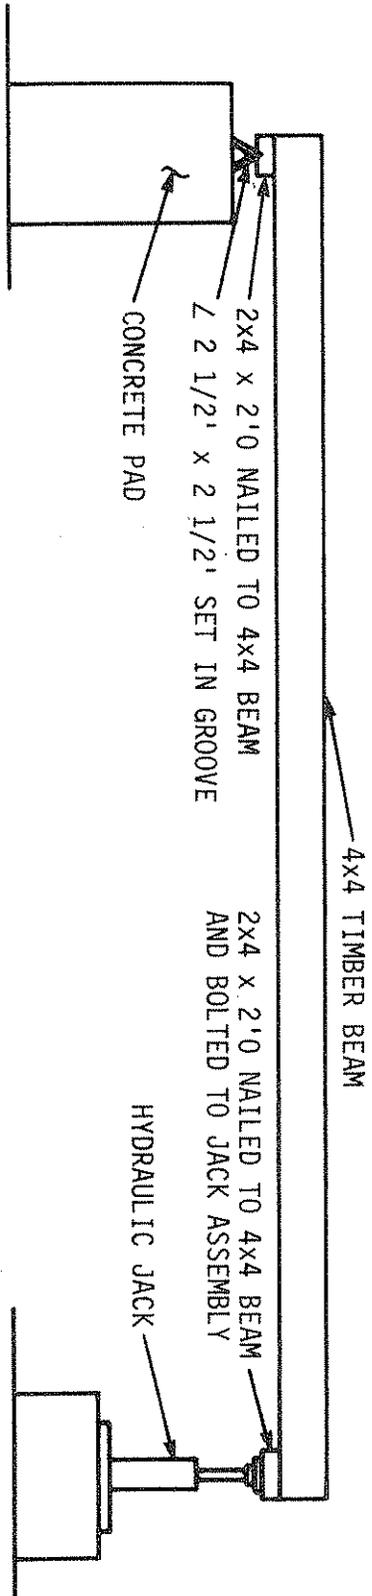
Fig. 12. Member details for Beam Tests 1, 2, and 3.

Figure 12 illustrates the layout for Beam Tests 1, 2, and 3. The tests were designed to achieve rigid body rotation. A 4 × 4 timber served as the beam member that was supported at one end on a rigid base with the freedom to rotate and was supported at the other end by a hydraulic jack, which allowed control of the vertical movement. The configuration allowed a rotation of the whole member in a vertical plane relative to the rigid base end. As shown in Fig. 12, a section of 2 × 4 lumber was carefully grooved and supported on a steel angle member laid on end to form an inverted vee shape. This detail created a hinge-type support that allowed rotation of the member end. At the opposite beam end, a hydraulic jack rigidly connected to the beam was used to raise the member to cause the member rotation. The jack was placed on a steel bearing pad, which rested on top of a concrete abutment.

Selection of the beam length was based upon two considerations. The desire to mount four sensors simultaneously for a portion of the testing dictated the beam length be relatively long. In addition, given the limited angular range of the tilt sensors, the rotation through which the beam could be rotated was limited. For ease in measuring displacements with photogrammetric and surveying methods, a relatively long member was required. Specifications for mounting the sensors for angular measurement require that the sensors be mounted in a plane within 5° of vertical of the planar rotation of the structure. This

ensures any difference between the actual structure angular movement and the sensor movement will be insignificant. By using the relatively long beam member, it was also felt that exact planar movement of the beam throughout the range of angular movement would be difficult to achieve and therefore would provide some insight into the adequacy of the sensor mounting specifications.

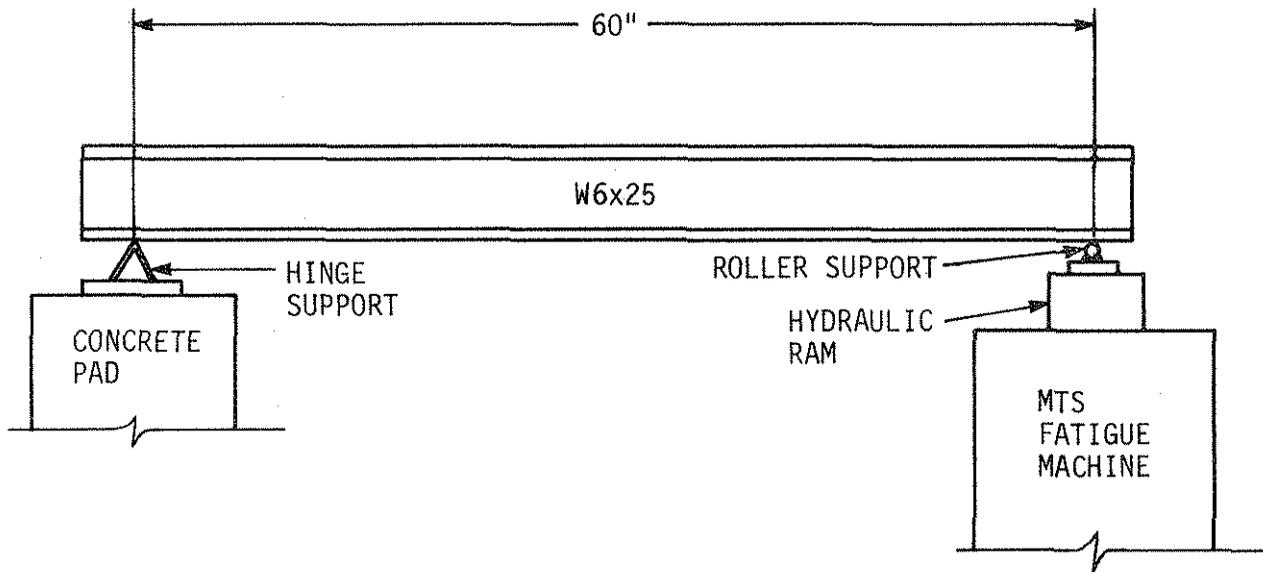
Fig. 13. Member details for Beam Test 4.

The beam member used in Beam Test 4 is shown in Fig. 13. As shown, it consisted of a six-inch wide flange steel section that was simply supported. One end was idealized as a hinge support, while the other end was supported on a roller on the hydraulic load ram of the MTS fatigue testing machine. The ram end of the member was displaced to cause rigid body rotation. The MTS machine was used so that a dynamic displacement could be applied and the response time of the sensors could be studied.

The relatively short member length was selected to contrast with the long dimension used in Beam Tests 1, 2, and 3. In these tests possible out-of-plane rotation of the member was more likely to occur; so the short member length was selected for Beam Test 4 to reduce the possibility of the same thing happening again.

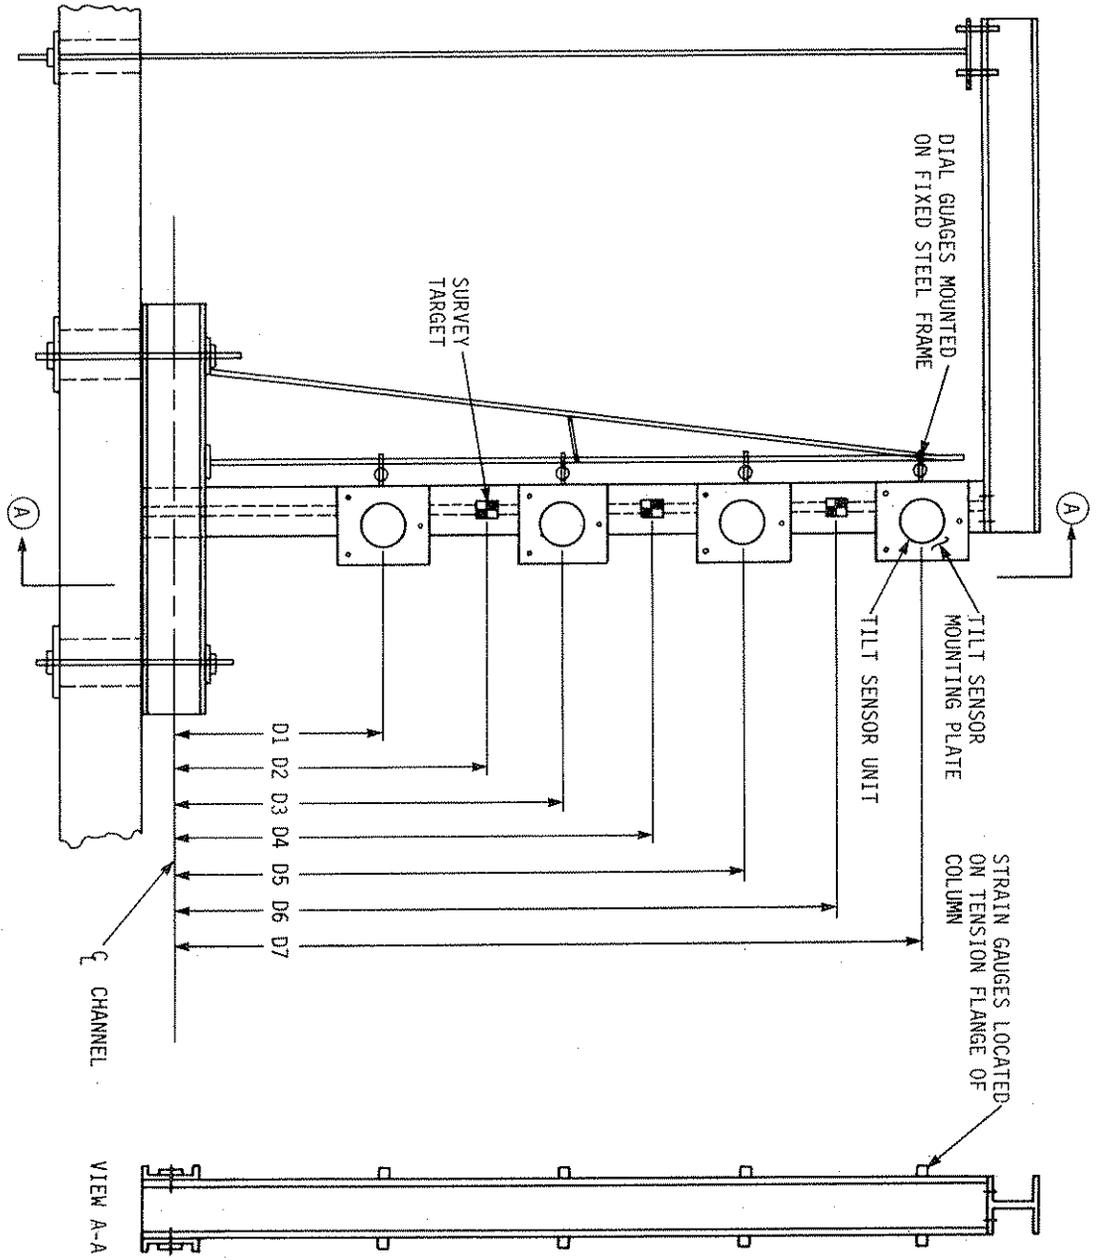
Fig. 14. Test setup and instrumentation for Column Tests 1 and 2.

Instrumentation for the steel column consisted of four dial gauges, four tilt sensors, and eight strain gauges as shown in Fig. 14. At each of the locations represented by distances D1, D3, D5, and D7 measured from the center line of the channel base fixture, one dial

gauge, one tilt sensor, and two strain gauges were utilized to measure column movements.

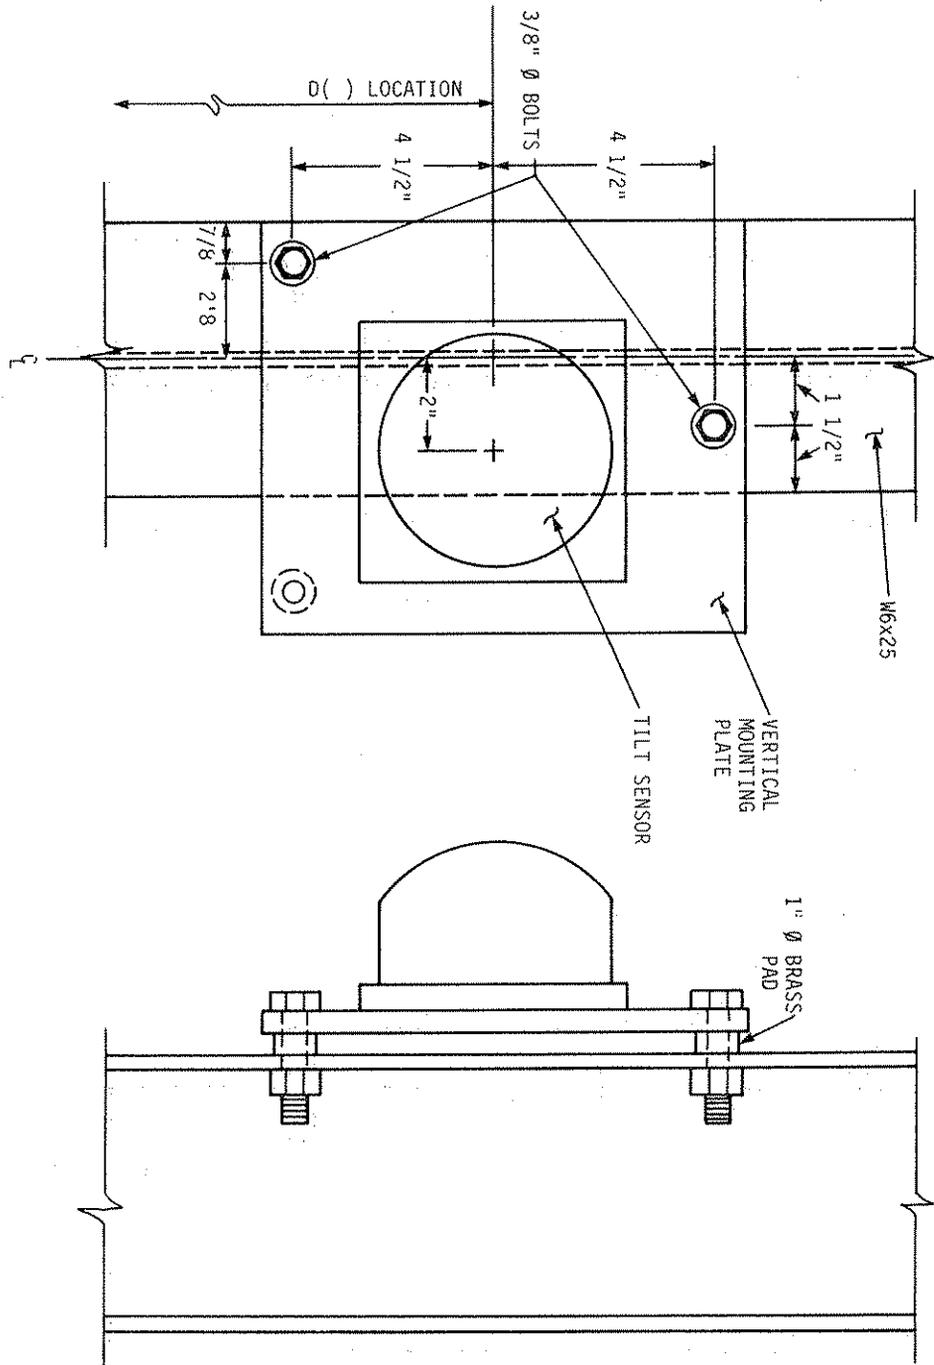
Fig. 15. Details and dimensions of the vertical mounting plate attachment to the column.

The tilt sensors were mounted on the steel column member with a vertical mounting plate attached to the column by two bolts. Recommended plate installation procedures suggests a three point mounting arrangement using all three mounting holes as shown in Fig. 3 for rough and/or curved surfaces. Brass mounting pads at the bolt hole locations on the plate assembly permit such a mounting. However, the column member flange was not wide enough to accommodate all three fasteners, so the two fastener arrangement was used (see Fig. 15). The two pads that rested on the column were sufficient to stabilize the mounting plate. The narrow column width made it necessary to offset the center line of the tilt sensor relative to the column center line. Since the sensor angular readings are measured relative to a gravitational reference line, this offset did not affect the measurements.

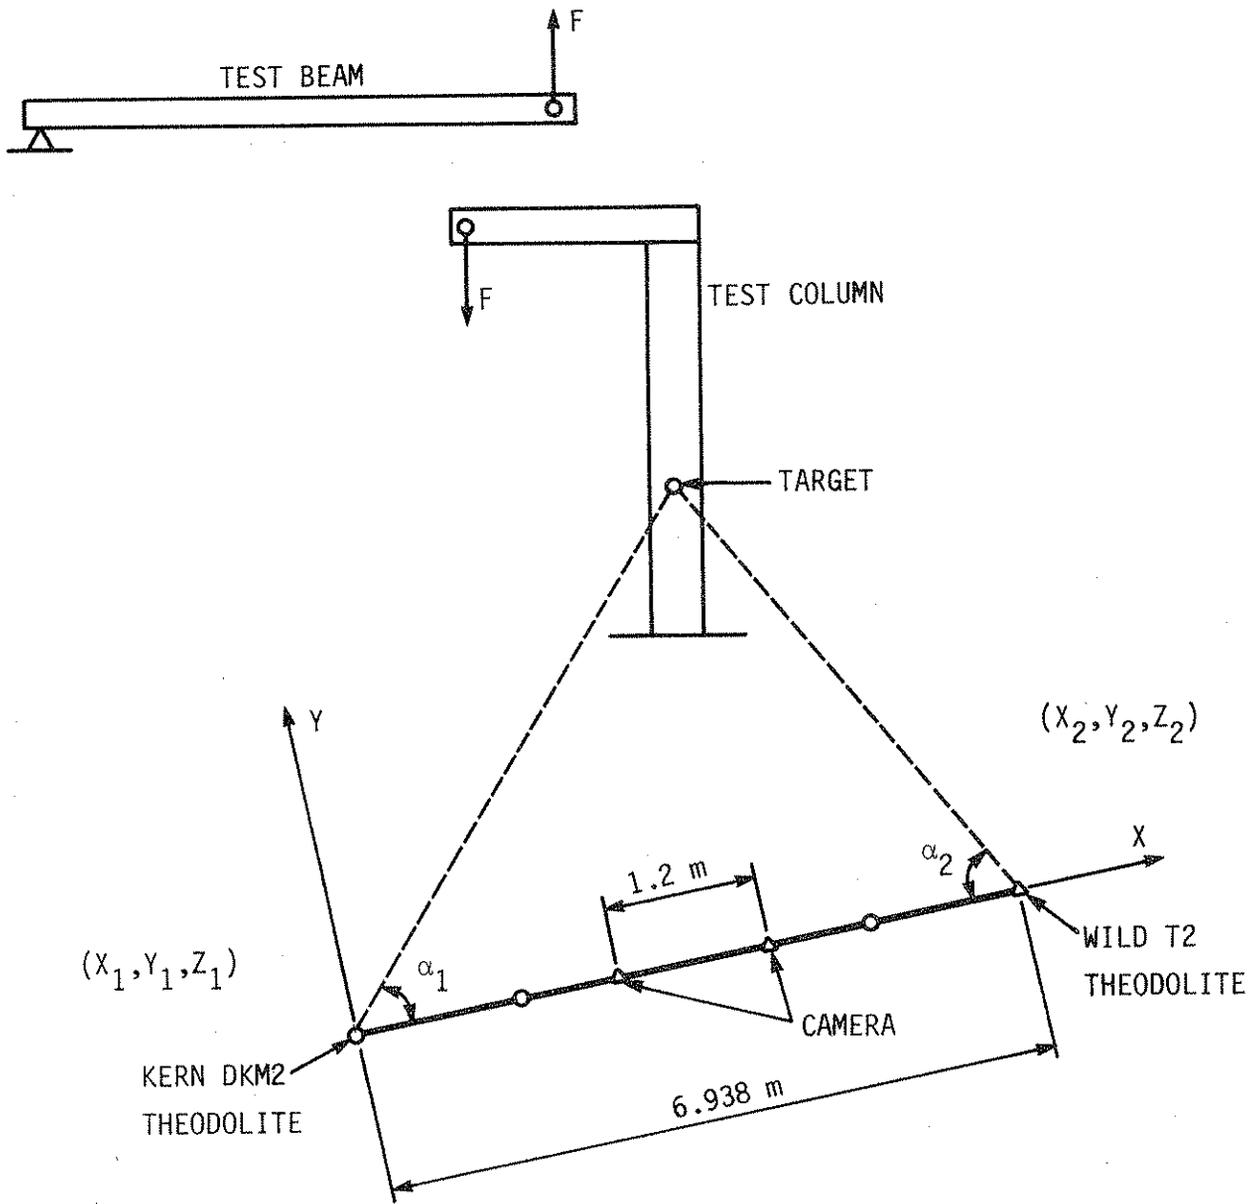
$\alpha_1, \alpha_2$  - measured angles

Fig. 16. Baseline and test setup for photogrammetric and surveying methods.

The test layout regarding the photographic and surveying techniques is shown in Fig. 16. The equipment location, as well as the baseline geometry, were the same for all column and beam tests. Three

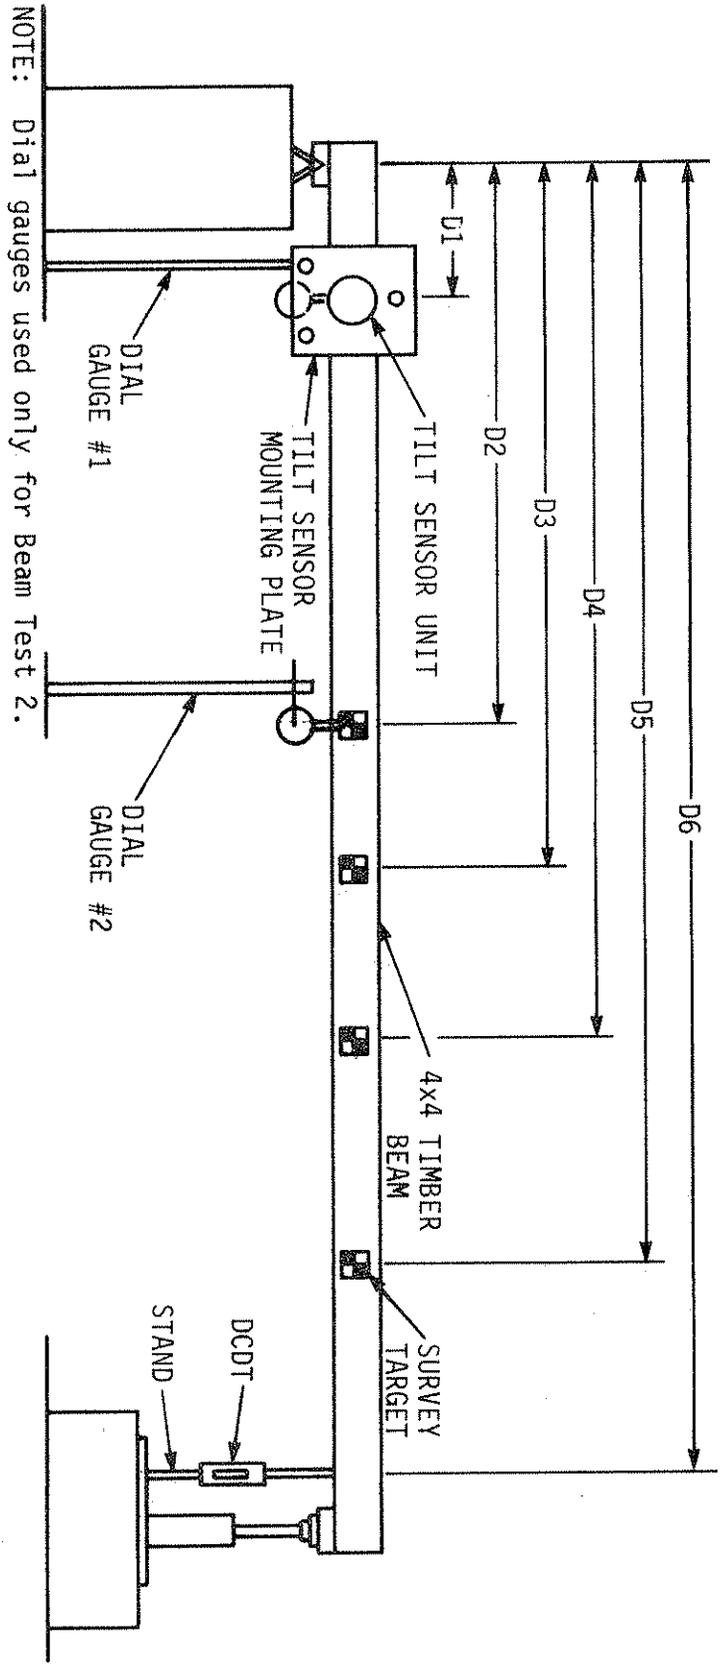
Fig. 18. Instrumentation setup and location for Beam Tests 1 and 2.

NOTE: Dial gauges used only for Beam Test 2.

Figure 18 shows the setup used for Beam Tests 1, 2, and 3 and the locations that were monitored for movement. Different arrangements of the instrumentation were utilized for each of the three tests performed on the beam. The instrumentation consisted of dialgauges, DCDTs, tilt sensors, and surveying and photogrammetry techniques.

The dial gauges were located under the beam, and their stems were placed at the beam center line. The DCDT located at one end of the member was positioned beneath the member center line and was placed on a

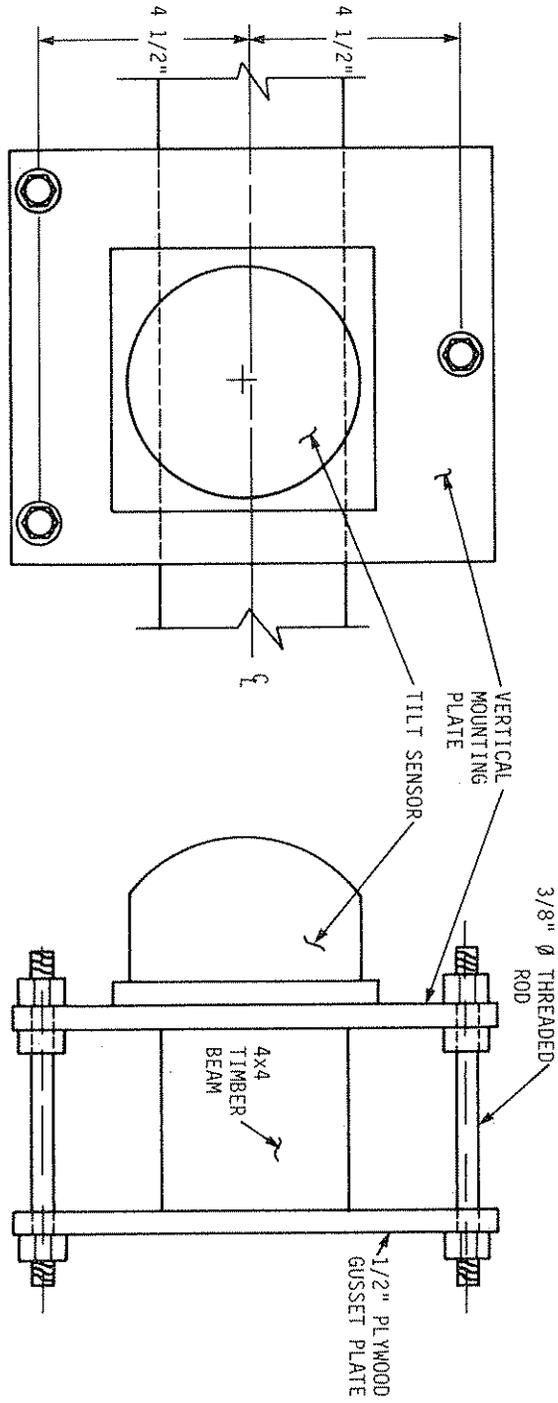
Fig. 19. Details and dimensions of the vertical mounting plate attachment to the beam member.

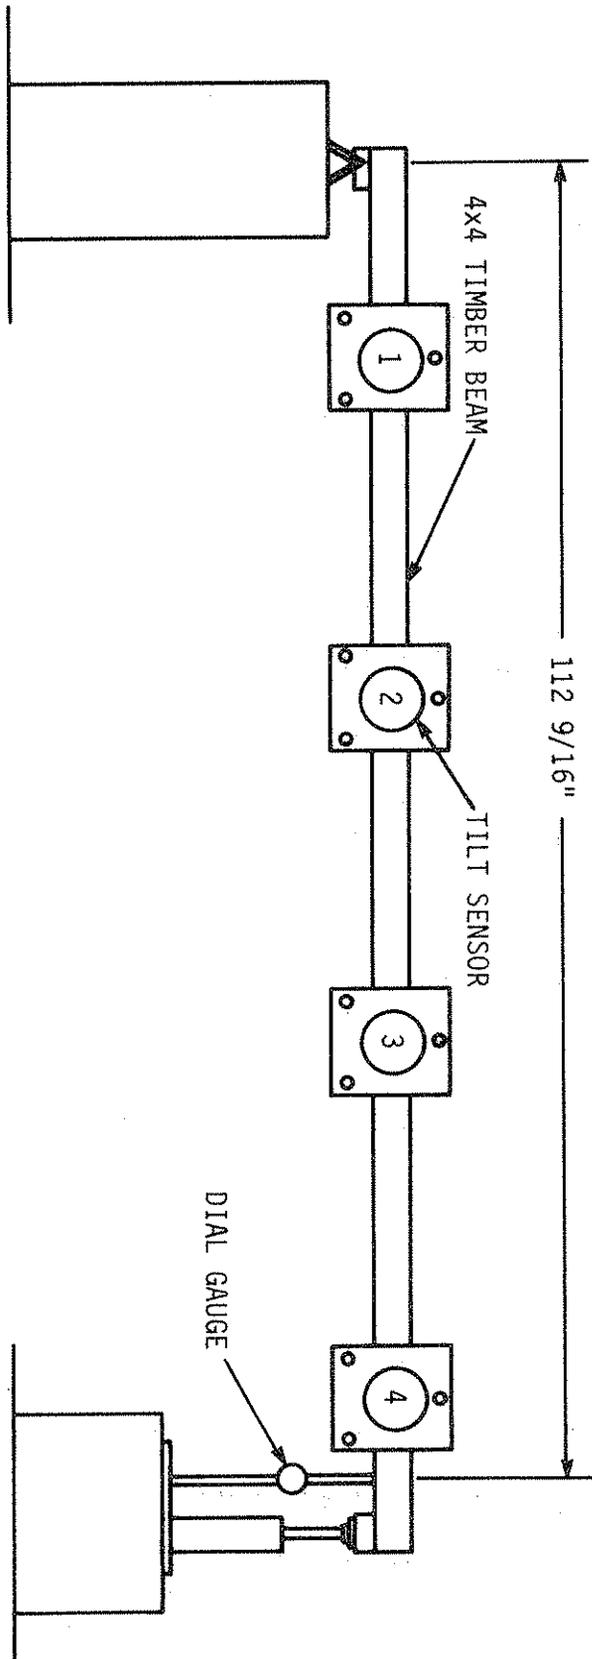
Fig. 20. Test setup for Beam Test 3.

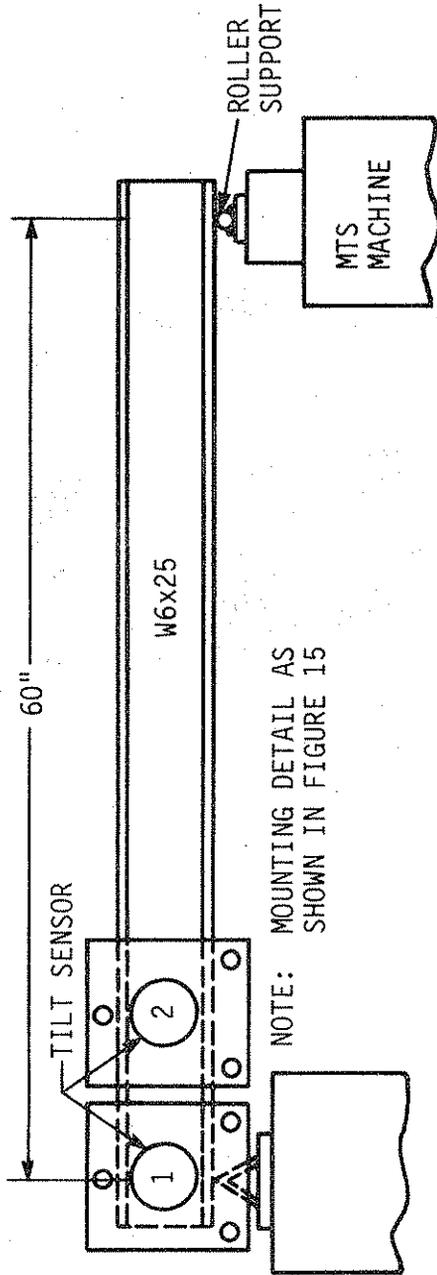
Fig. 21. Test setup for Beam Test 4.

The instrumentation used in Beam Test 4 is shown in Fig. 21, and the test layout is illustrated in Fig. 22. Beam Test 4 used the MTS

fatigue testing machine to apply displacements to the simply supported member end at selected rates of displacement. The tilt sensors were attached at the hinge-supported end of a W 6 × 25 steel section. The sensors were connected to the member using the same procedure as Beam Tests 1, 2, and 3 and are shown in Fig. 19. The roller-supported end of the member was supported on the load-displacement cylinder of the MTS machine. The displacements and rates of displacement were controlled and monitored by the computerized control console of the machine.

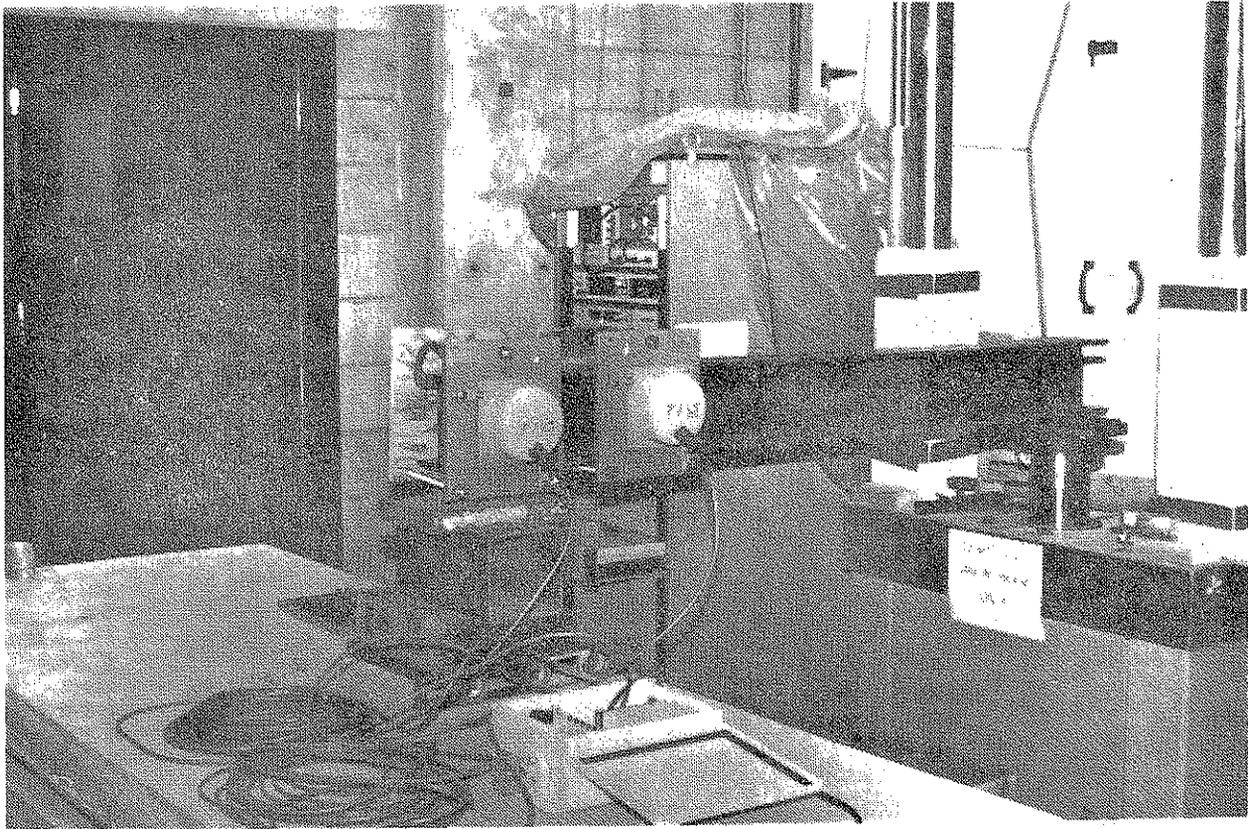
Fig. 22. Test layout for Beam Test 4.

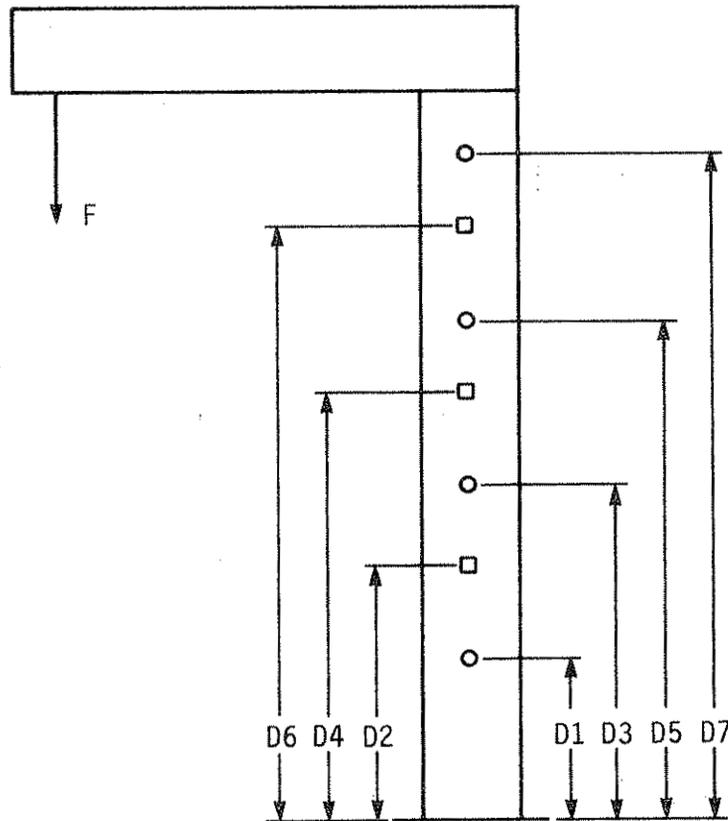
- TILT SENSOR, DIAL GAUGE, AND STRAIN GAUGE LOCATIONS
- ◻ TARGET LOCATIONS FOR SURVEYING AND PHOTOGRAMMETRY

Fig. 23. Locations of monitored positions for Column Tests 1 and 2.

Data from Column Tests 1 and 2 consisted of measured deflections, strains, and rotations at various locations along the column length. Four load increments were applied in sequence to the column to cause member deformation. These increments will be referred to as Load Cases C1, C2, C3, and C4. Figure 23 indicates the monitoring positions. Positions D1, D3, D5, and D7 correspond to tilt sensor, strain gauge, and dial gauge locations. Because of unavoidable obstructions in the laboratory, location D1 was not monitored by either the photogrammetry or surveying techniques. Targeted locations D2, D4, and D6 were used for use by the cameras and theodolites.

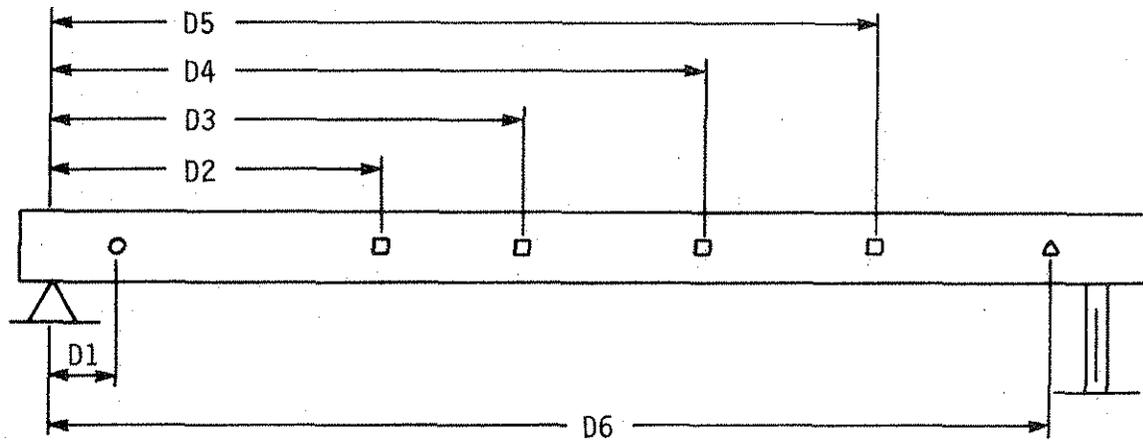
- TILT SENSOR LOCATION
- TARGET LOCATIONS FOR SURVEYING AND PHOTOGRAMMETRY
- △ DCDT LOCATION

Fig. 24. Locations of monitored positions for Beam Tests 1 and 2.

The comparisons between surveying, DCDT, and tilt data in Tables 8 and 10 indicate that the methods yield very consistent results. At each location except D1 in Beam Test 2, the surveying results were smaller and the tilt sensor results larger than deflections measured
