# Long-Term Structural Movement

February 1986

Iowa DOT Project HR-275  
ERI Project 1795  
ISU-ERI-Ames-86205

College of  
Engineering  
Iowa State University

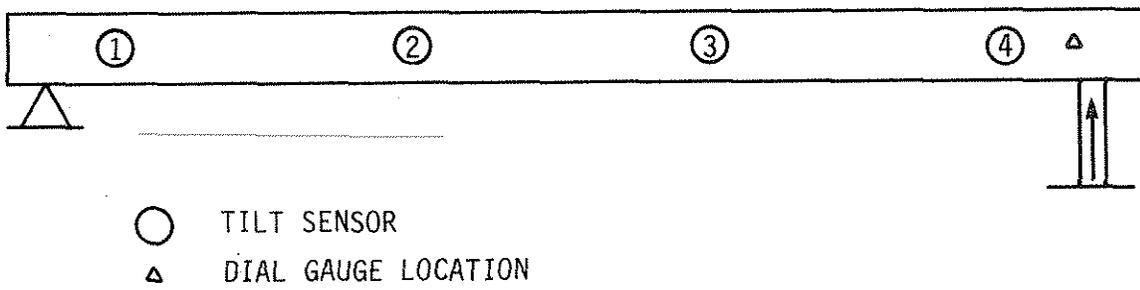
Fig. 25. Location of instrumentation for Beam Test 3.

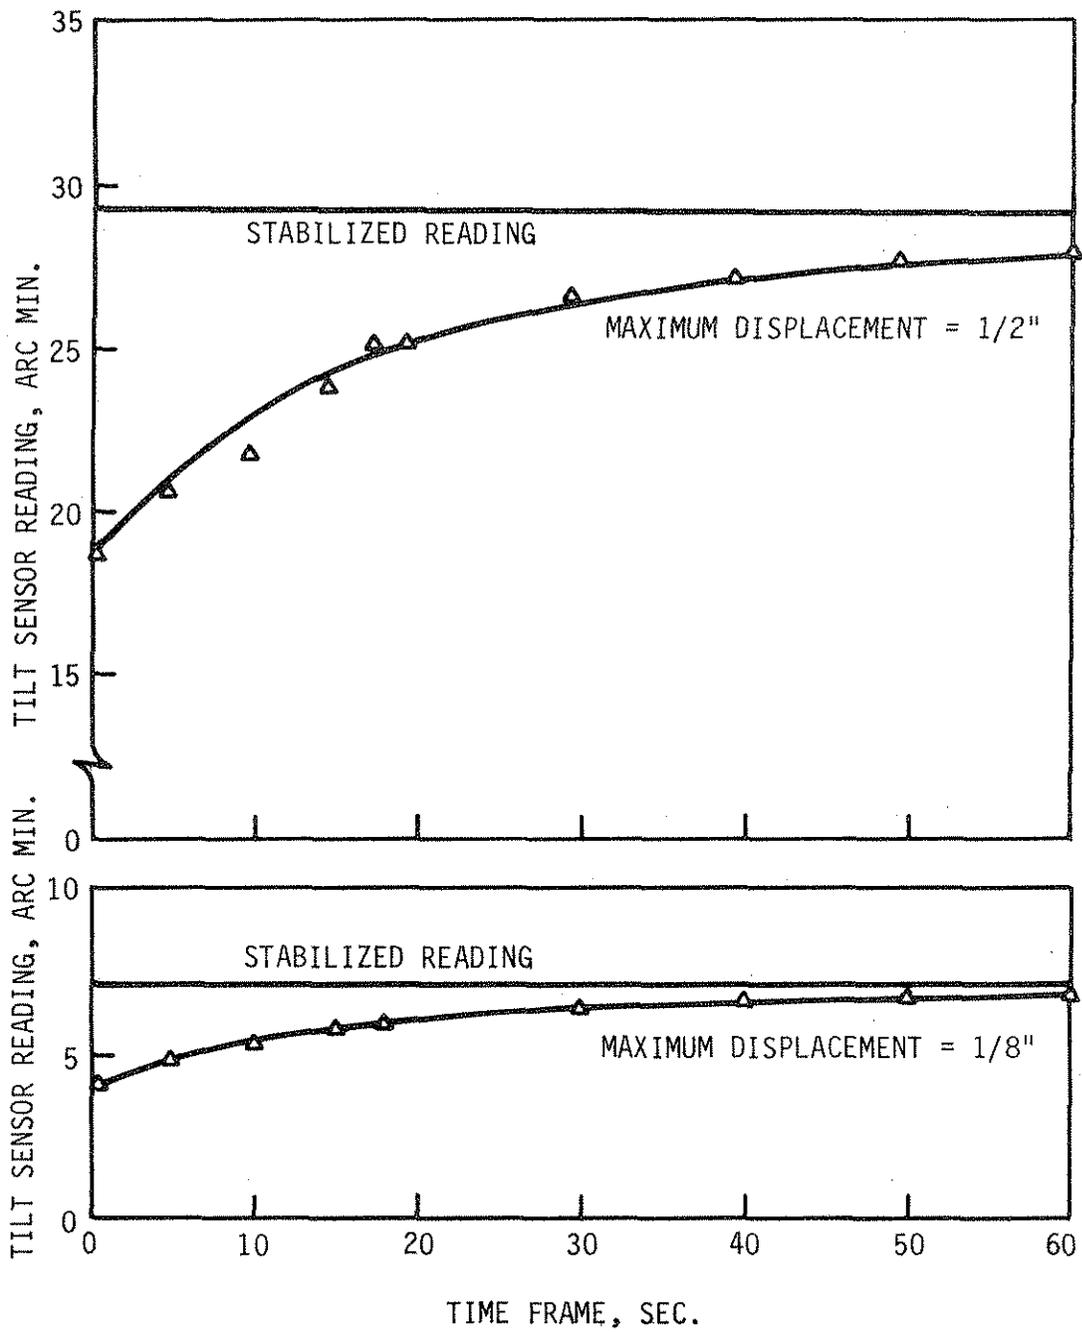
Fig. 26. Plot of response data for the tilt sensor.

body motion using the displacement data obtained from the MTS transducers. As shown for all cases, the difference in the angular readings is quite small and is well within the  $\pm 5\%$  range associated with the sensors. The data from these tests further illustrate the excellent repeatability of the sensors' performance.

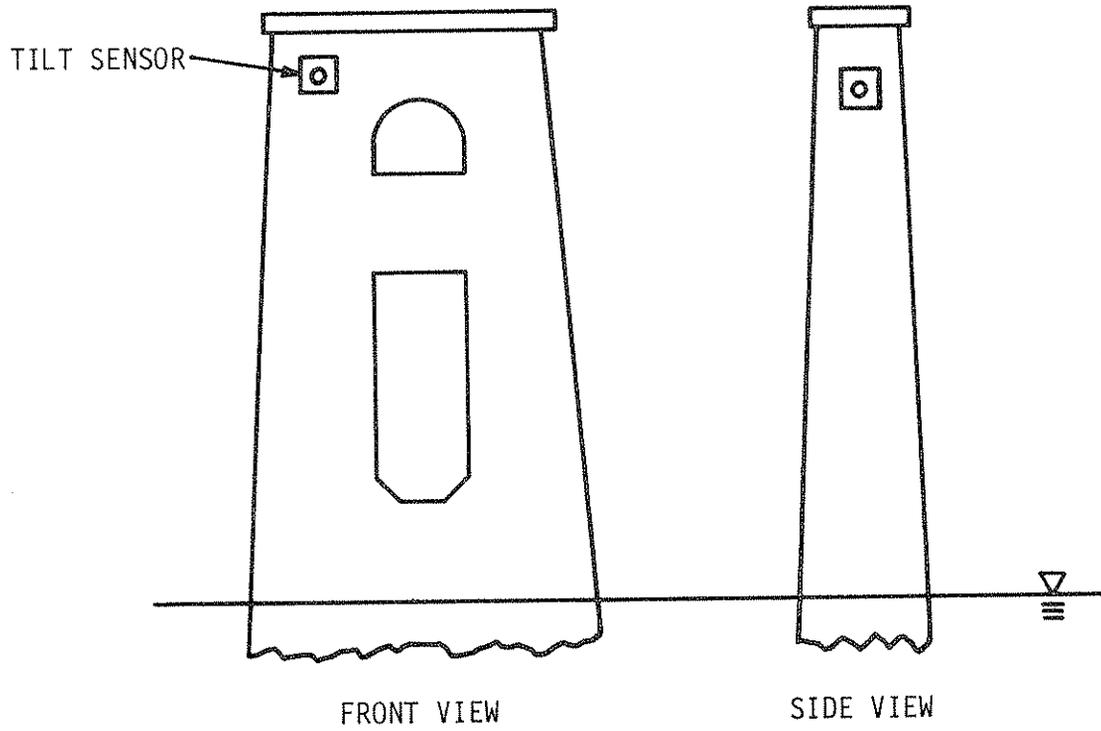
Fig. A.1. Tilt sensor arrangement for monitoring pier movement.

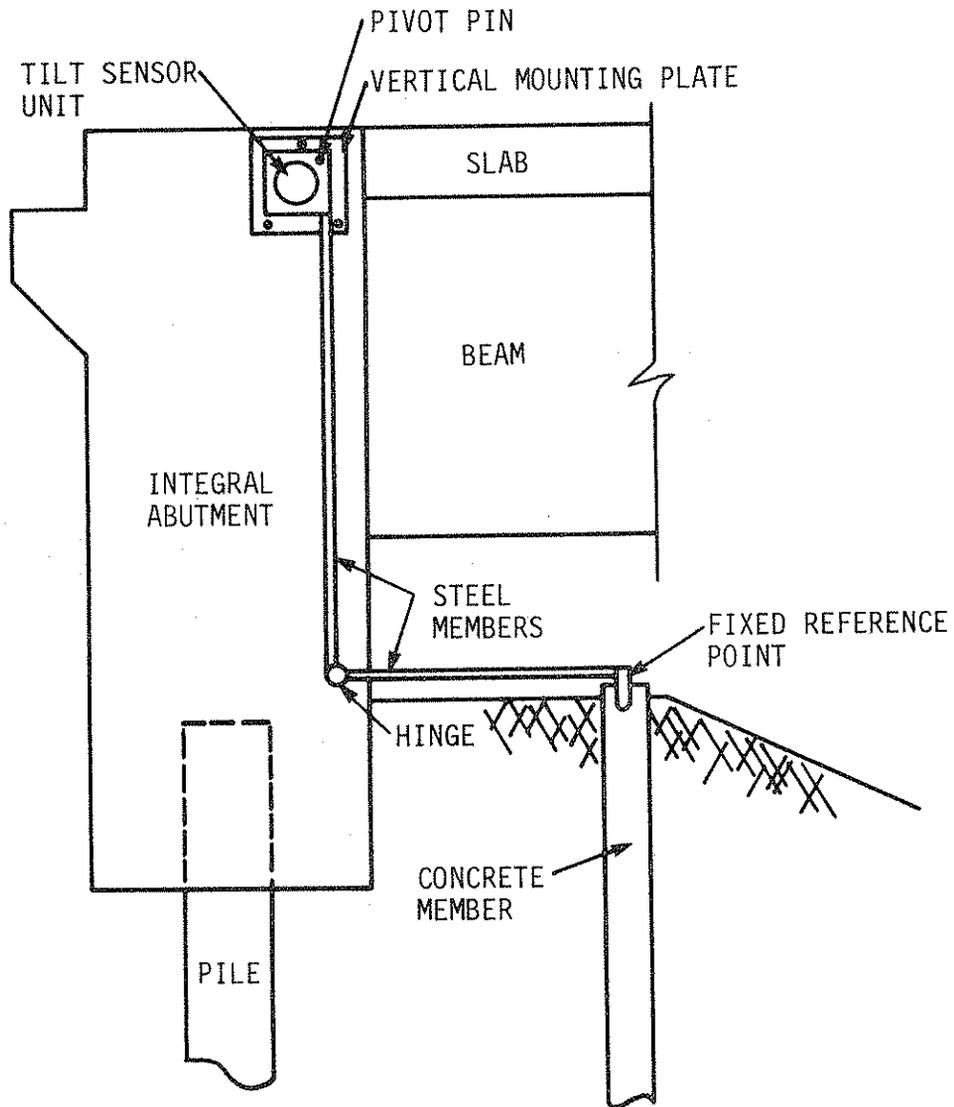
Fig. A.2. Tilt sensor arrangement for monitoring abutment translation (alternative 1).

line as well as cause abutment rotation. Monitoring abutment rotation may be performed using the tilt sensor system, which may involve mounting a single tilt sensor unit at a convenient location on the side face of the abutment's diaphragm. Rotation of the abutment is essentially that of a rigid body because of a large width-to-depth ratio of the abutment, so again a single tilt sensor unit is sufficient to monitor rotational movement. In order to monitor abutment translation, a mechanical device in combination with another tilt sensor unit may be used to record abutment motion continuously. Because the tilt sensor can only measure the angular rotation of an object, it is necessary to convert abutment translation into a rotation. To accomplish this task, a fixed reference point must be provided about which a rotation may be measured. Once a reference point is established, connections may be made to the tilt sensor unit that is allowed to rotate as translations occur. The tilt sensor unit could be mounted on the abutment itself or on a simple frame connected to the abutment. Figures A.2 and A.3 show these two possible setups. Possible problems exist in locating a reference point near the abutment where the reference point could be subject to movement by earth pressures from abutment movement. While the advantage in using the tilt sensor system (that of making use of a gravity reference thereby eliminating the need to maintain some fixed reference point) is lost in having to establish another reference location, making use of other tilt sensory system components required for monitoring of abutment rotation is feasible.

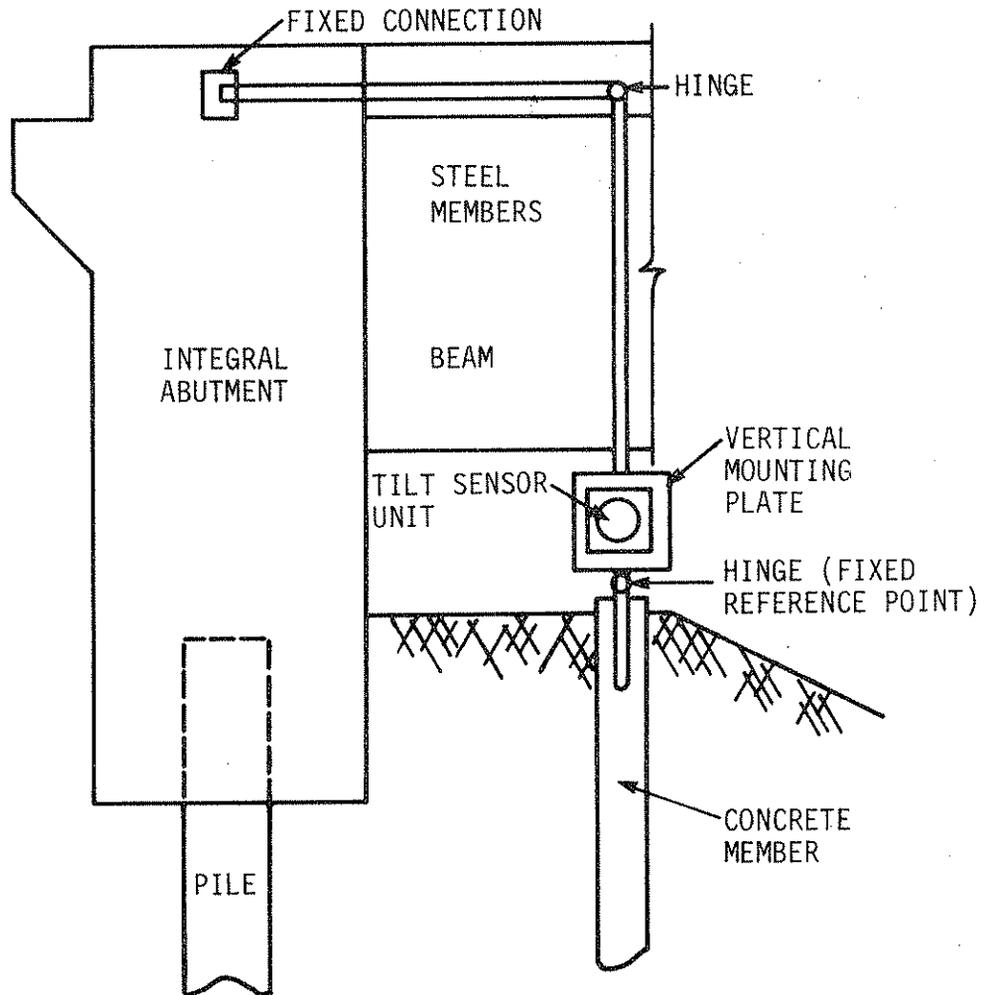
Fig. A.3. Tilt sensor arrangement for monitoring abutment translation (alternative 2).

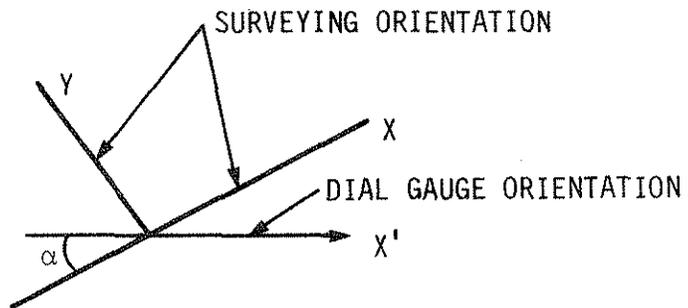
Fig. B.1. Axes' orientation for surveying calculations and movement's orientation as measured by dial gauges.

The baseline for making surveying measurements was not parallel to the axes in which the member deflections were taken (see Fig. B.1). The relation that was used to correct this misalignment was

$$\Delta X' = \Delta X \cos\alpha - \Delta Y \sin\alpha \quad (B9)$$
