# **FAST TRACK AND FAST TRACK II CEDAR RAPIDS, IOWA**

**FINAL REPORT  
IOWA DEPARTMENT OF TRANSPORTATION  
RESEARCH PROJECT HR-544**

**FEDERAL HIGHWAY ADMINISTRATION  
SPECIAL PROJECT 201**

**NOVEMBER 1993**

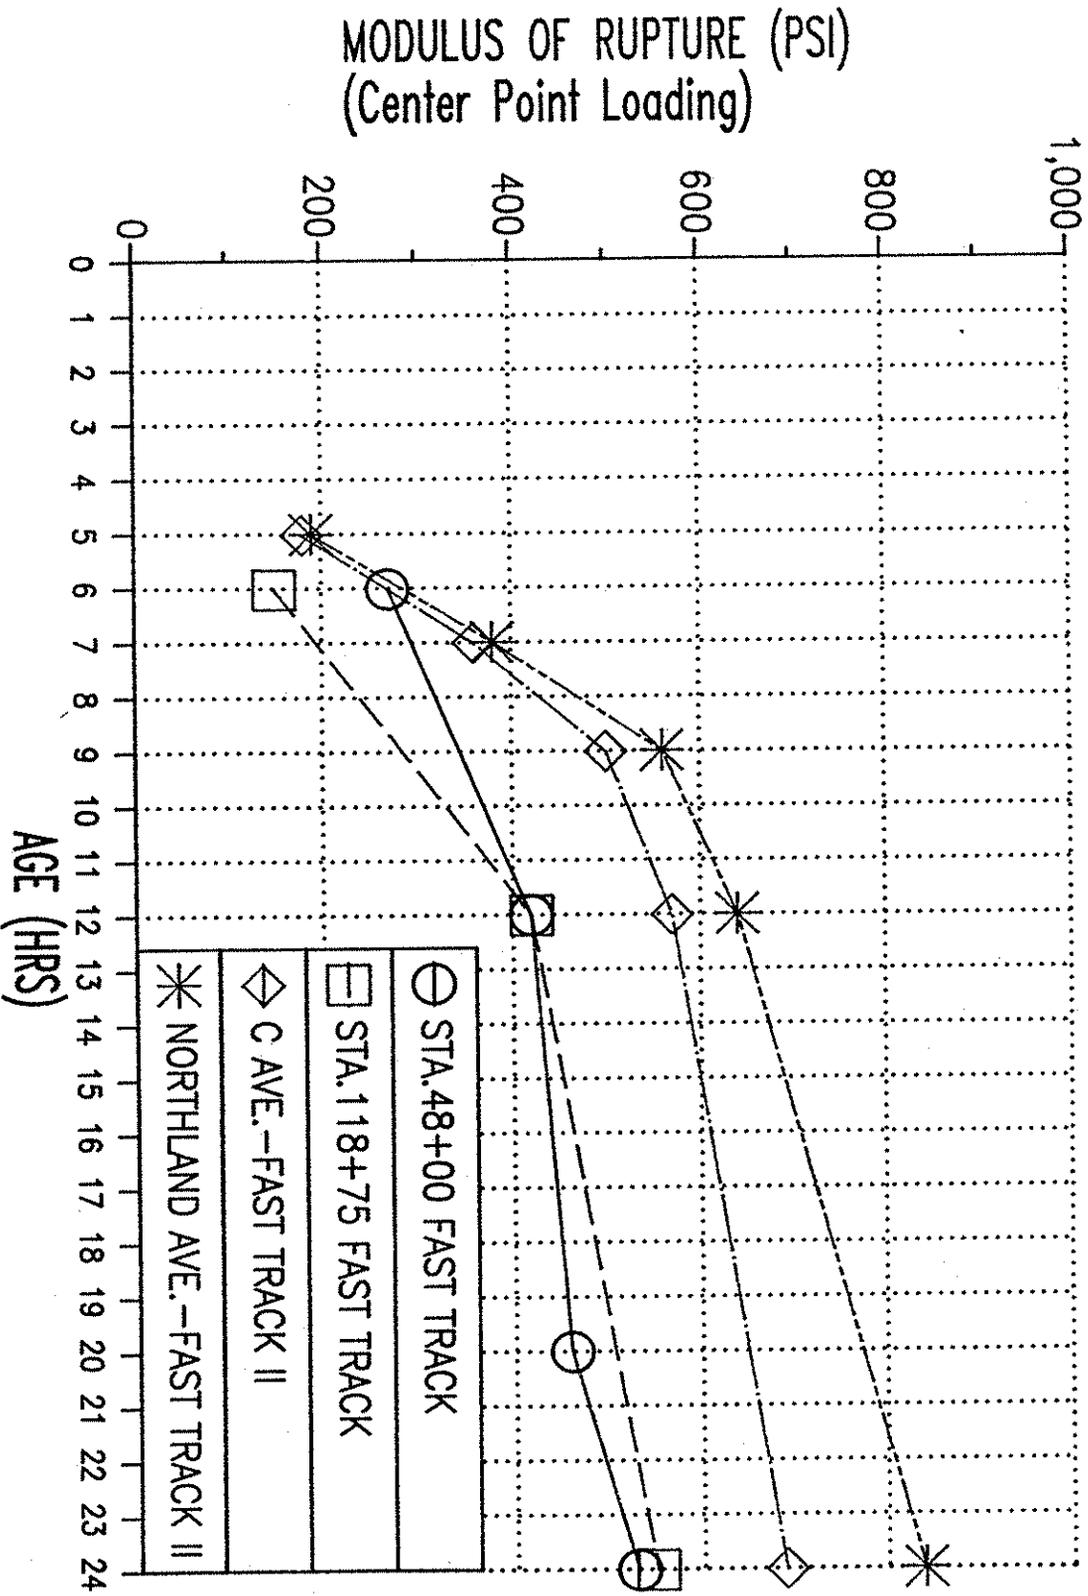
FIGURE 2  
EARLY FLEXURAL STRENGTHS

Three beams and three cylinders were tested at each test time. The flexural strength of the concrete was determined using center point loading. The test results are listed in Table 5 and shown in Figures 2, 3, 4 and 5 for both the flexural tests and the compression tests. In Table 5 a dash (---) is used for data that is not available.

**Fast Track:** The two Fast Track sections exhibited strength gains which were similar. The flexural tests resulted in virtually identical strengths at twelve hours, twenty-four hours, and fourteen days. The compression tests were virtually identical for the first twenty hours. This consistency is an important verification of the results.

Both mainline test sections reached the 400 psi flexural strength required for opening in less than twelve hours. Also, they

reached 500 psi, the opening strength required for conventional paving, in less than twenty-four hours. The results of these tests are shown in Figures 2 and 3 and are very similar to other Fast Track projects constructed in Iowa in the past three years.

The flexural strengths at both intersections were virtually identical for the first seven hours. Both intersections exceeded the 350 psi flexural opening strength requirement by that age, even though both had strengths less than 200 psi at five hours. The goal of this mix was achieving 350 psi in six hours. In both test sections, that strength was reached in less than seven hours but more than six hours. These results closely matched research conducted by the Iowa Department of Transportation in October 1988 with the Fast Track II mix in Dubuque County, Iowa. The previous work was conducted under very different weather conditions and with different materials. With all three test

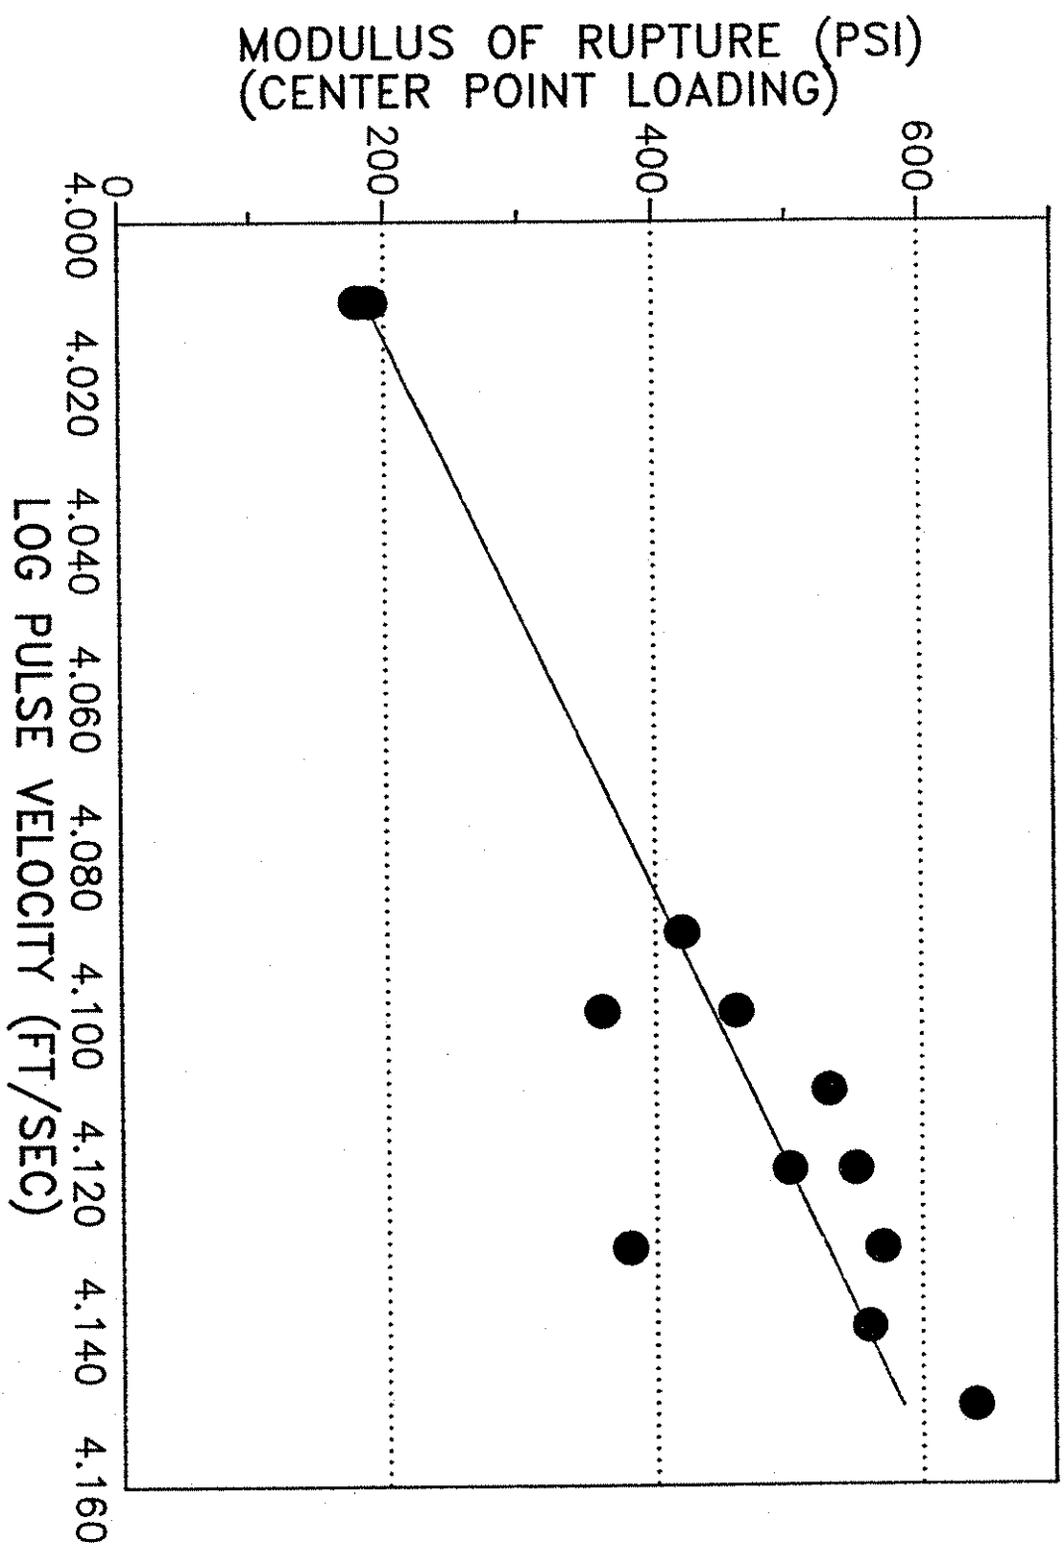
FIGURE 6  
PULSE VELOCITY VS. FLEXURAL STRENGTH

ultrasonic transducers was smoothed out using a steel trowel. The two holes were then covered with insulating blankets. Every time a strength test was performed, ultrasonic pulse velocity measurement of the pavement was also taken. A best fit line between the flexural strength and pavement pulse velocity measurement of the pavement was also taken. A best fit line between the flexural strength and pavement pulse velocity is developed and presented in Figure 6.

Figure 6 shows the relationship between the pulse velocity and the flexural strength and compressive strength, respectively. This integration yielded R-squares of 0.88.

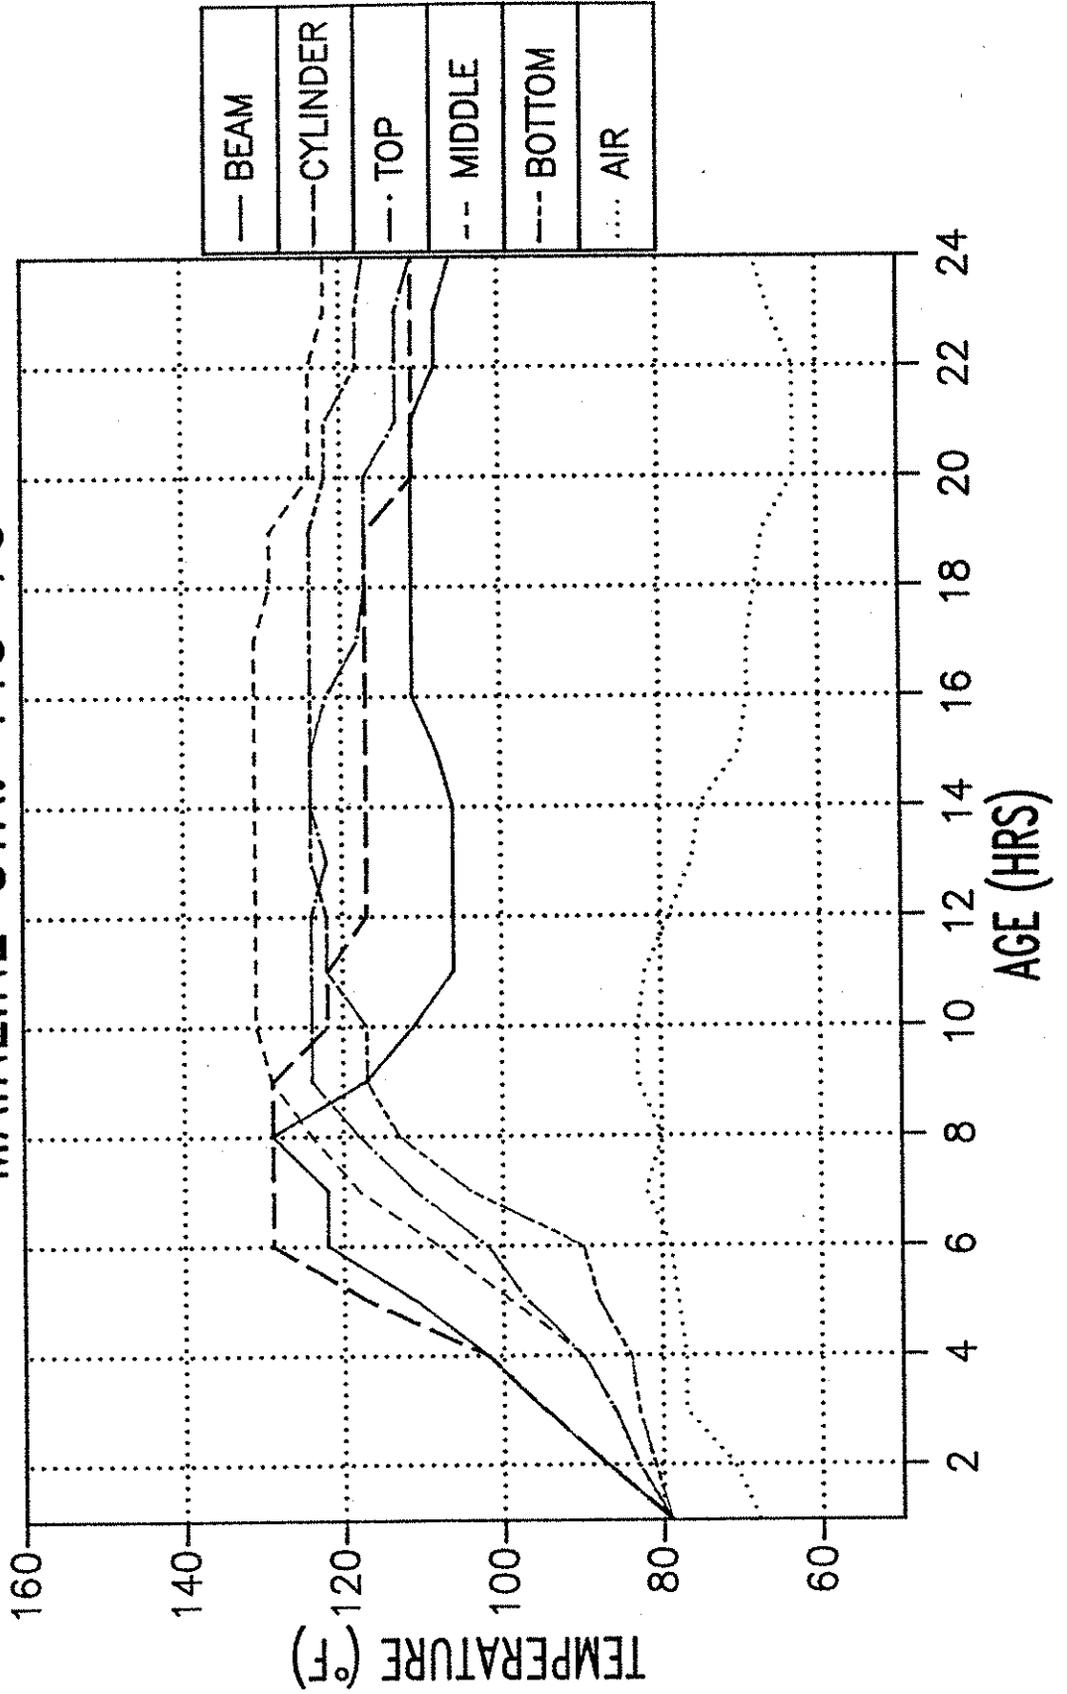
FIGURE 7  
FAST TRACK TEMPERATURES  
MAINLINE STA. 118+75

In the Cedar Rapids-Collins Road Fast Track project, the test locations in the pavement and field cured test specimens were monitored by an M-meter. The following positions for the temperature probe thermocouples were monitored:

- At center slab - 0.5 inch from top, 0.5 inch from bottom, and mid-depth

- One foot from edge of slab - same as at center slab
- Air
- Test Specimens -  $4\frac{1}{2}$  inch diameter cylinder and 6" x 6" x 20" beam

Figures 7 and 8 present the time/temperature data for the above positions in one Fast Track section and one Fast Track II section, respectively. A maturity versus flexural strength correlation was developed from the data (integration of time/temperature plot using the Nurse-saul equation).

**Fast Track:** The temperature versus age plots are shown in Figure 7 for one of the Fast Track mainline test sections. Maturities were determined at the two locations being monitored

and indicate that the test beams exhibit a maturity which is within the range of maturities within the slab.

Compression tests were performed on the cylinders. The maturity of the cylinders varied between the two test sections. At Station 48+00 the cylinder had a higher maturity than the slab at this age but at Station 118+75, the maturity was lower than the slab. The cause is certainly a result of the sun heating up the small specimen at the first section. This research would suggest that in terms of the test specimens representing the actual concrete in the pavement, the flexural beams give a strength which represents the pavement more closely than cylinders.

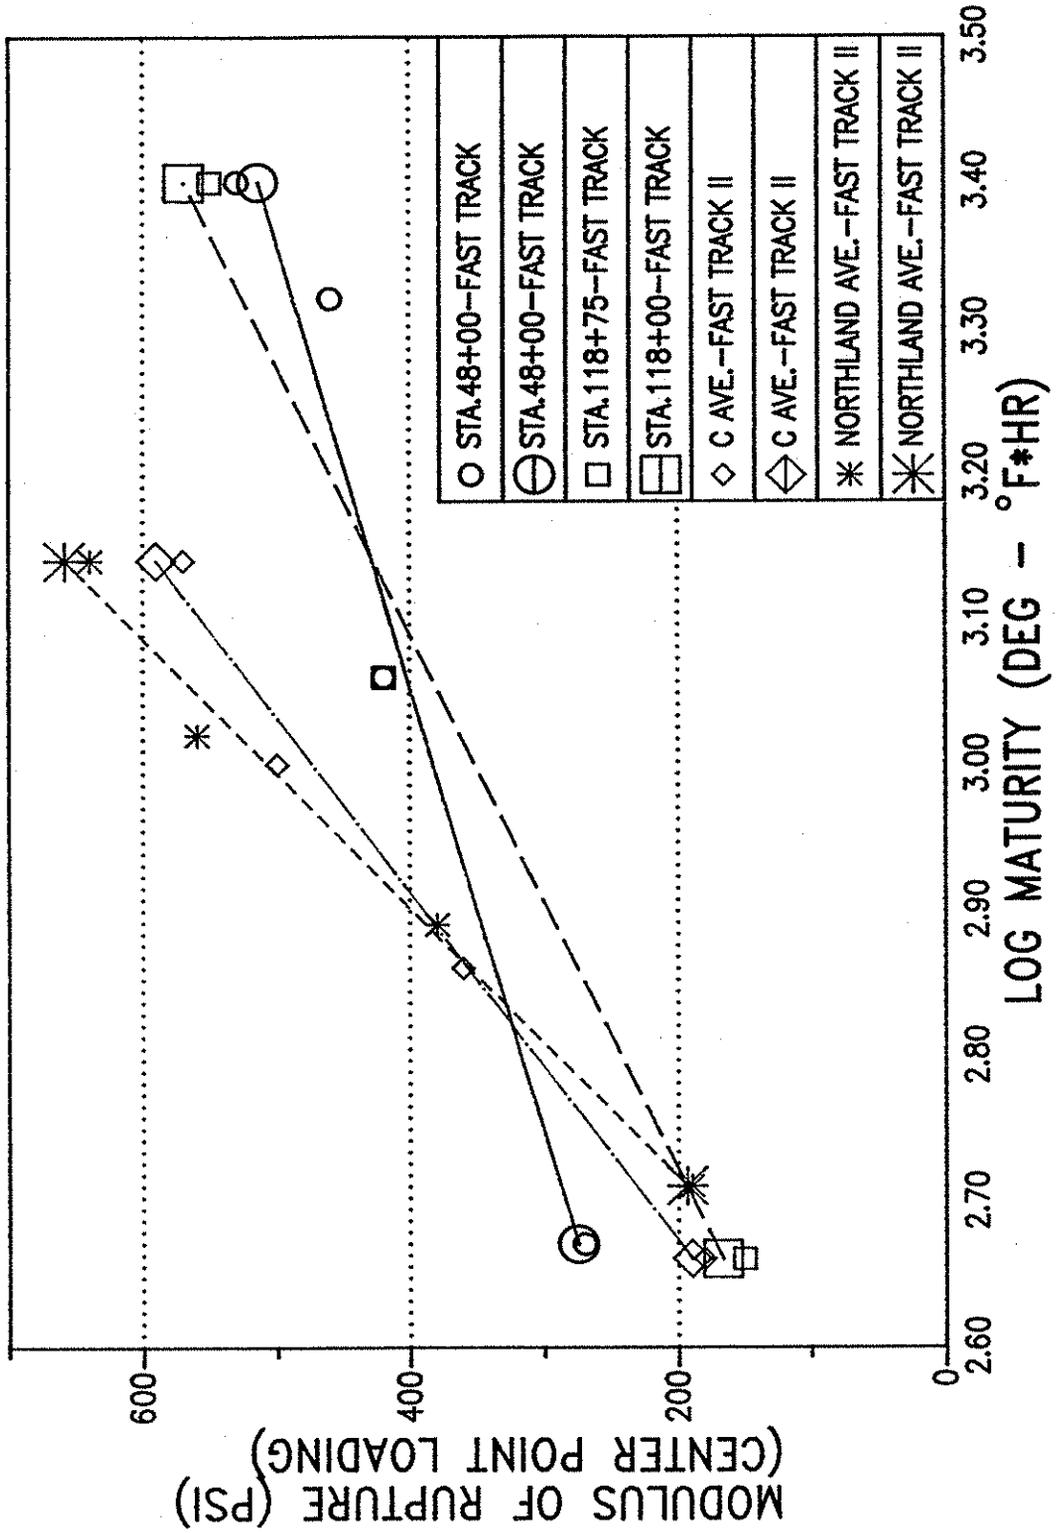
FIGURE 9  
MATURITY VS. FLEXURAL STRENGTH

The correlations are presented in Figure 9.

Figure 9 is a plot of the maturity versus the flexural strength results. The figure illustrates the best fit lines of our test data and represent predictive models which have R-square values greater than 0.8.
