Pavement Evaluation Using the Road Rater™ Deflection Dish

**Final Report
for
MLR-89-2**

**Iowa Department
of Transportation**

Final Report
for
Project MLR-89-2

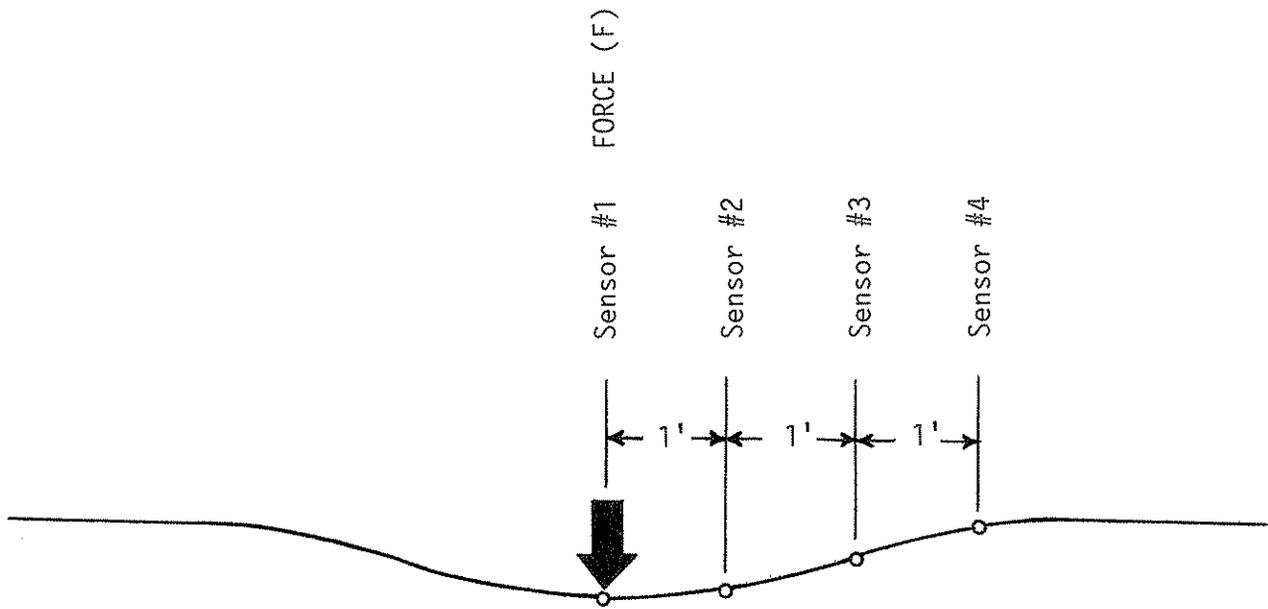
Figure 1
Road Rater Deflection Dish

four velocity sensors. One sensor is positioned directly under the ram, and the other three sensors are positioned at one foot, two feet and three feet respectively, from the ram (Figures 1, 2 and 3).

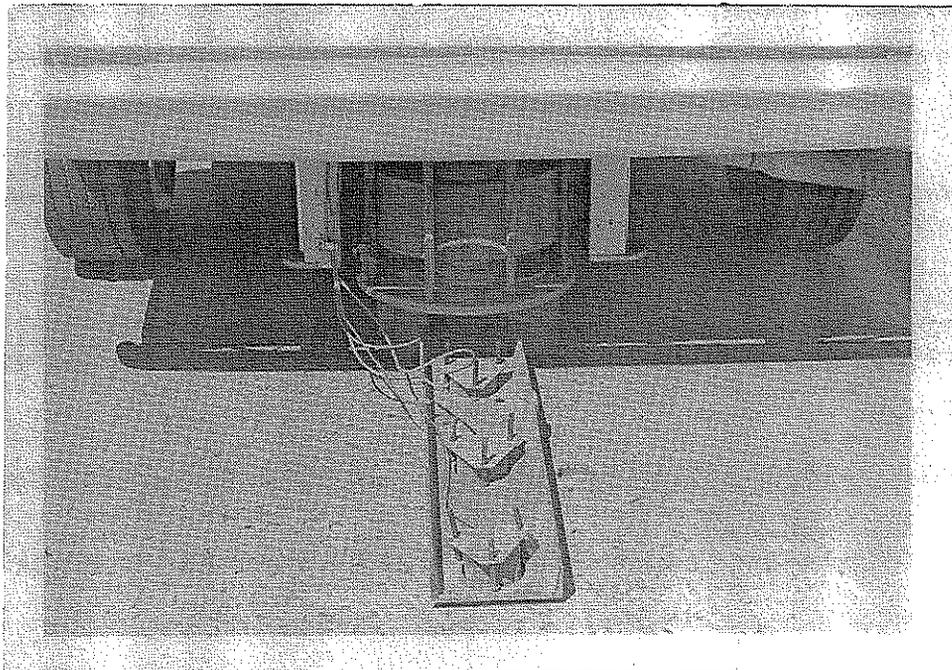
Figure 3
Mass and Sensors

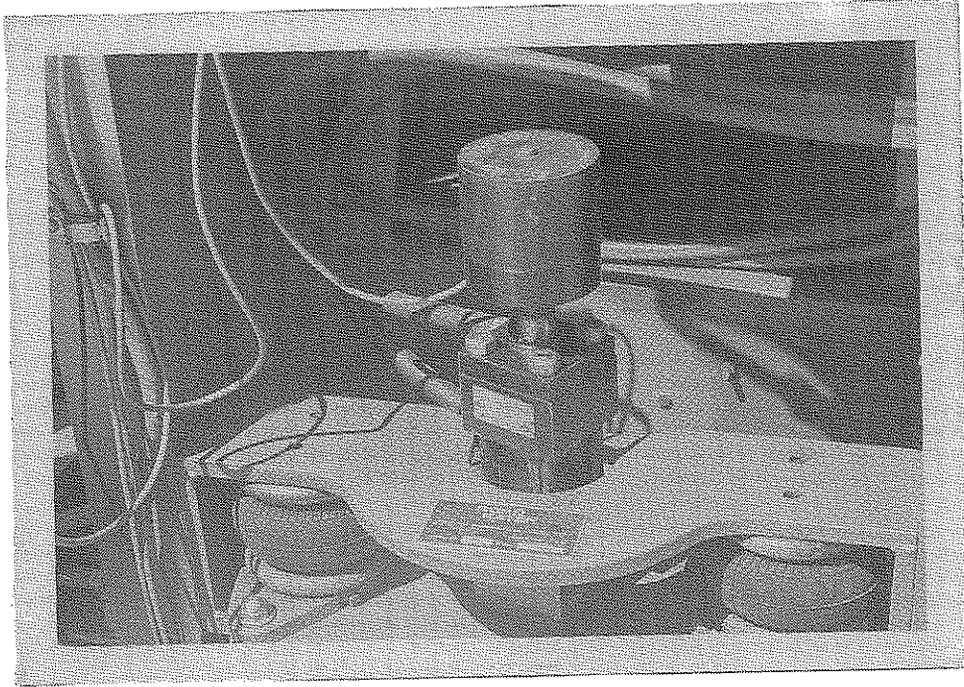
Figure 4
Velocity Sensor on Top of Ram

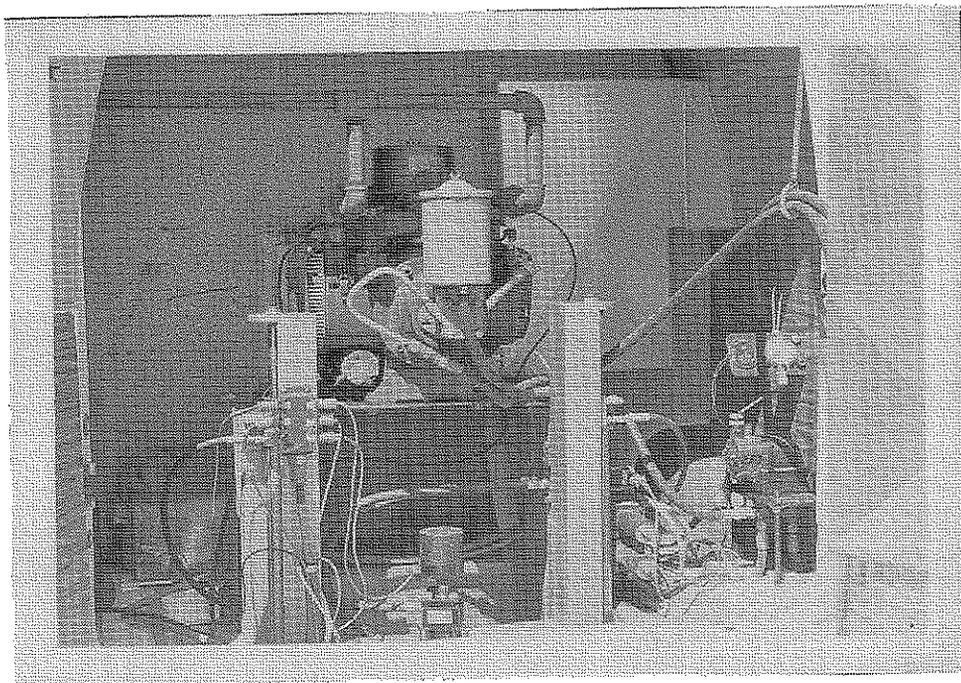
Figure 5
Auxiliary Motor

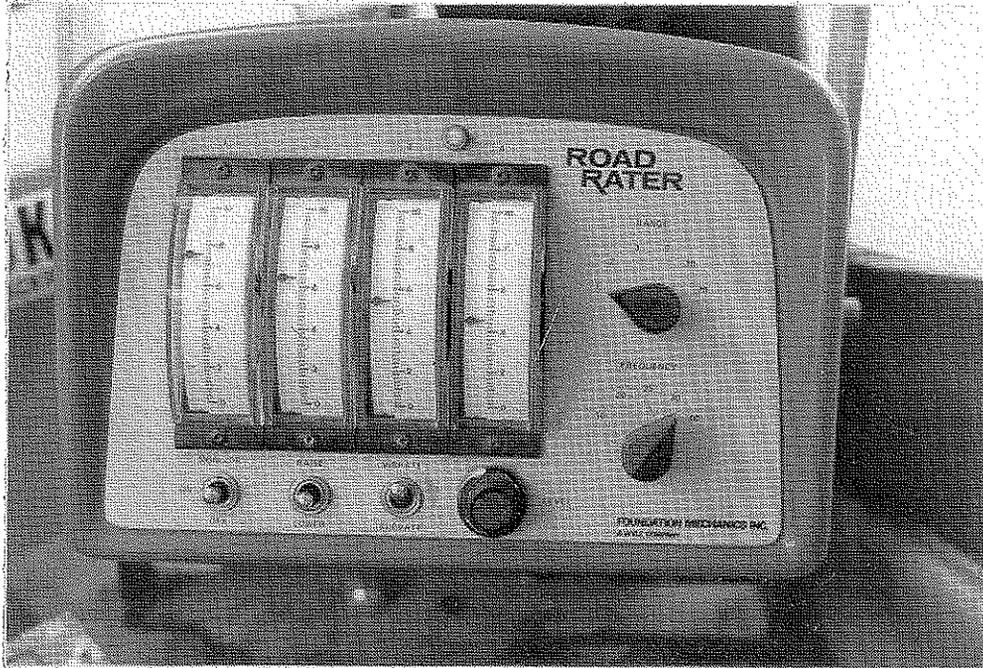
Figure 6
Control Console and Display Meters

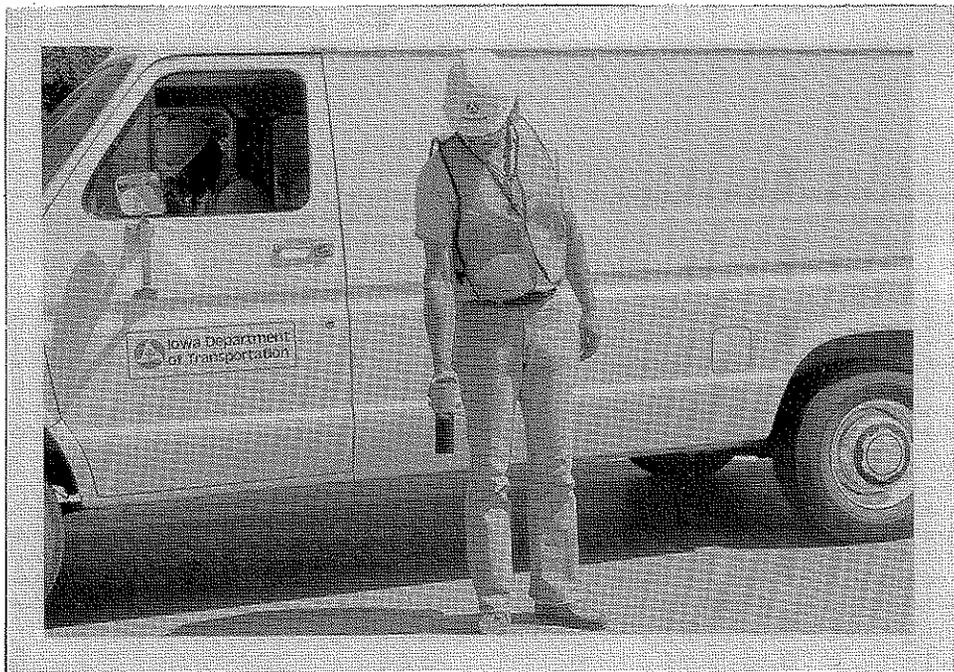
Figure 7
Pavement Temperature Measurement

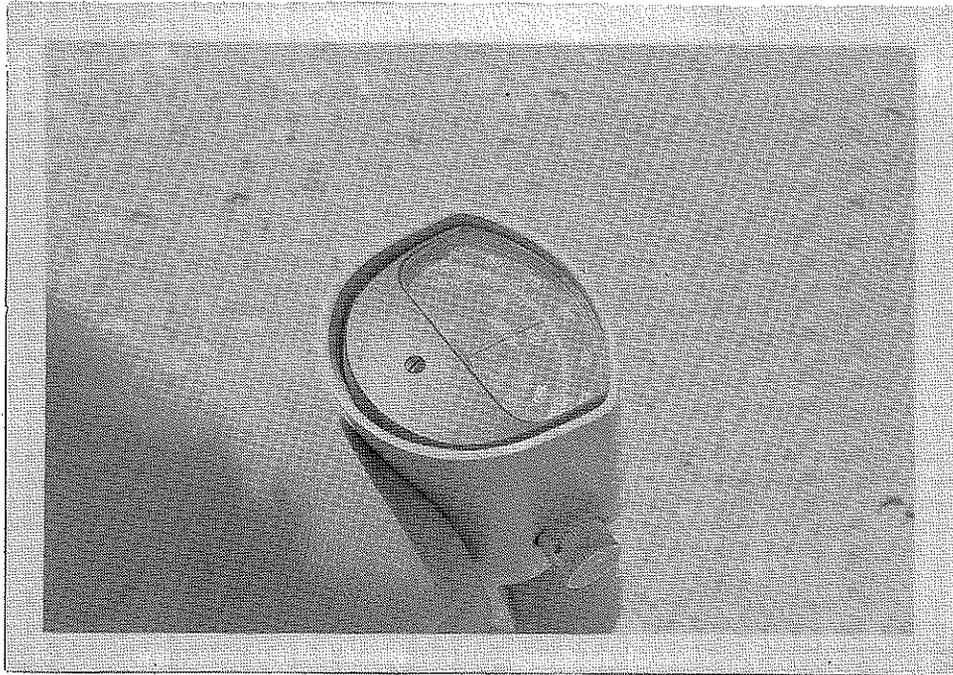
Figure 8
Raytek Infrared Temperature Gun

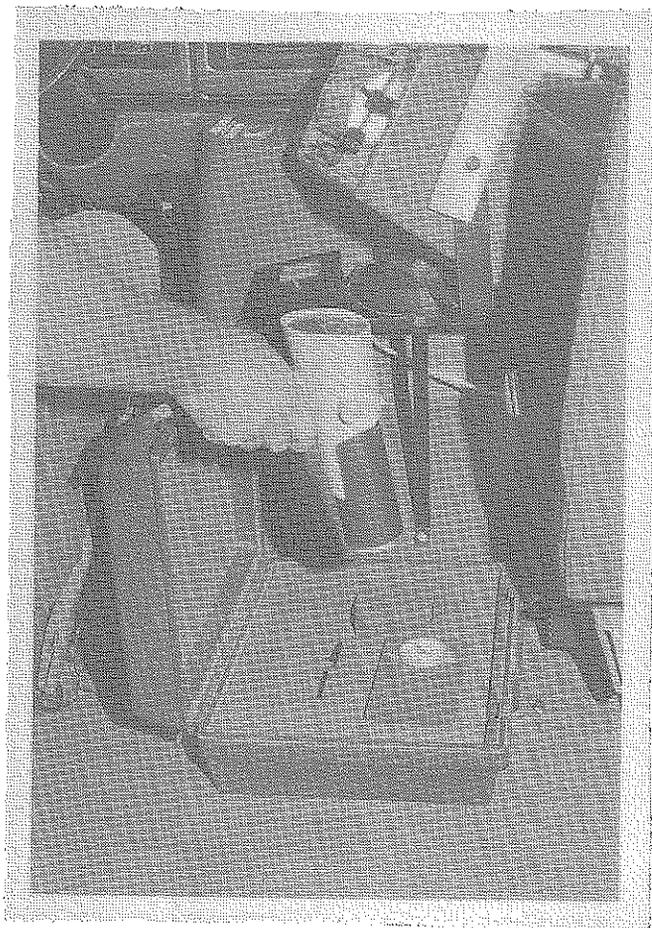
Figure 9
Infrared Temperature Gun Calibration

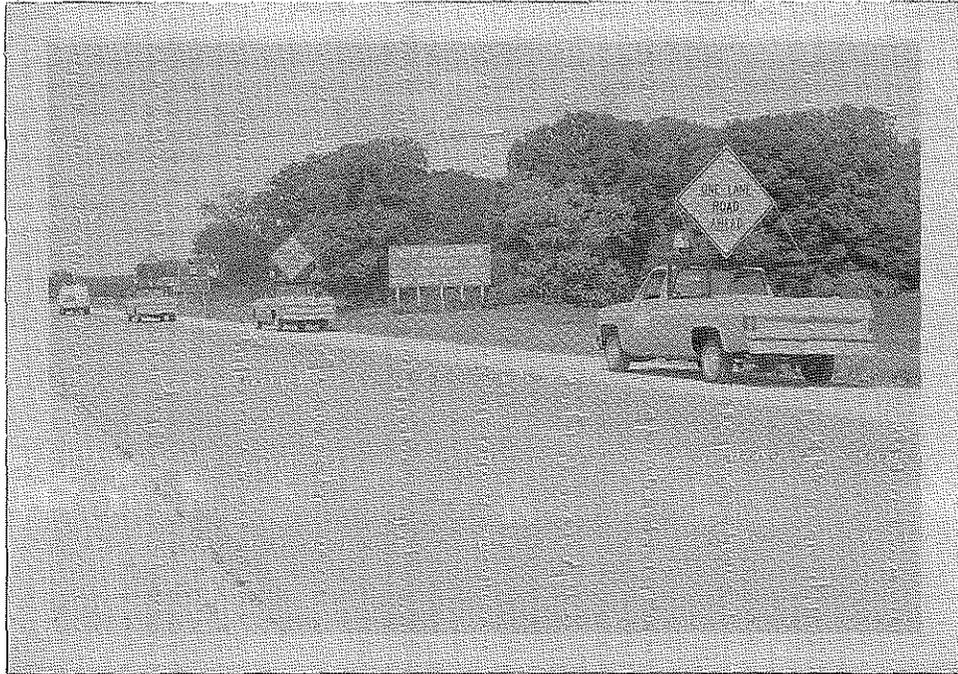
Figure 10
Road Rater Safety Vehicles

The Iowa DOT paid \$25,000 for its Model 400 Road Rater mounted in a van in 1975. Another Model 400 Road Rater was purchased in 1986 due to increased demand for deflection testing and cost \$40,000 mounted in an Iowa DOT van. Two Road Rater crews operate simultaneously in the springtime annually. Safety vehicles with signs (or a flashing arrow board) are used to control traffic and protect the test vehicle (Figure 10).

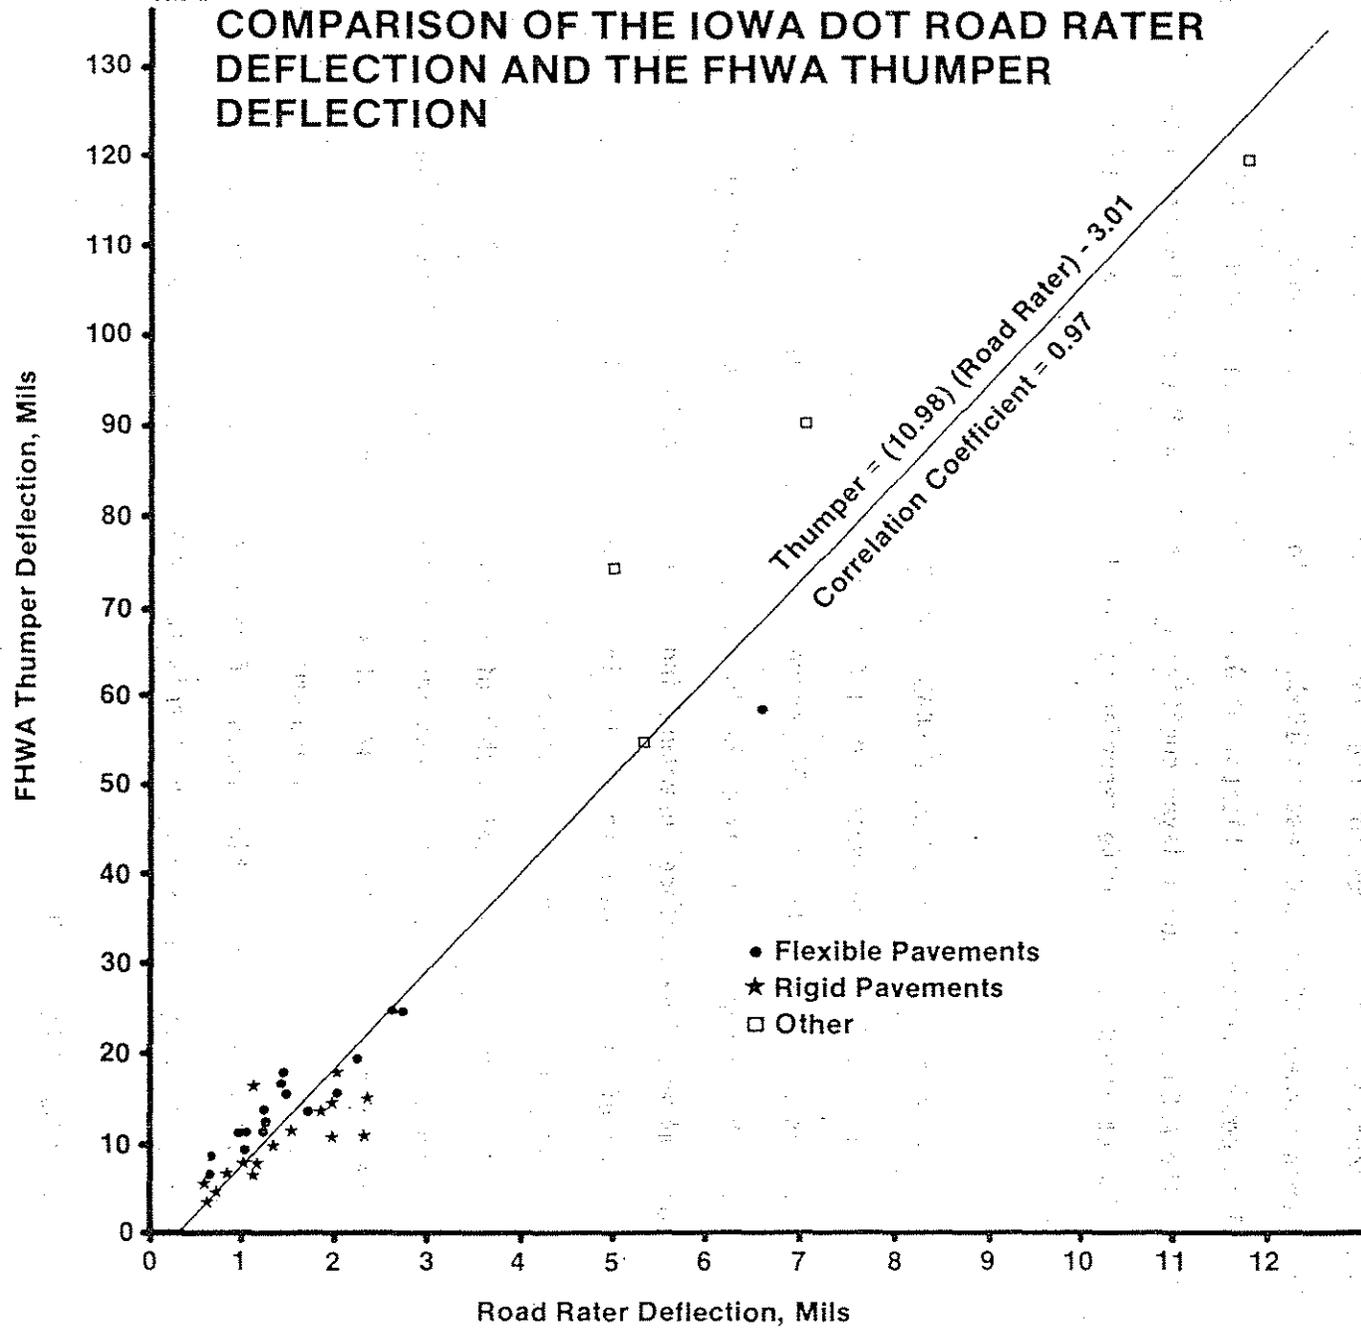
Figure 12

The FHWA Thumper tested most of the 39 pavement sections at the 3,000, 6,000 and 9,000 pound force settings. A linear relationship existed among deflections at these force settings. That is, the 6,000 pound deflection was twice the 3,000 pound deflection, and the 9,000 pound deflection was three times the 3,000 pound deflection. This information provided the confidence that the Model 400 Road Rater had sufficient force to evaluate rigid and composite pavements.

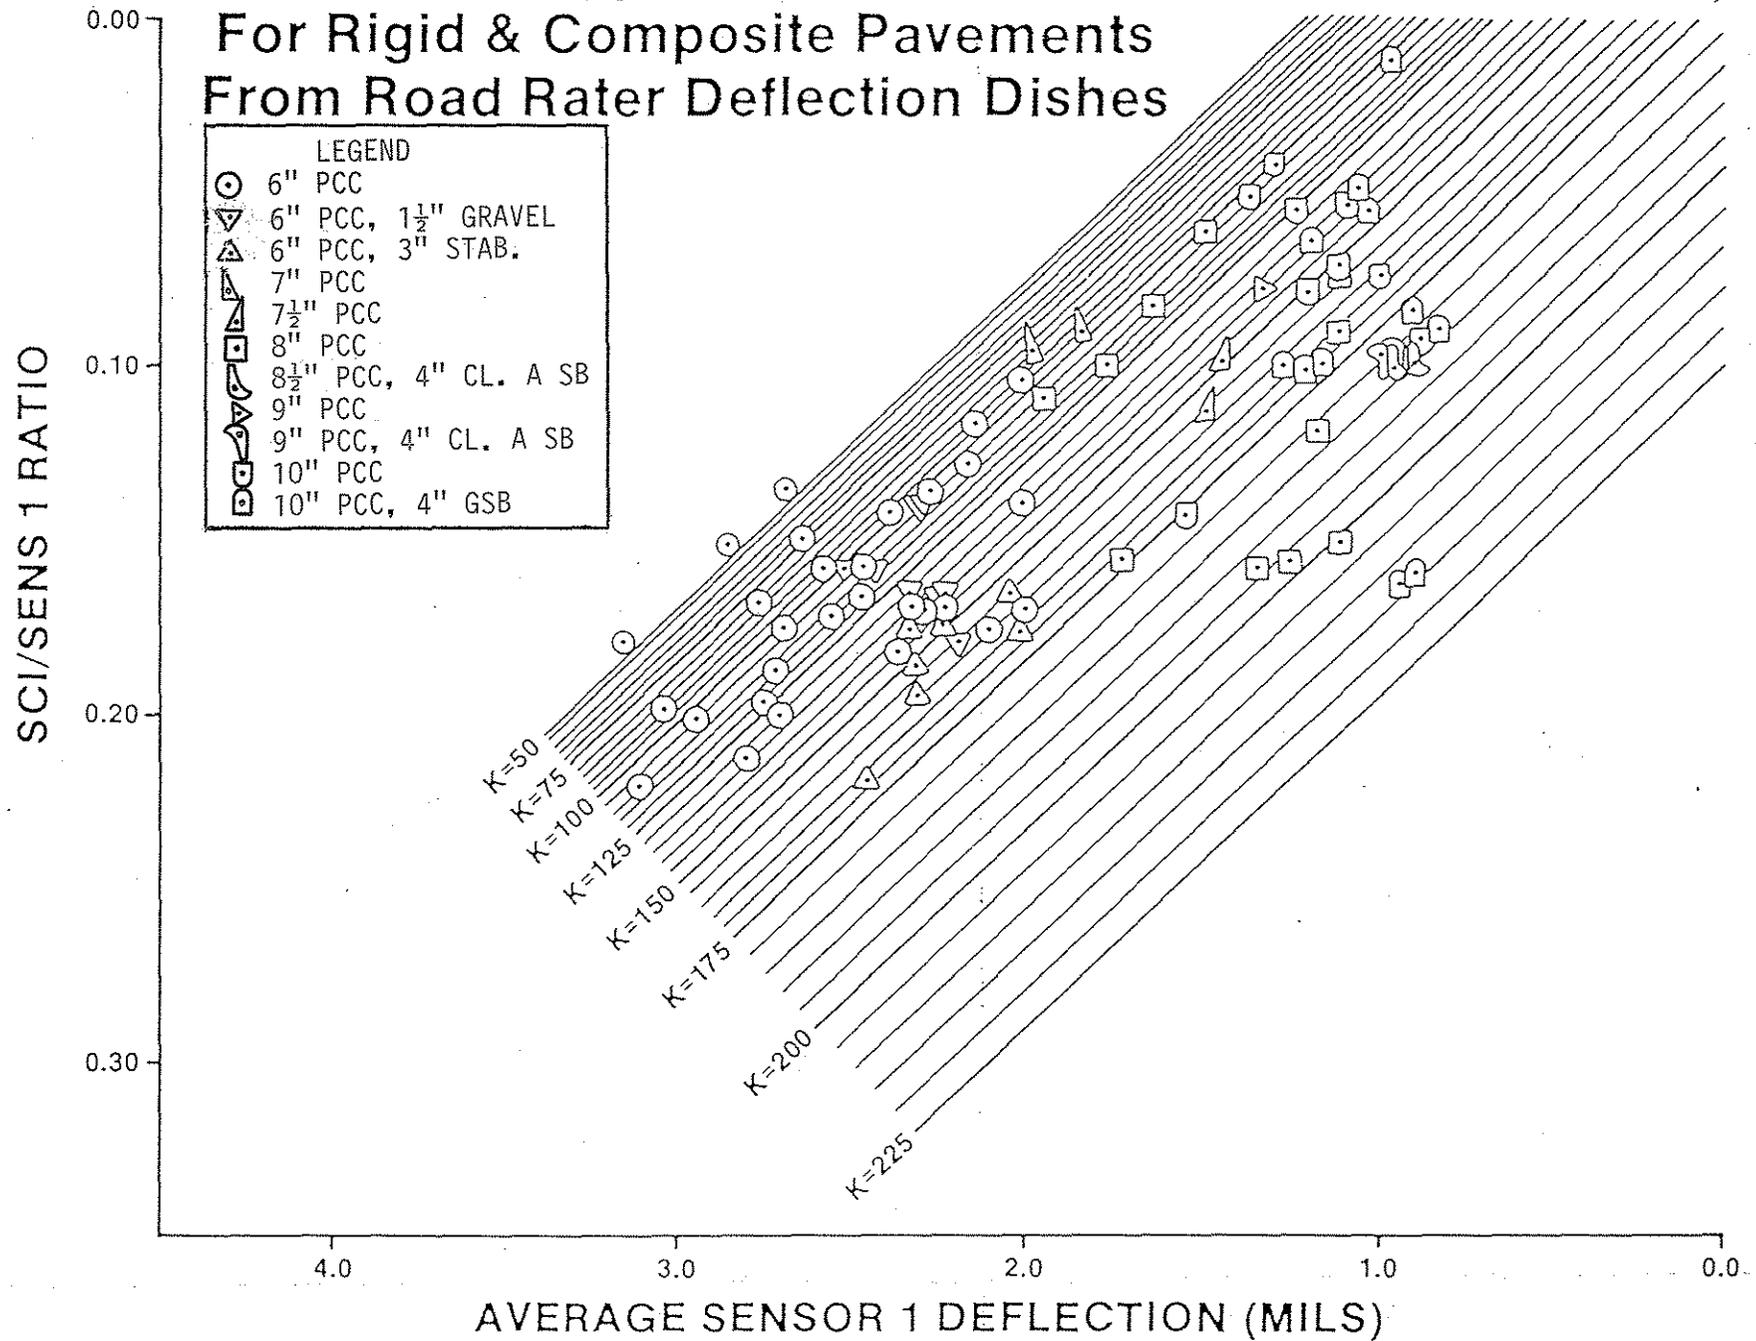
Soil Support K Values For Rigid & Composite Pavements From Road Rater Deflection Dishes

Soil Support K Value Charts were developed since it was recognized that the existing subgrade soil support could affect the overlay thickness required by several inches when using the AASHTO Design Chart for Flexible Pavements, $p_t=2.5$. It was also recognized that subgrade moisture could affect Road Rater deflection readings, but that this effect could be normalized by annual testing in April and May (only) when the pavements are in their weakest condition after the frost is out. Subgrades are generally saturated in April and May and can be identified by soil type or density through Road Rater deflection testing in

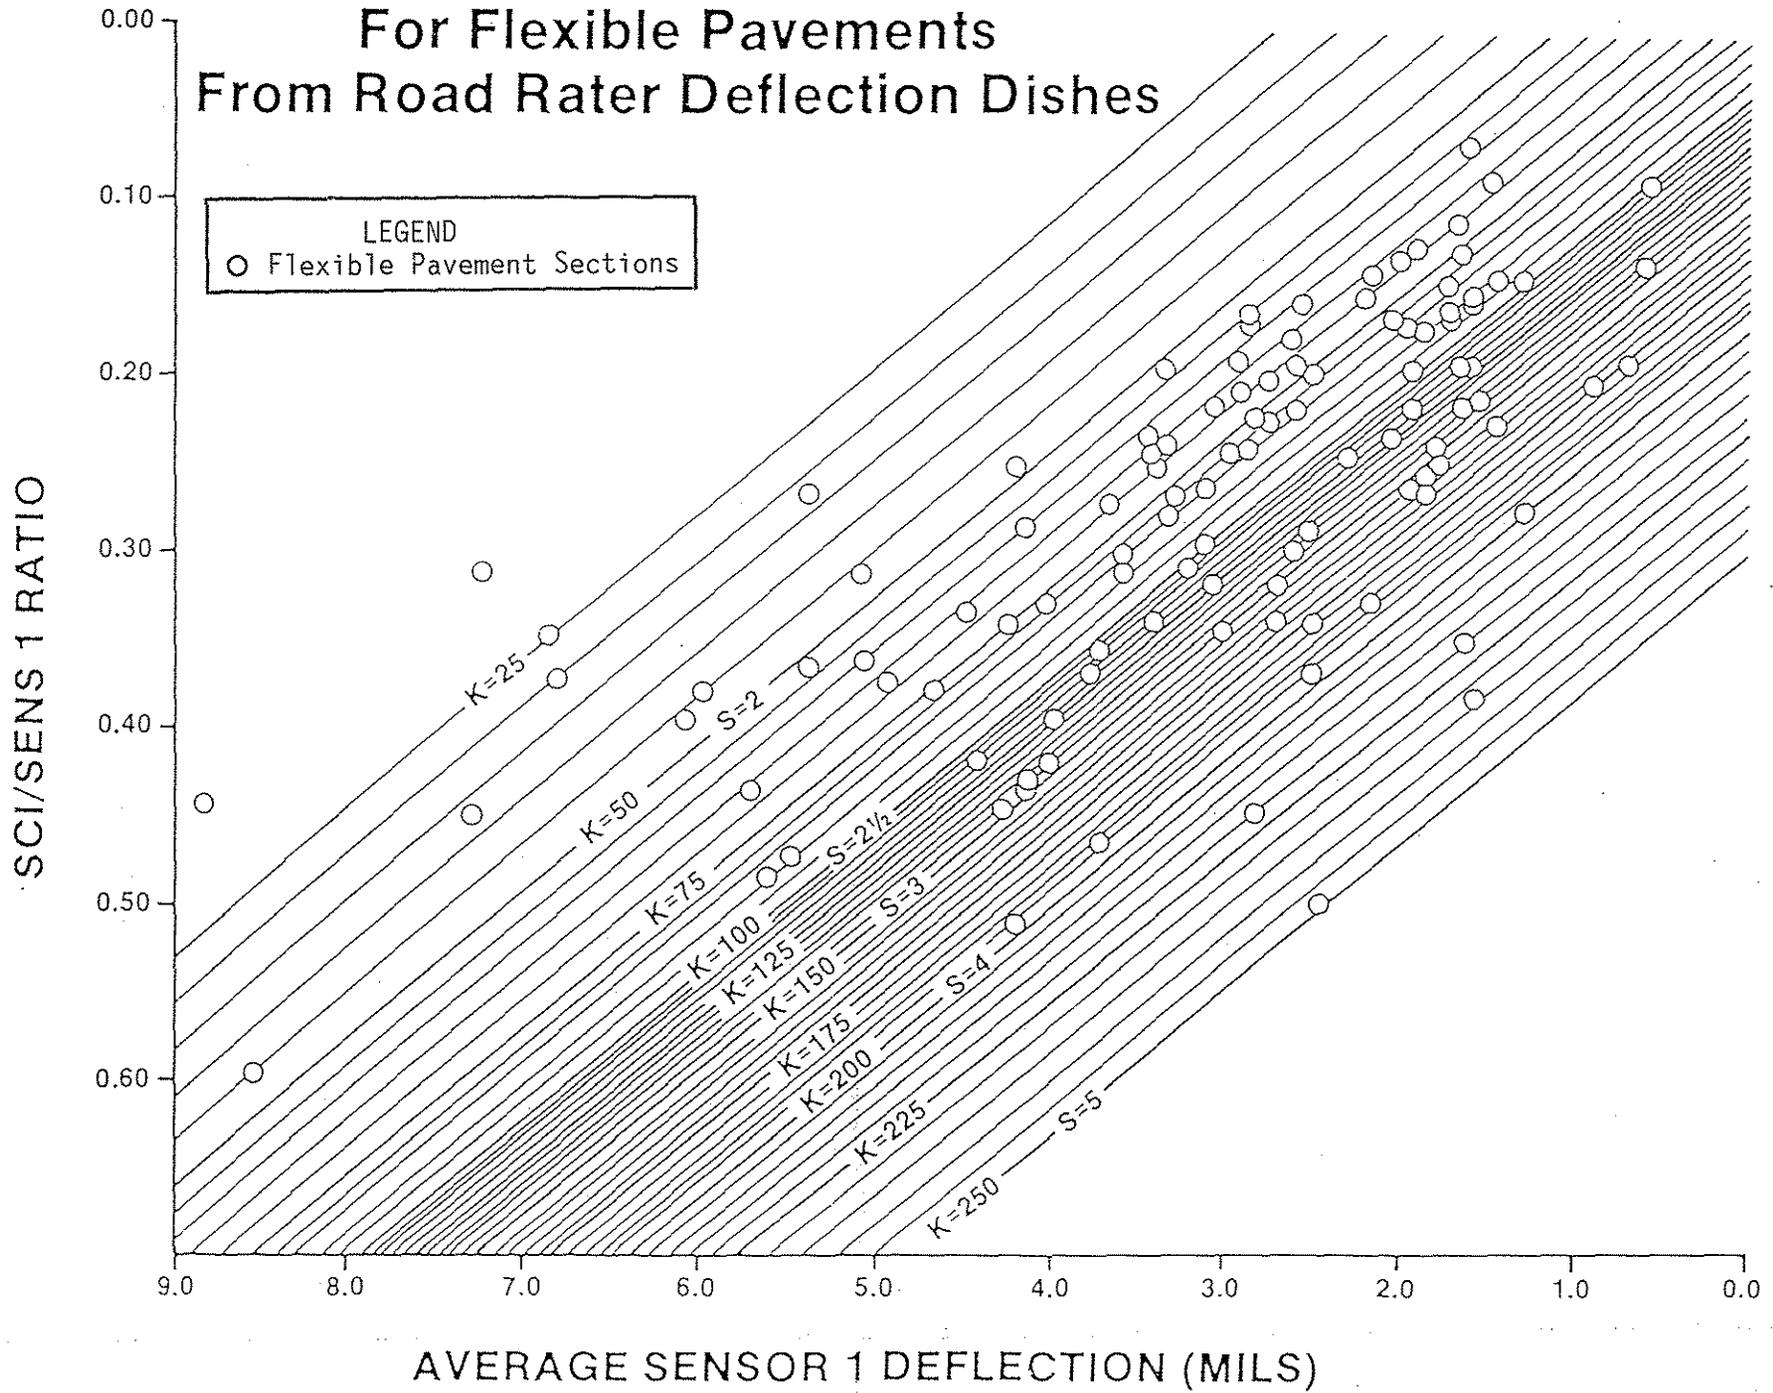
Figure 14

Soil Support K And S Values For Flexible Pavements From Road Rater Deflection Dishes

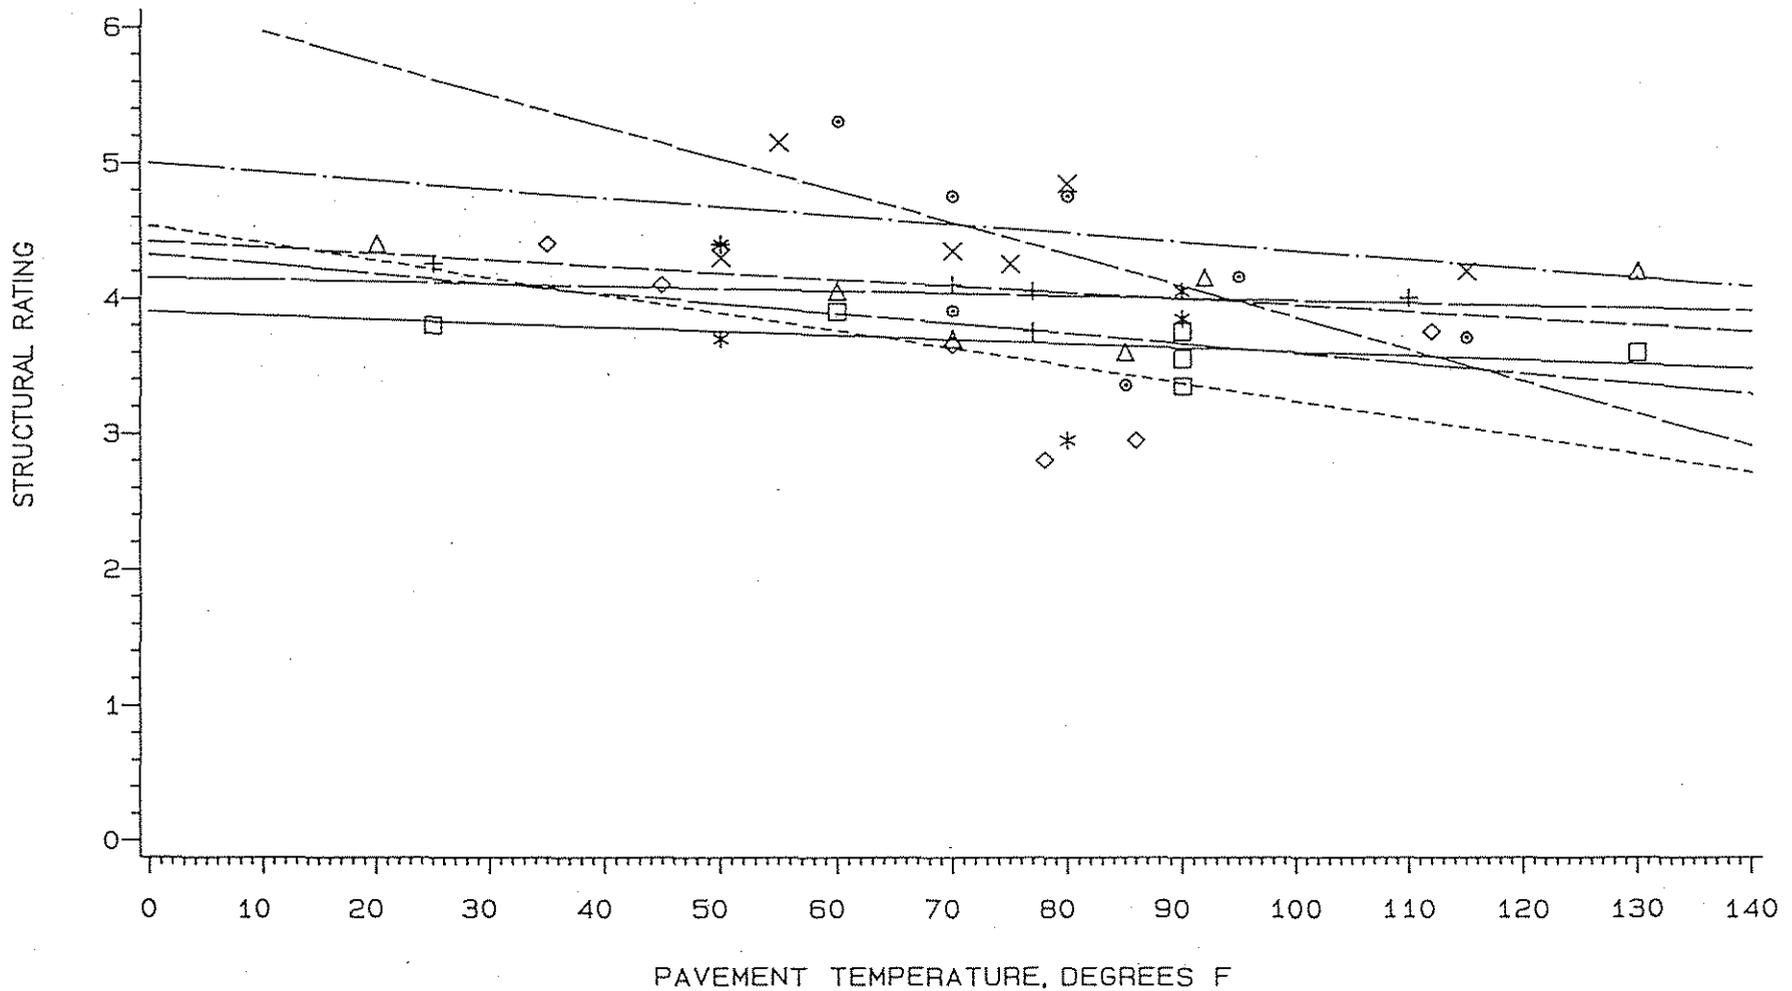
FIGURE 15
ROAD RATER STRUCTURAL RATING
VERSUS
PAVEMENT TEMPERATURE
FOR RIGID PAVEMENTS

Temperature correction factors for Road Rater deflection data were more difficult to determine for rigid and composite pavements than for flexible pavements. This was due to discontinuities because of joints, joint lockup during high pavement temperatures, and slab curling due to temperature differentials on rigid pavements. Temperature corrections for composite pavements were originally thought to be functions of the a.c. overlay thickness, materials properties of the a.c. overlay, and the condition of the underlying p.c.c. pavement. A study of the effects of temperature on Iowa's rigid pavement study sections is shown

in Figure 15. A full range of temperatures could not be obtained at one time and, therefore, the seasonal effects and influence of different subgrade conditions complicated attempts to develop a general temperature correction factor or equation which could be applied to all rigid pavements. Most of the rigid pavement temperature study sections in Figure 15 had very flat slopes indicating very little influence on the Structural Ratings from temperature. Some rigid pavements do have a tendency to deflect more at high pavement temperatures, however, and this is attributed to slab curling at mid-panel which is concave in shape and results in higher Road Rater deflections. Since no well-defined trends could be established from Figure 15, no temperature correction factors are applied to rigid pavements. This is a logical strategy since all Road Rater testing is conducted in April and May only when the average pavement temperature is about 70°F, and the range of temperatures is relatively small. Composite pavement temperature study sections are shown in Figure 16. The slopes of most composite pavement lines were similar and resulted in the following temperature correction equation:

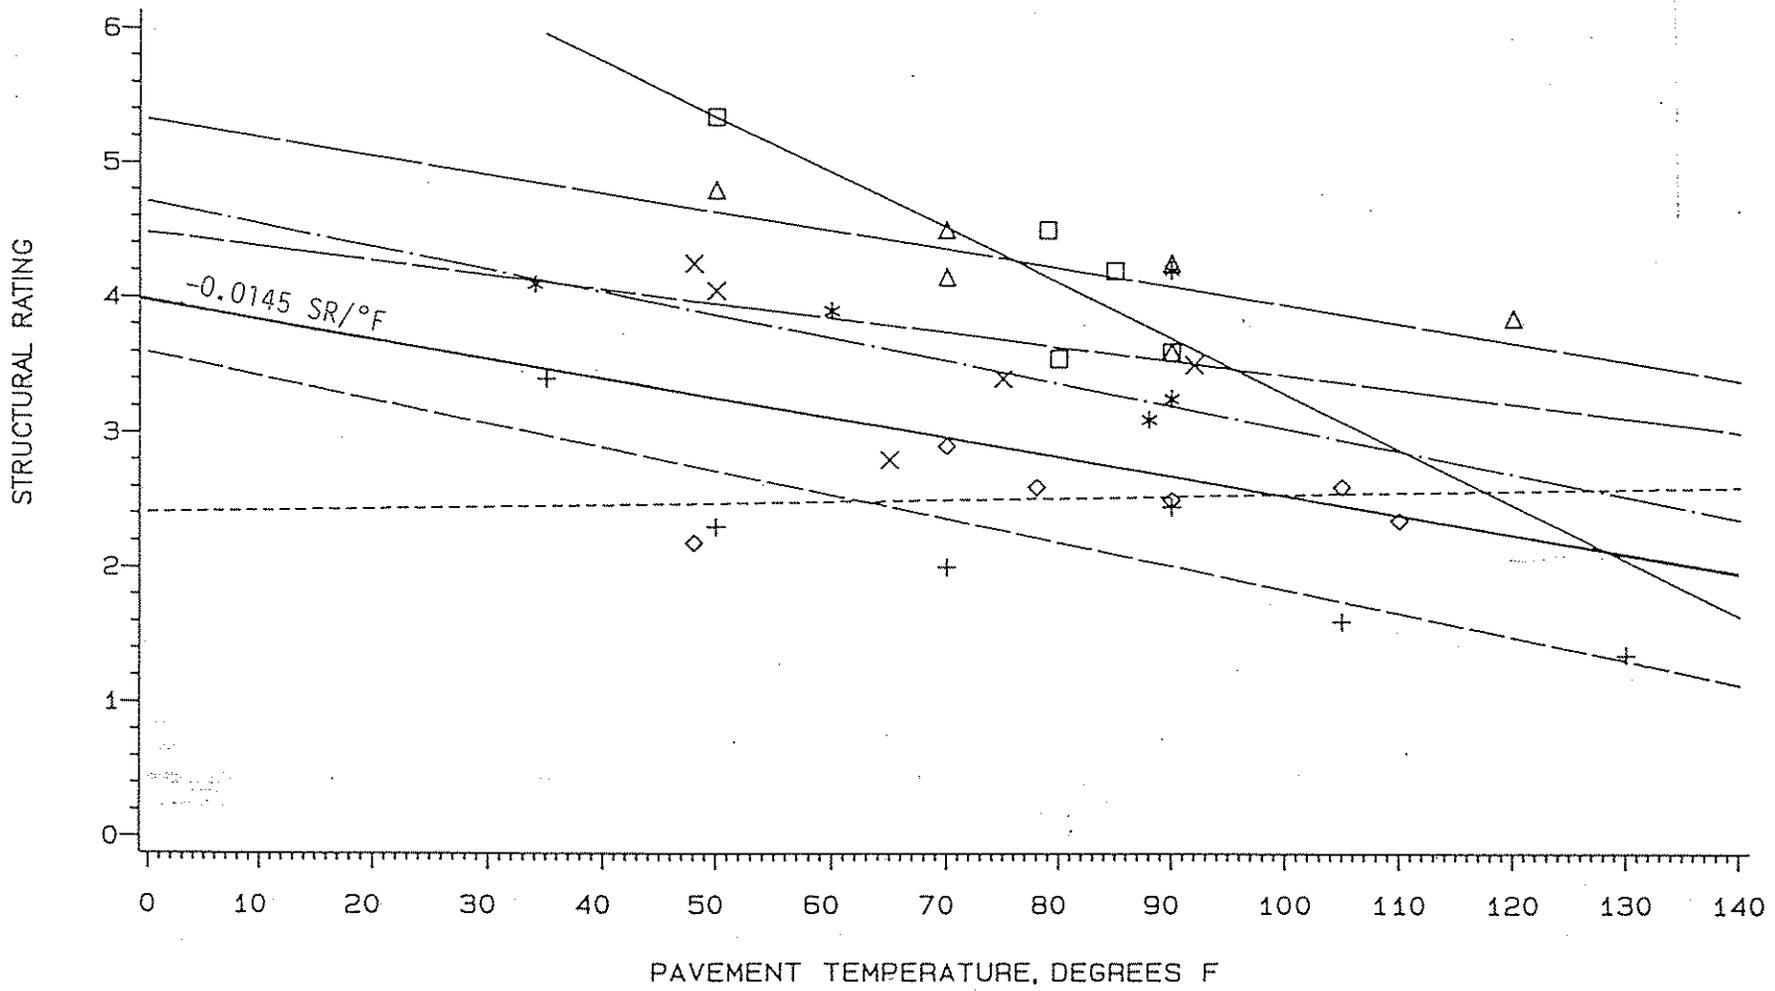
FIGURE 16
ROAD RATER STRUCTURAL RATING
VERSUS
PAVEMENT TEMPERATURE
FOR COMPOSITE PAVEMENTS

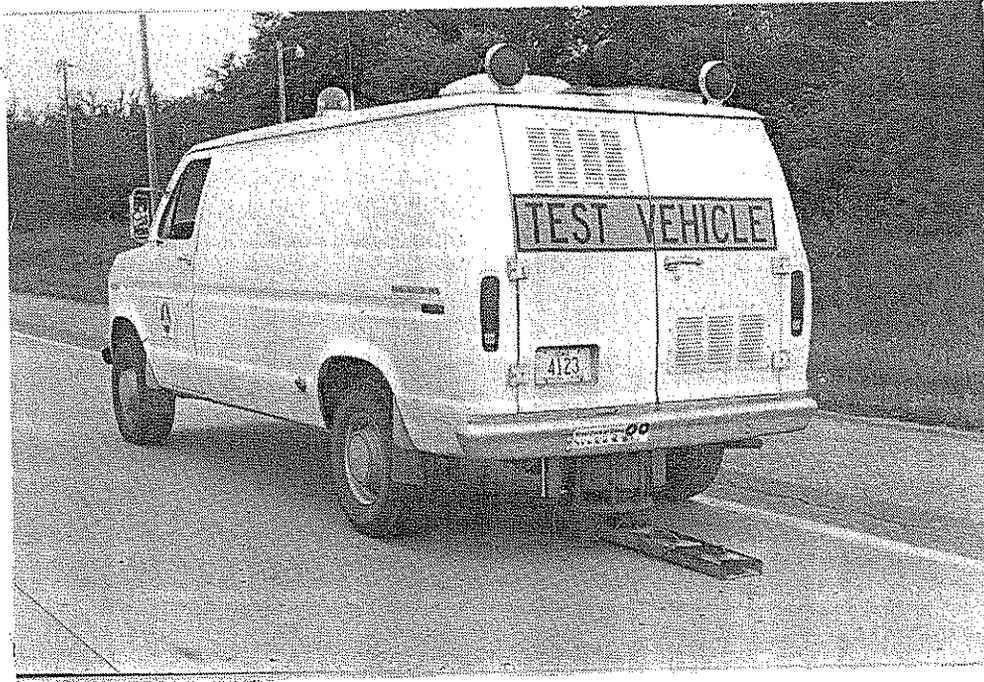
Figure 1
The Road Rater

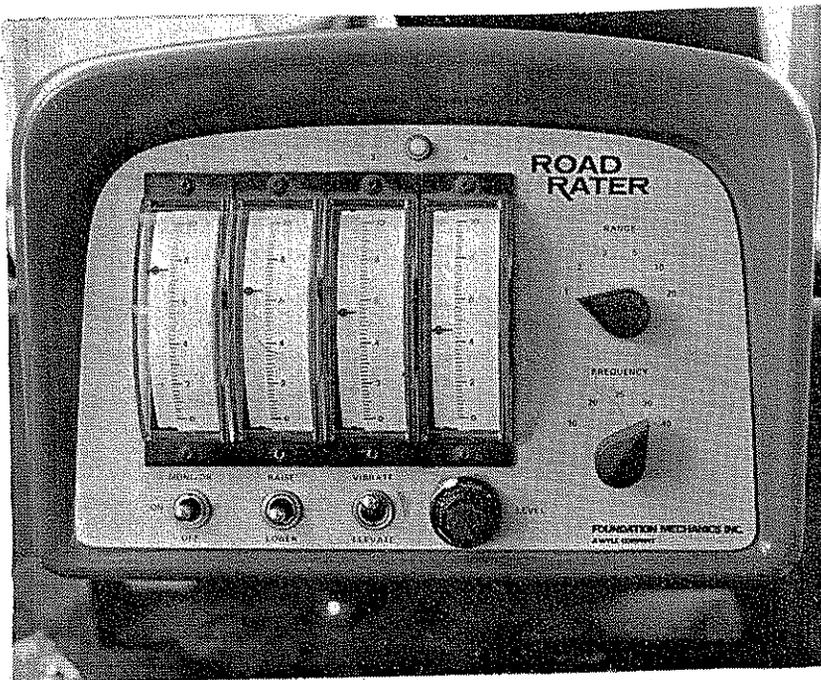
Figure 2
Road Rater Control Console

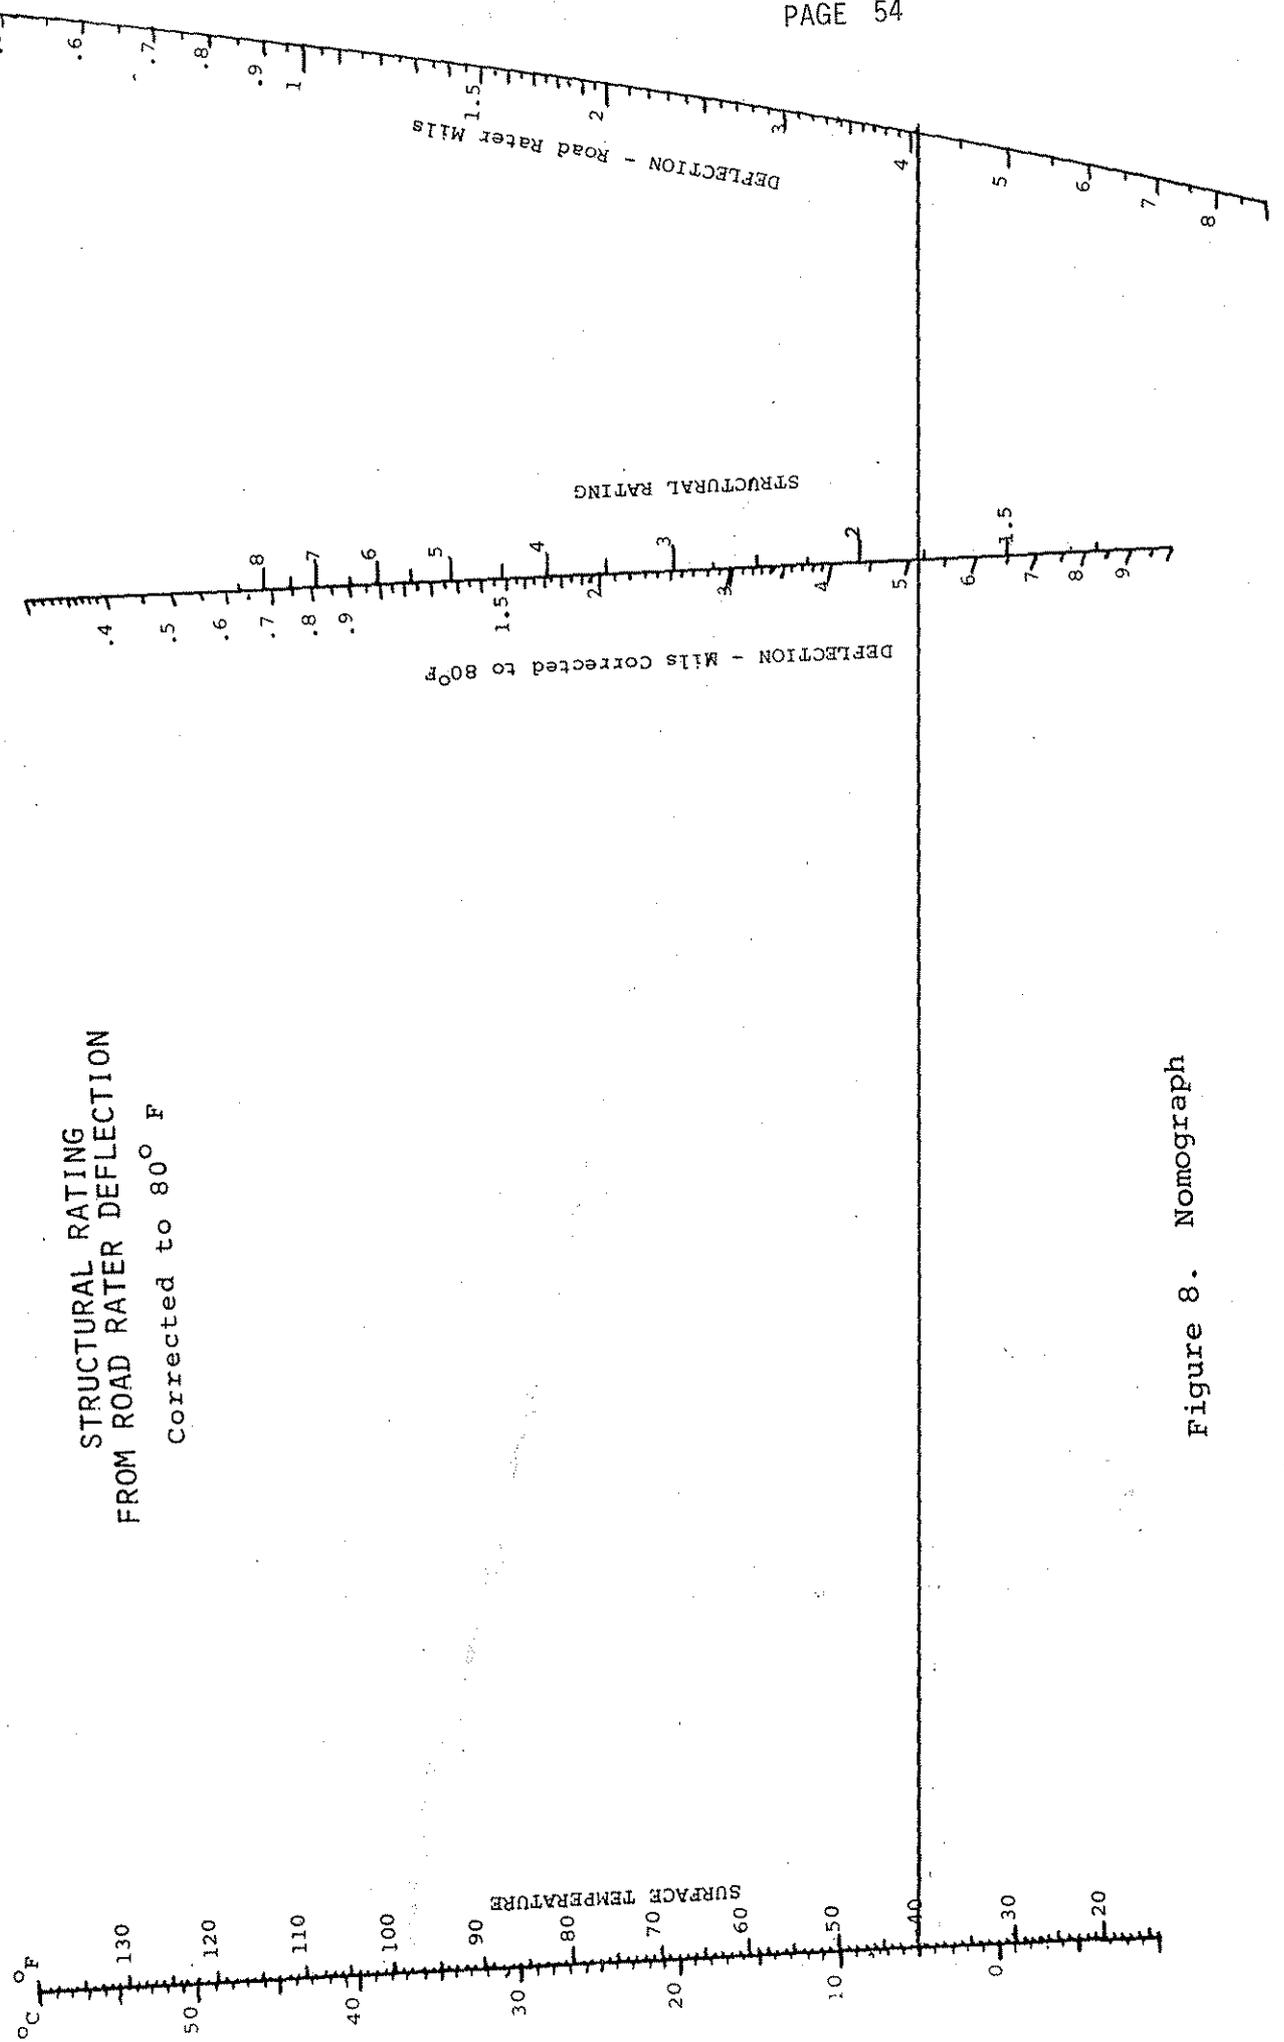
Figure 8. Nomograph

STRUCTURAL RATING
FROM ROAD RATER DEFLECTION
Corrected to 80° F

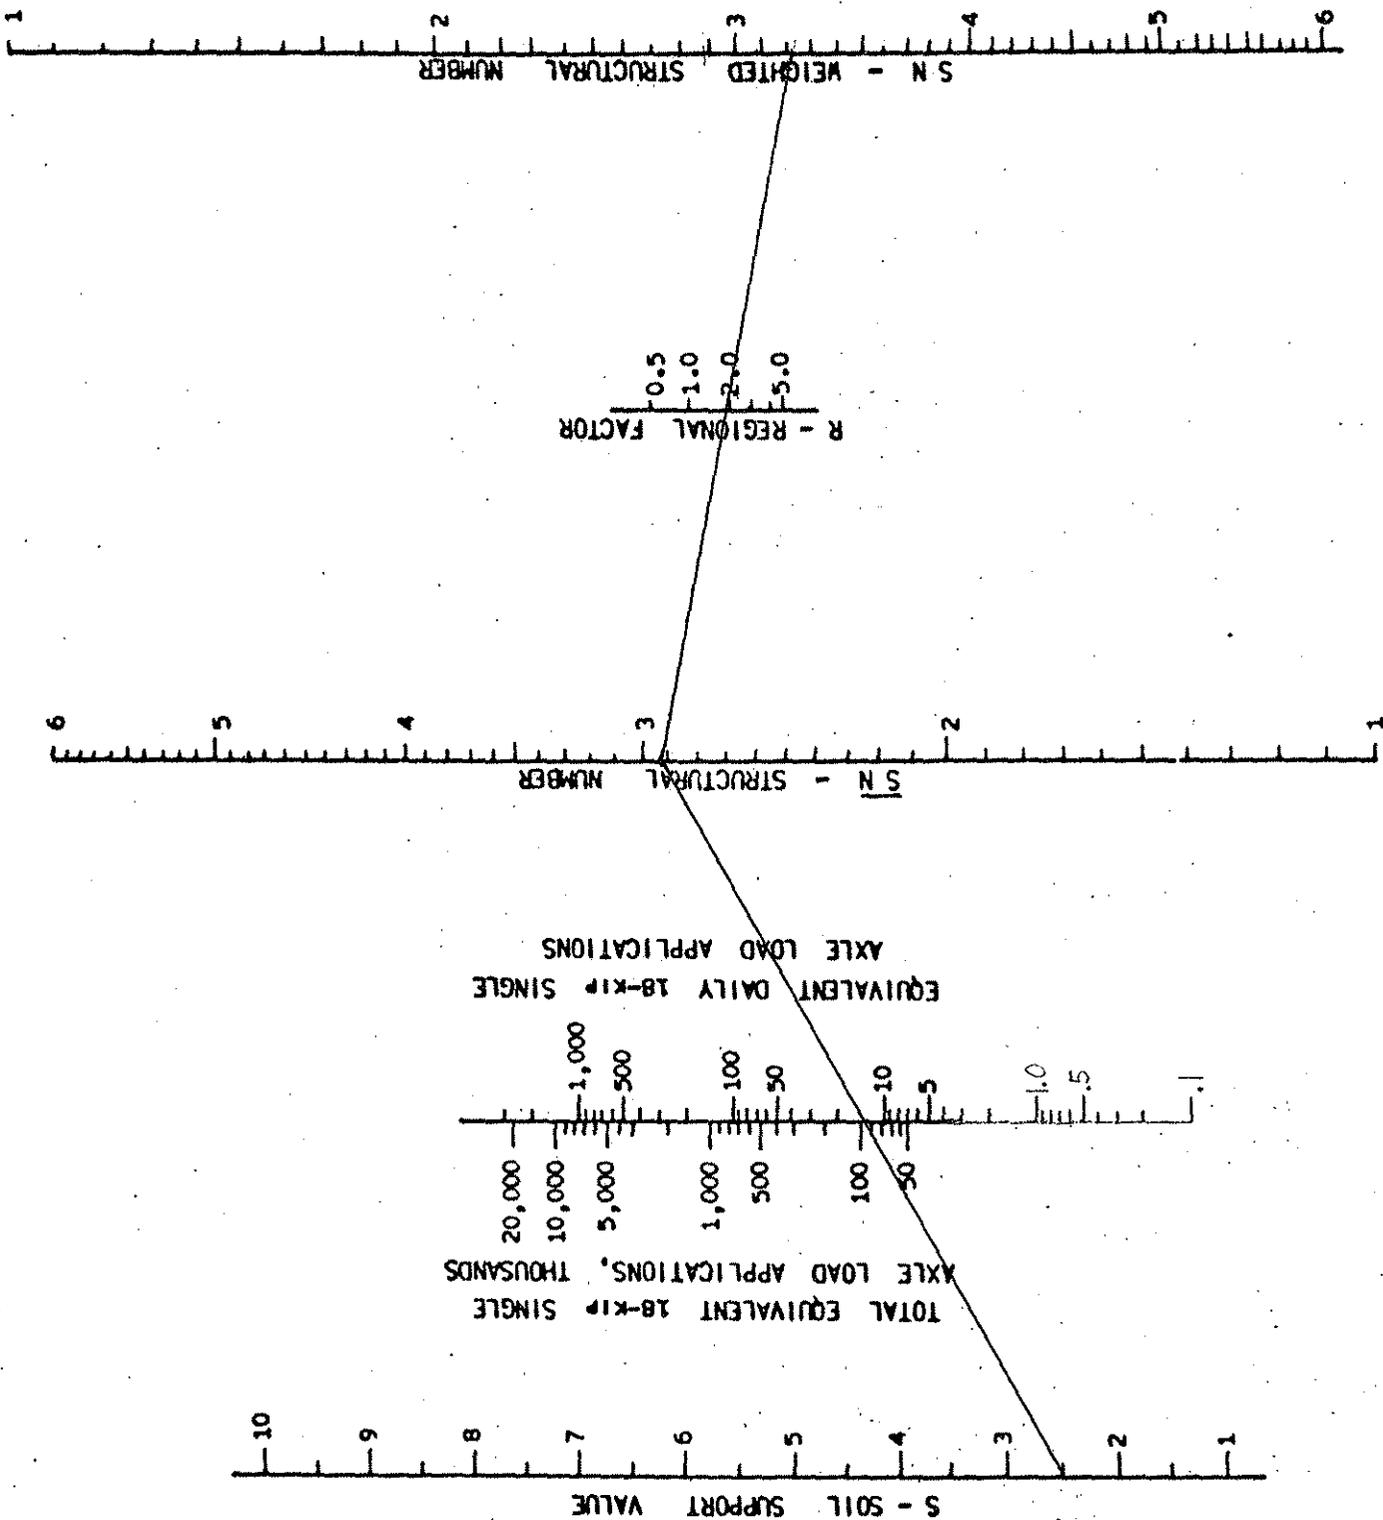
Figure II-1 Design Chart for Flexible Pavements, $P_t = 2.5$
