Pavement Evaluation Using the Road Rater™ Deflection Dish

**Final Report
for
MLR-89-2**

**Iowa Department
of Transportation**

Final Report
for
Project MLR-89-2

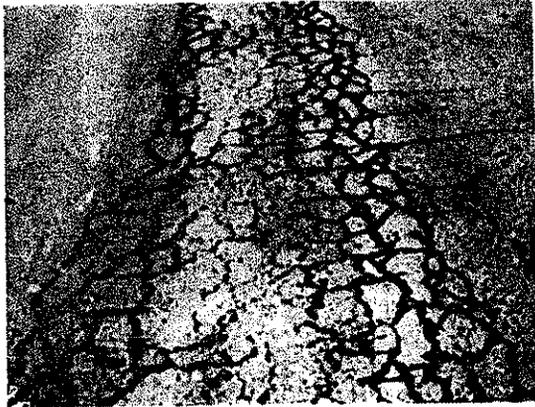
Figure 1.

Alligator cracking

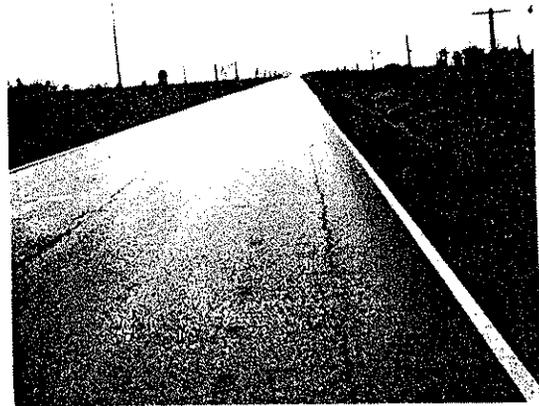
Figure 2.

Longitudinal Cracks

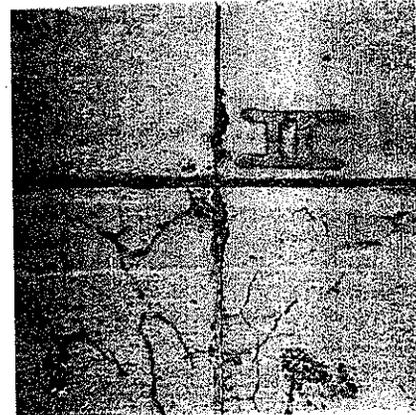
Figure 4.

D-cracking, D, refers to a characteristic pattern than can develop in portland cement concrete. Initially, the occurrence of D-cracking may be preceded and accompanied by staining of the pavement surface near joints and cracks. However, not all stained joints and cracks develop D-cracking. D-cracked concrete will first exhibit fine parallel cracks adjacent to the transverse and longitudinal joints at the interior corners. The D-cracks will bend around the corner in a concave or hourglass pattern. As the D-cracking progresses, the entire length of the transverse, longitudinal and random cracks will be affected. The cracked pieces may become loose and dislodged under the action of traffic. The occurrence of D-cracking in the check sections will be rated on a point scale as described in the Test Procedure section.

D-cracking - Initial stages

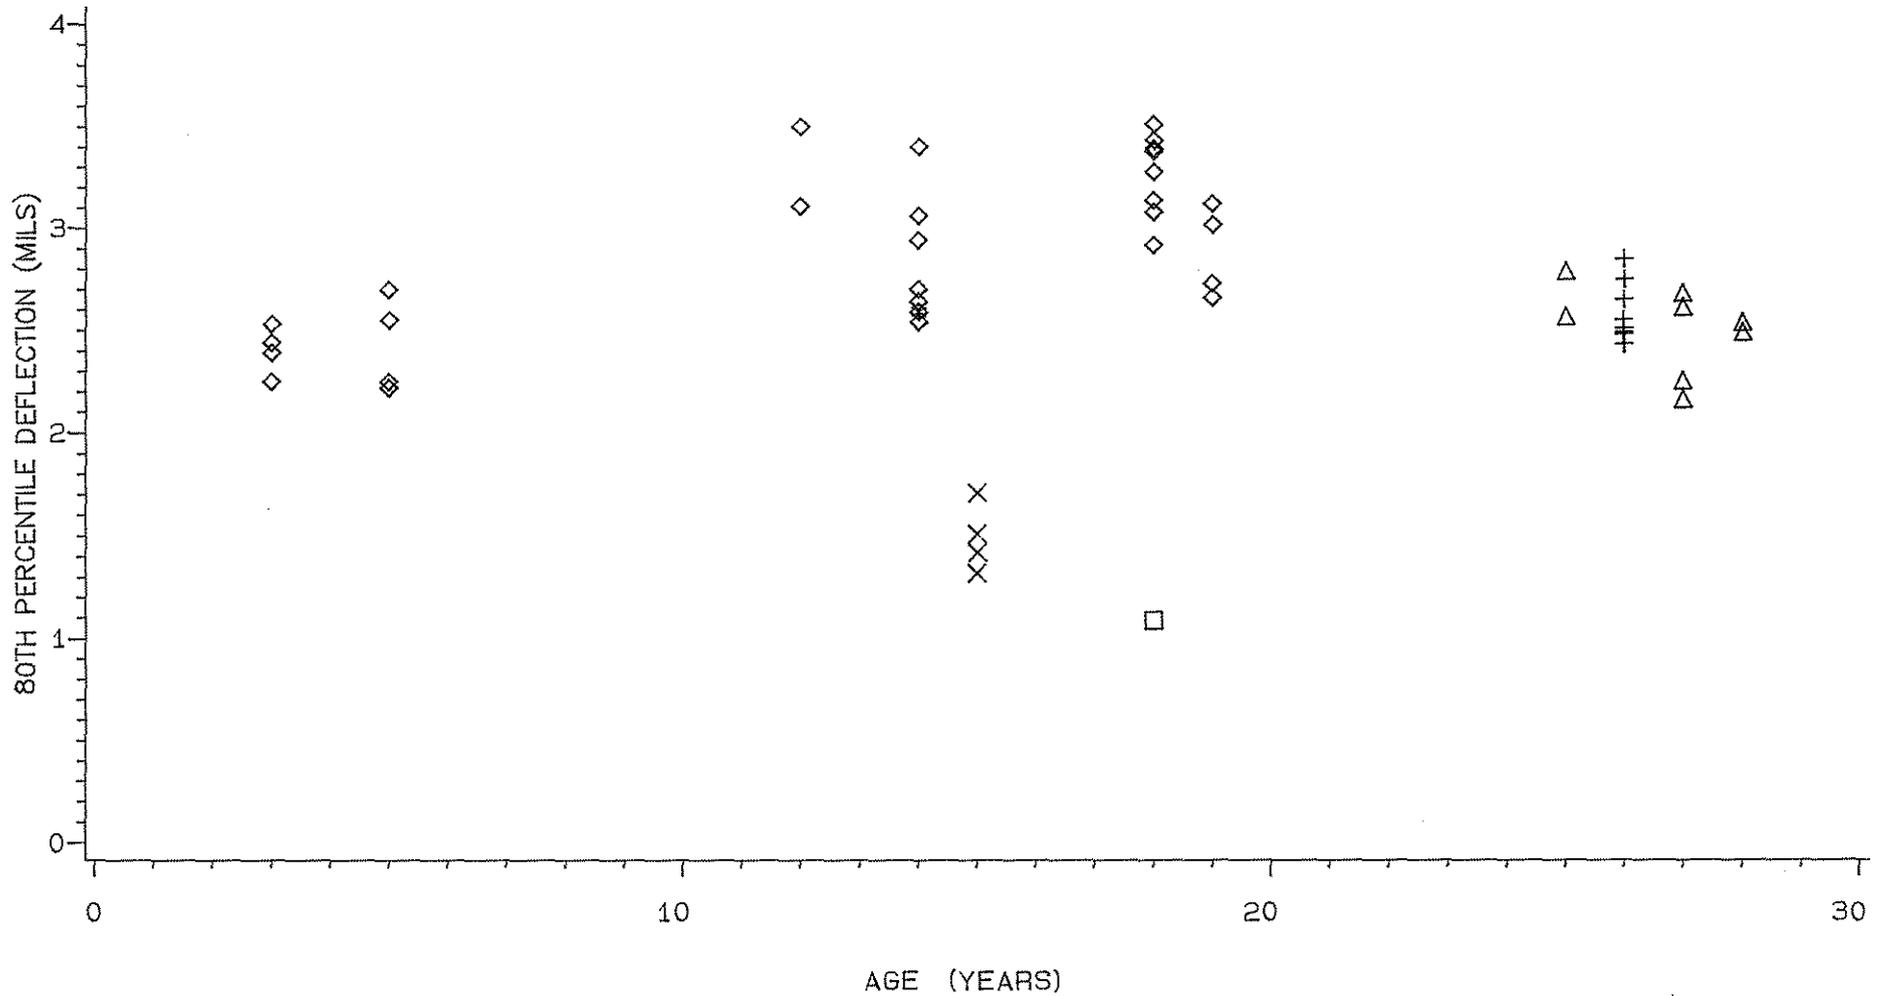
80TH PERCENTILE DEFLECTION VERSUS AGE

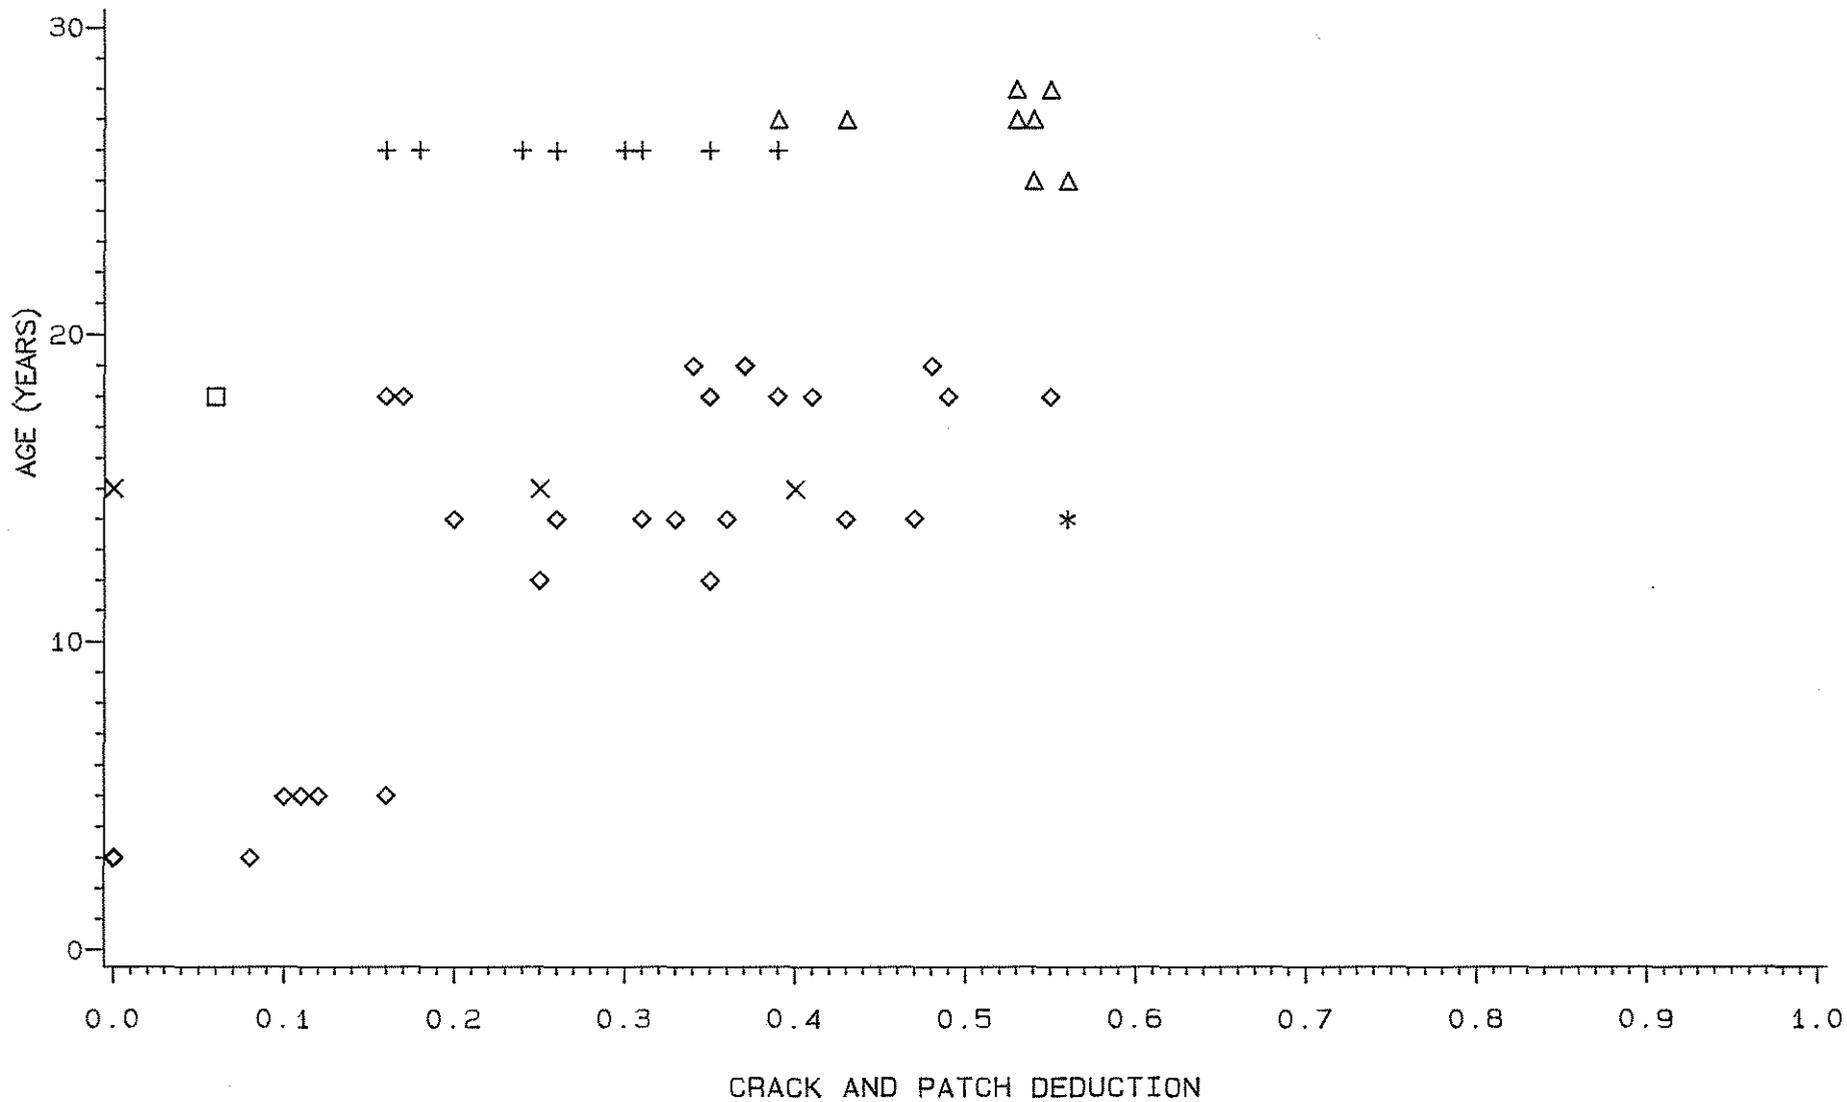
AGE VERSUS CRACK AND PATCH DEDUCTION

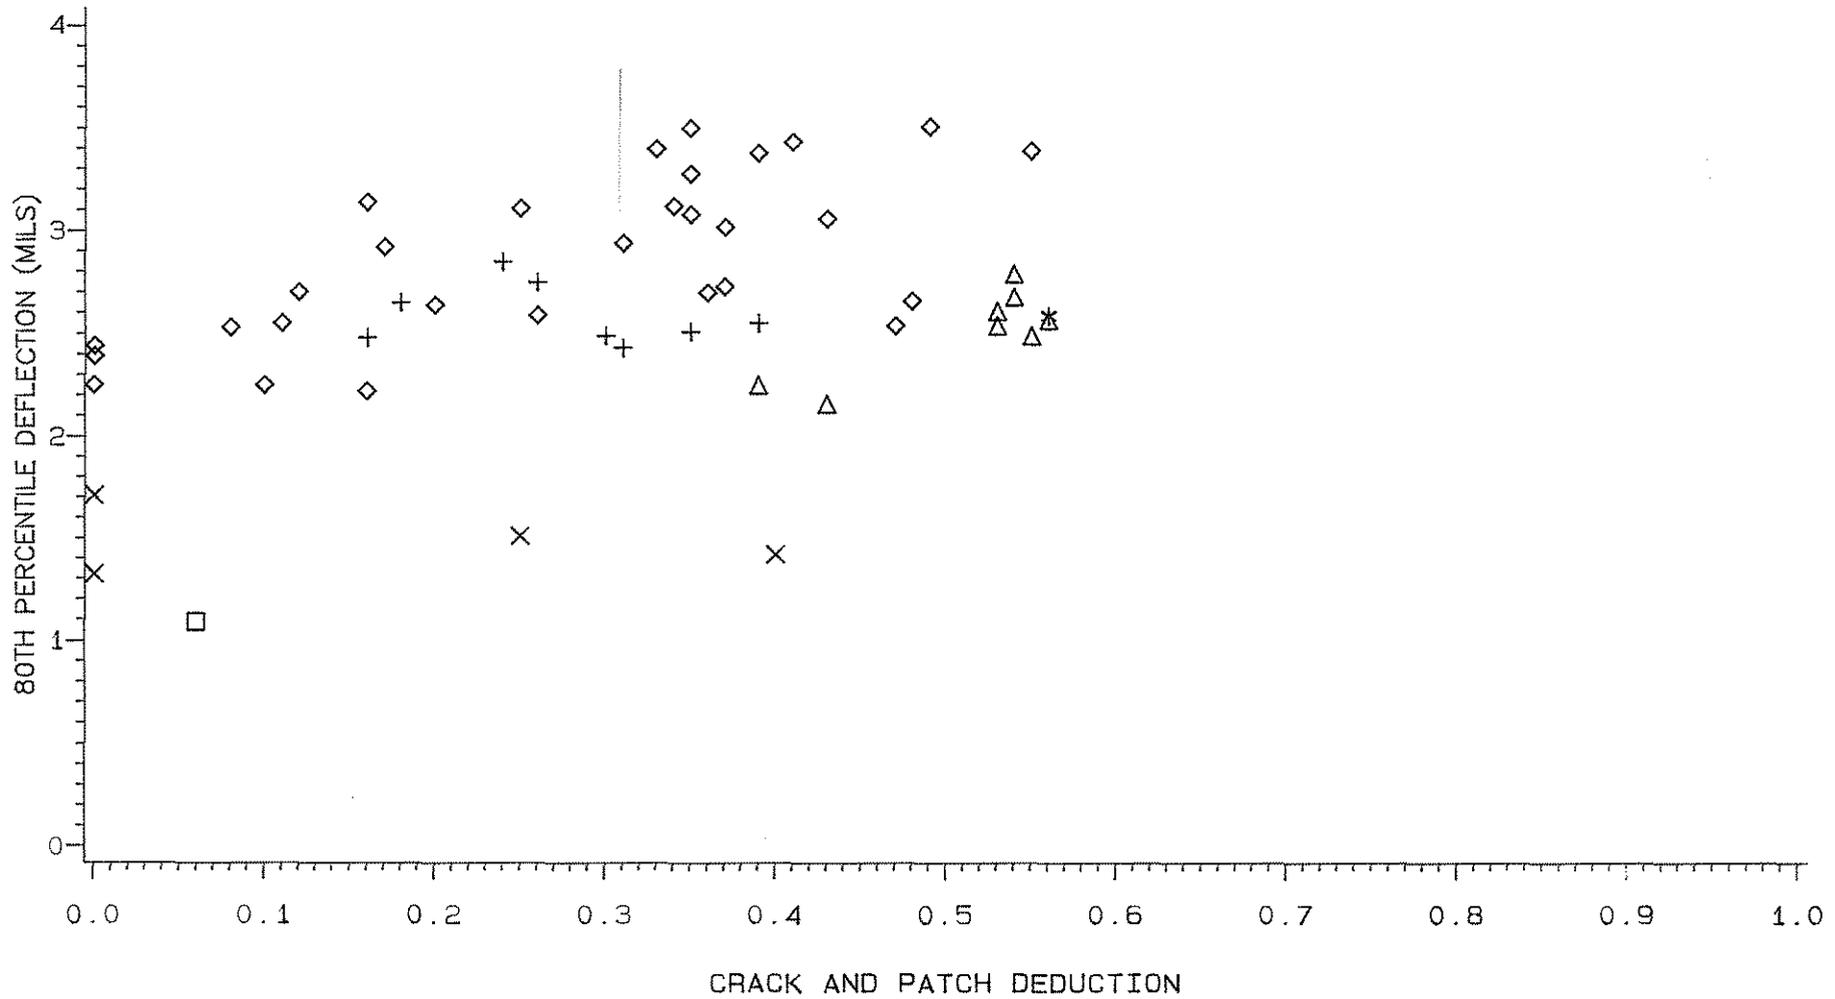
80TH PERCENTILE DEFLECTION VERSUS CRACK AND PATCH DEDUCTION

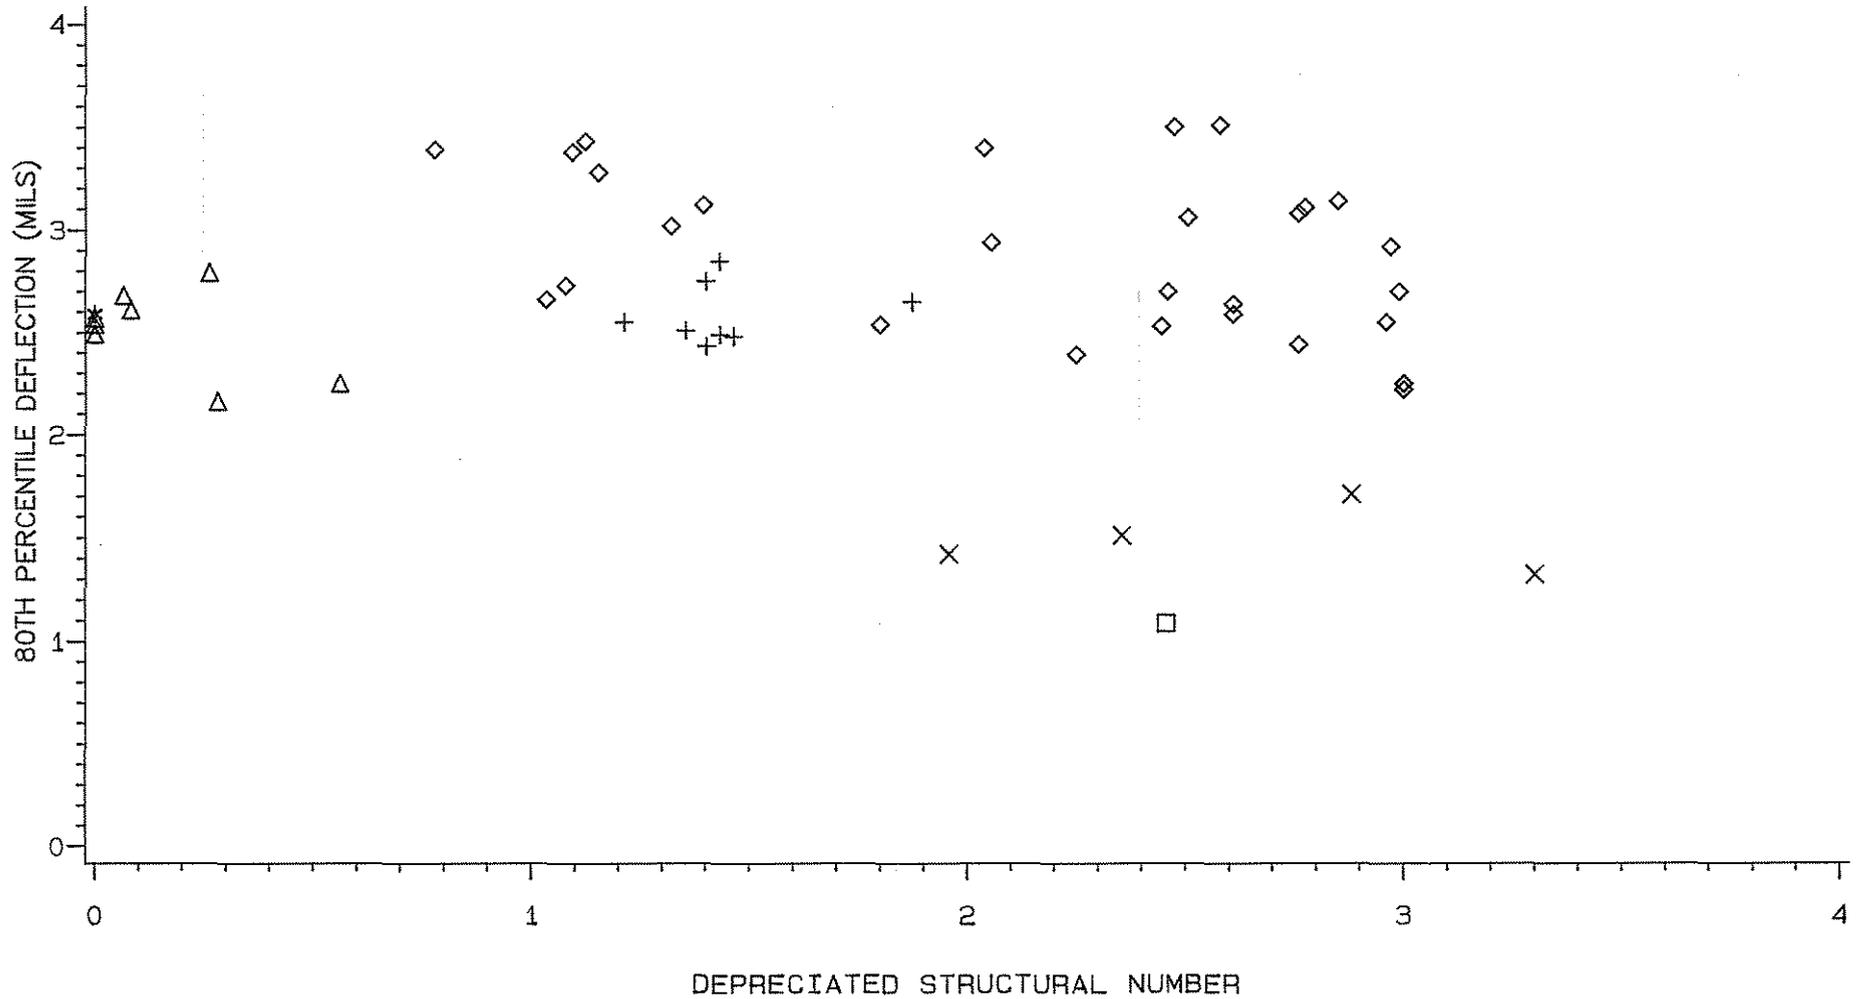
**80TH PERCENTILE DEFLECTION
VERSUS
DEPRECIATED STRUCTURAL NUMBER
 $(1 - (4.5 - \text{PSI}) / 2.00) * \text{NEW SN}$**

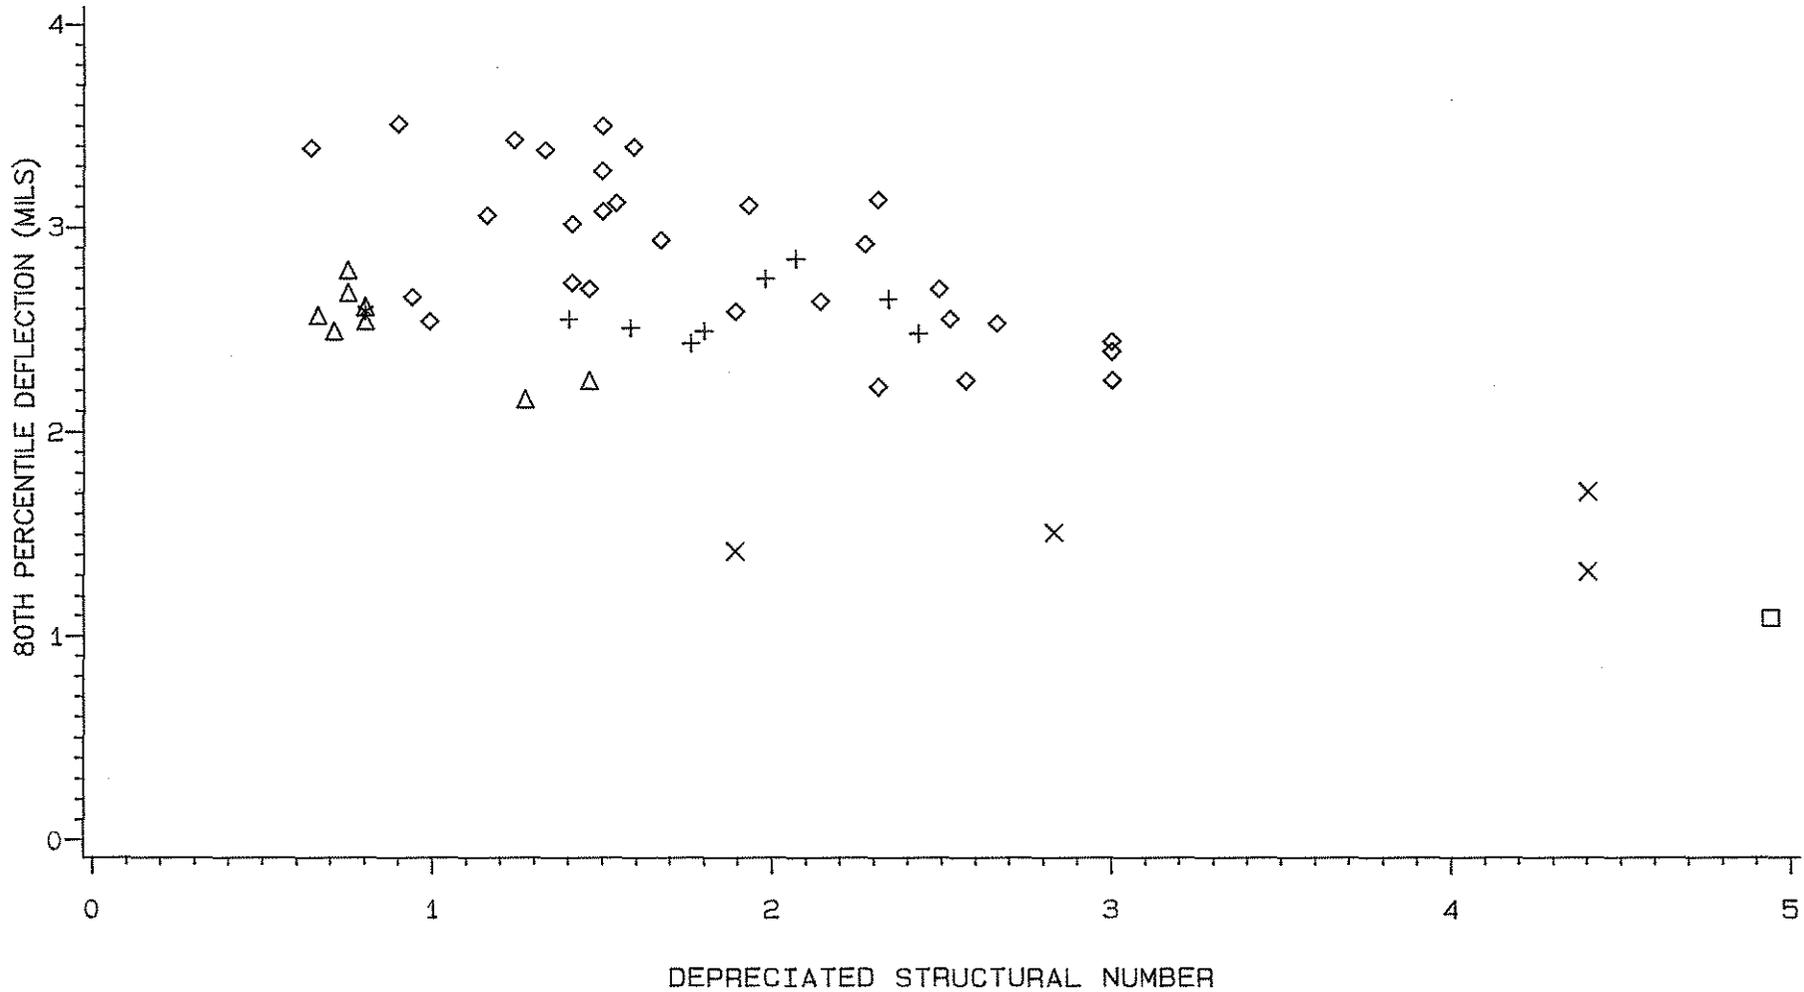
**80TH PERCENTILE DEFLECTION
VERSUS
DEPRECIATED STRUCTURAL NUMBER
 $(1-(C \& P)/0.70)*NEW\ SN$**

non-reinforced concrete pavements, but cracks were less than 1/4" wide and, therefore, CRC pavements did not follow this depreciated SN model. The correlation plot on page 83 excluded CRC pavements, but a few badly cracked pavements still would not follow the depreciated SN model based on the amount of cracking, C. The SCI/SENS 1 ratio compensated for this problem and was incorporated on the plot on page 84.

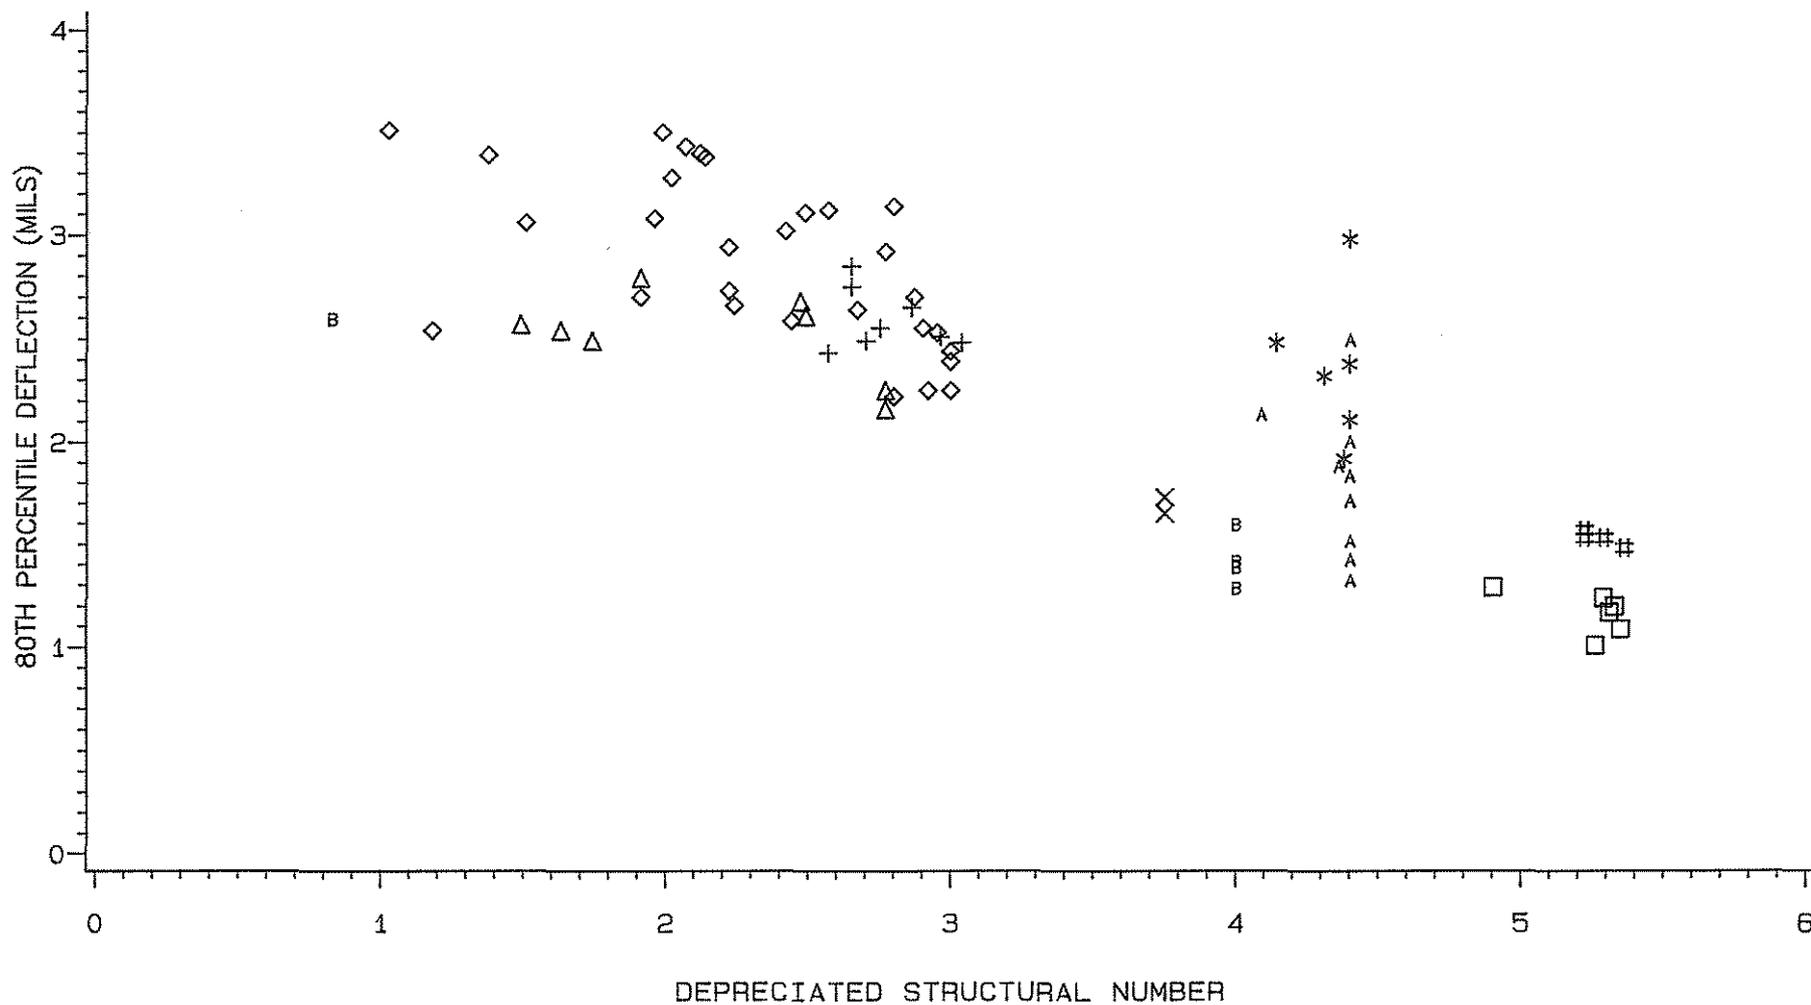
**80TH PERCENTILE DEFLECTION
VERSUS
DEPRECIATED STRUCTURAL NUMBER
(1-(C/45))*NEW SN**

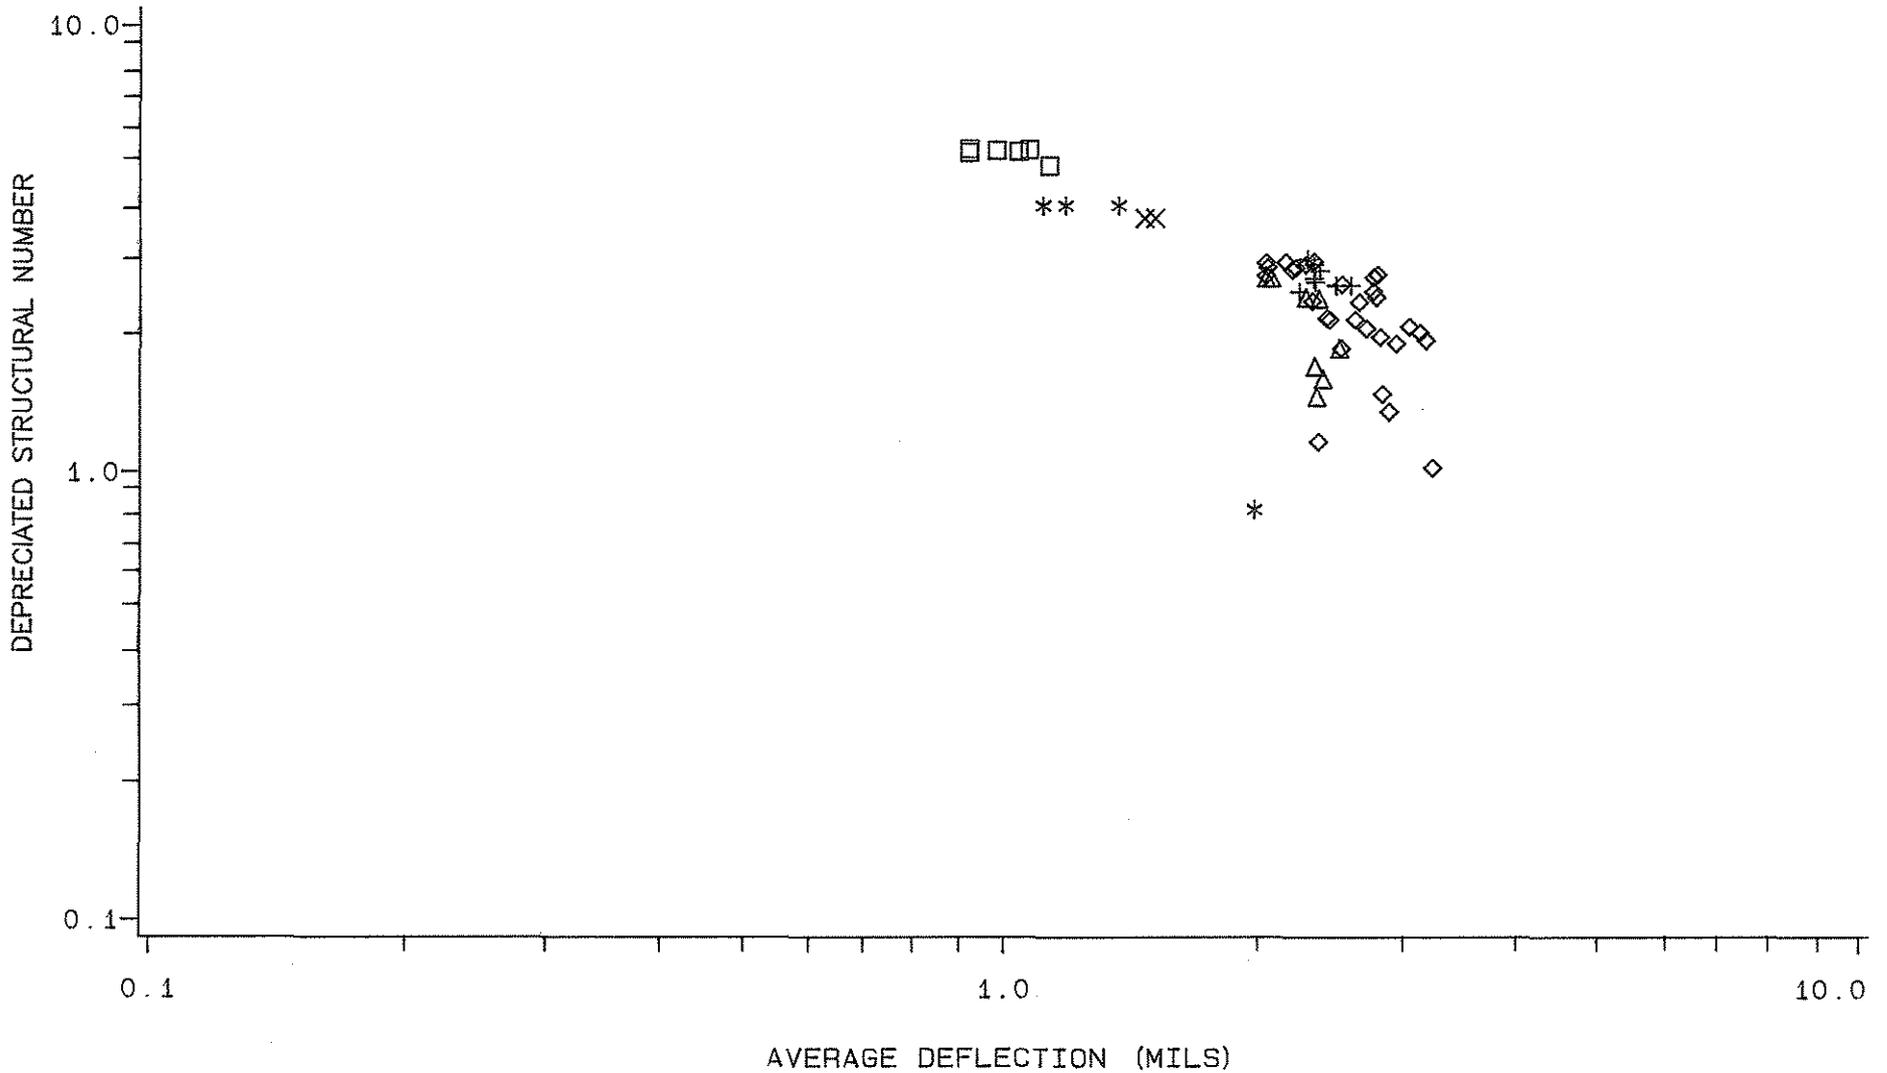
**AVERAGE DEFLECTION
VERSUS
DEPRECIATED STRUCTURAL NUMBER
(1-(C/45))*NEW SN**

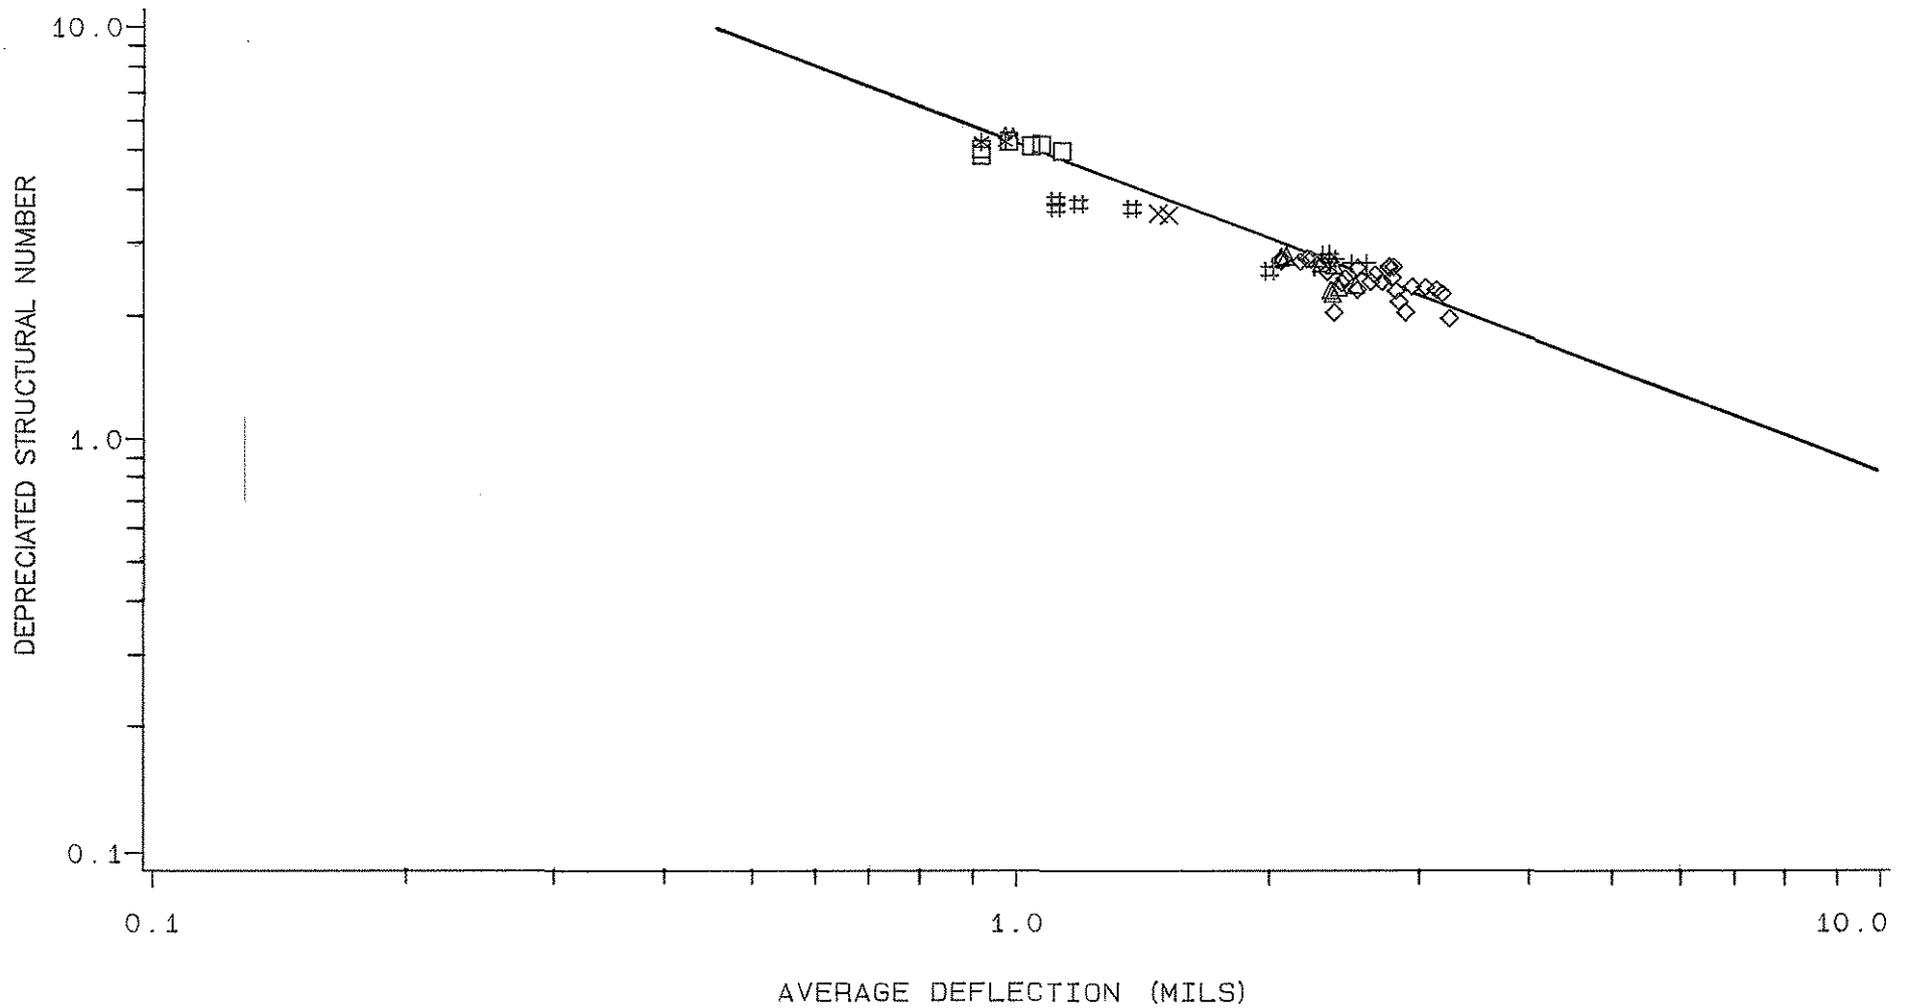
**AVERAGE DEFLECTION
VERSUS
DEPRECIATED STRUCTURAL NUMBER
 $.5((1 - ((SCI/SENS1)/0.90)) + (1 - (C/60))) * NEW SN$**

The base relationship to evaluate rigid pavements with the Road Rater is shown on page 85 of Appendix E and was verified with additional test data obtained in 1983. These additional data points are shown added to the base relationship on page 86. Some badly cracked pavements deflected less than expected, and this may be due to unusually good subgrade support, interlocking pavement pieces because of tighter cracks or joints, or collapsed pavement pieces into voids beneath the pavement. If pavements behaved in a totally predictable manner based on thickness and amount of cracking, there would be no need to perform Road Rater deflection testing. As it is, the Road Rater can be used to identify a "rubble" condition in the lower portion of a rigid or composite pavement. The Road Rater tends to read the inches of sound material from the top of the pavement to the first delamination plane. This was illustrated by pavement cores drilled on Iowa's 21 Long Term Monitoring (LTM) Sections for a FHWA Study (see Appendix F). The Road Rater can also be used to determine the subgrade support values for each individual pavement in the critical spring-thaw period annually. The rigid and composite

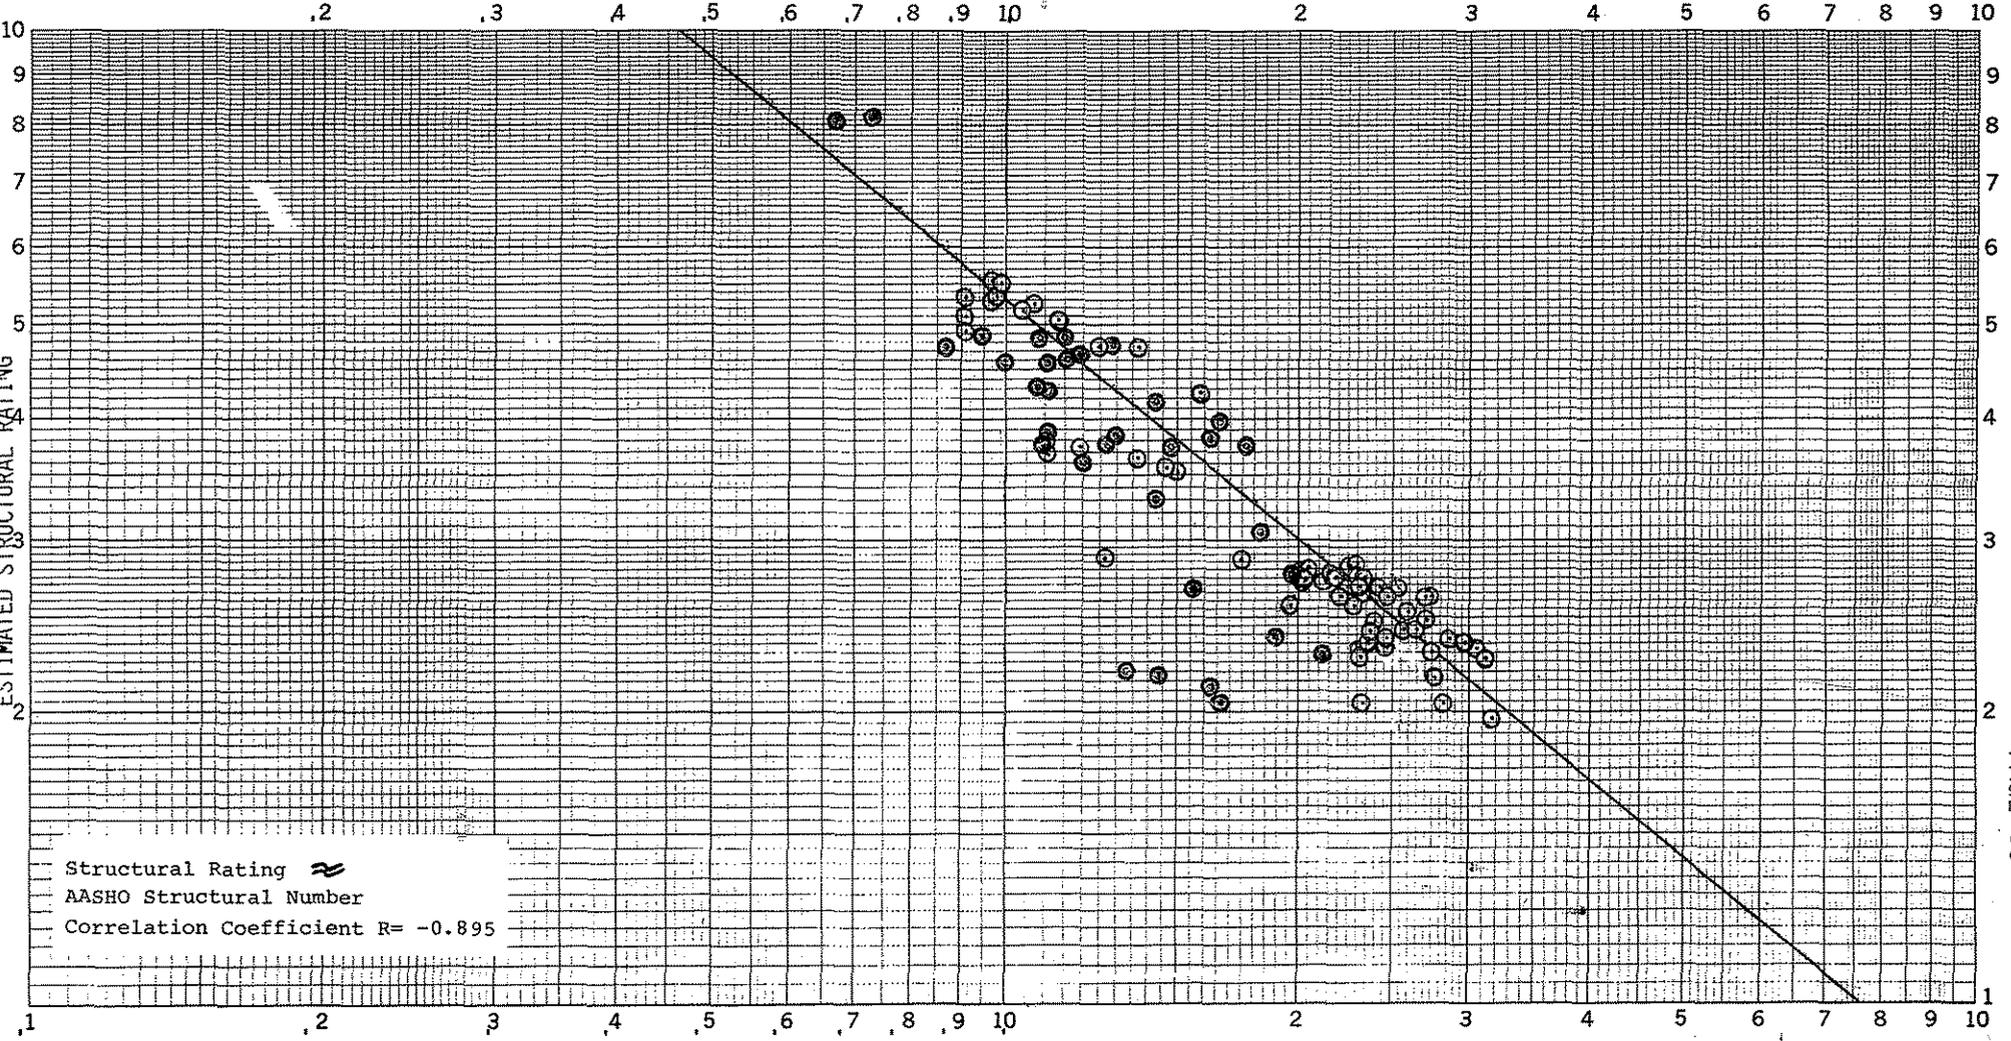
Structural Rating \approx
AASHO Structural Number
Correlation Coefficient R = -0.895
