RFID Tags for Detecting Concrete Degradation in Bridge Decks

**Final Report
December 2013**

Sponsored by
Federal Highway Administration
Iowa Department of Transportation
(InTrans Project 11-404)

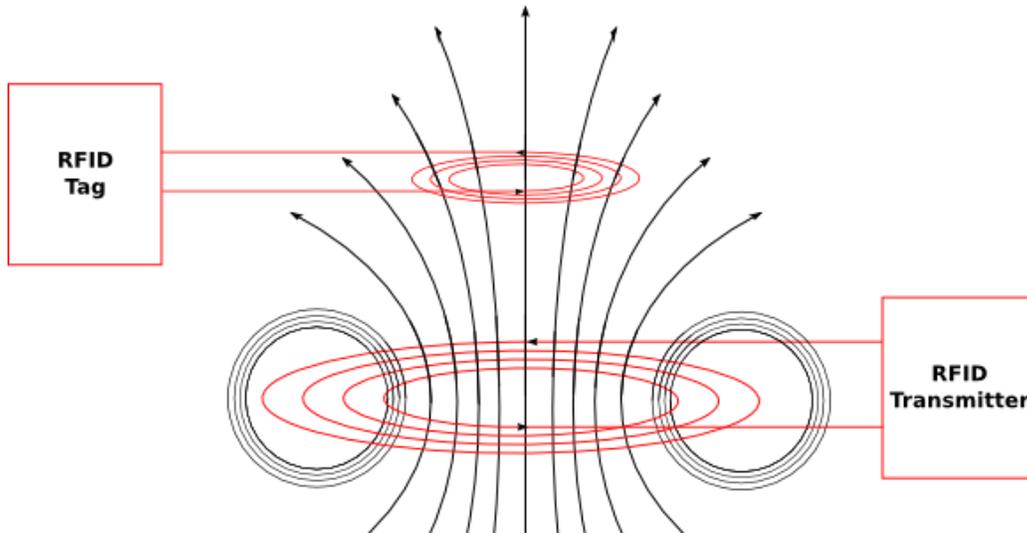
There are some difficulties associated with embedding RFID tags in concrete. As previously mentioned, this project utilized tags using near-field communication. This is based on the principle of mutual inductance, whereby some of the magnetic field lines induced by a loop of current in the reader antenna also pass through the tag antenna and create a loop of current in the tag. This is illustrated in Figure 1.

Figure 1. Mutual inductance in RFID near field communication

Communication with the tag is governed by the laws of electromagnetics, as they apply to the tag and the concrete above the tag, and by the resonant circuits that are the tag antenna and the reader antenna. Specifically, the key material properties of the concrete are its electrical permittivity ϵ and its conductivity σ . These are compared to the permittivity of the surrounding air, the physics constant $\epsilon_0 = 8.854 \times 10^{-12}$ Farads/meter, and the zero conductivity of the surrounding air. The remaining key electromagnetic property, magnetic permeability μ , is roughly the same for concrete as for empty space (10).

The permittivity ϵ affects electrical capacitance. The tag antenna is a tuned resonant circuit where energy oscillates between being stored in the electric field of the antenna capacitance, C and the magnetic field of the antenna inductance, L (10). The resonant frequency is as follows:

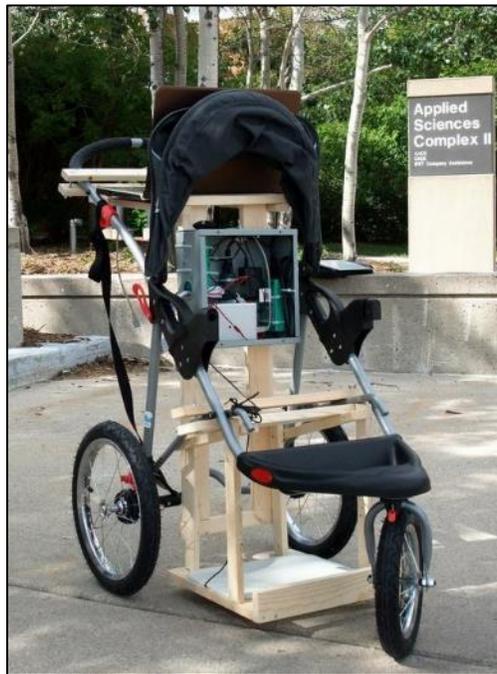
As shown in Figure 2, a modified infant stroller was chosen as an apparatus to make the equipment mobile and easily usable in the field.

Figure 2. RFID equipment cart

A wooden frame was built around the stroller to mount all of the equipment. An electrical pull box was used to house a battery, charging circuit, and the RFID reader. A 14.4 V NiMH battery was chosen, along with an appropriate smart charger for the battery. A simple relay circuit was built, as detailed in Appendix A with complete specifications for the apparatus, to allow the equipment to function on an external power supply while charging.

An appropriate 13.56 MHz RFID reader allowing an external antenna was chosen, again with specifications provided in Appendix A. An appropriate external antenna for the reader was also chosen and mounted to place it parallel to and as close to the ground as possible.

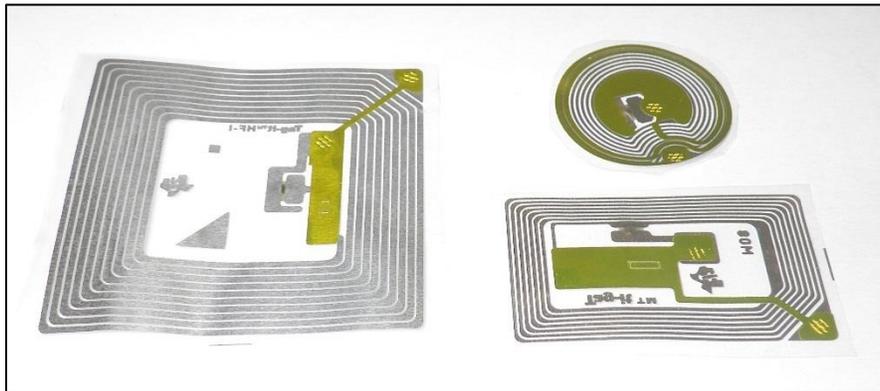
Early work in the project tested several different types, shown in Figure 4; however, we eventually decided on using a Texas Instrument RI-I16-114A-01 24.2 mm circular RFID tag. This model tag was chosen due to its small form factor and the desire to minimize the inclusion in the concrete.

Figure 4. Several RFID tag styles tested

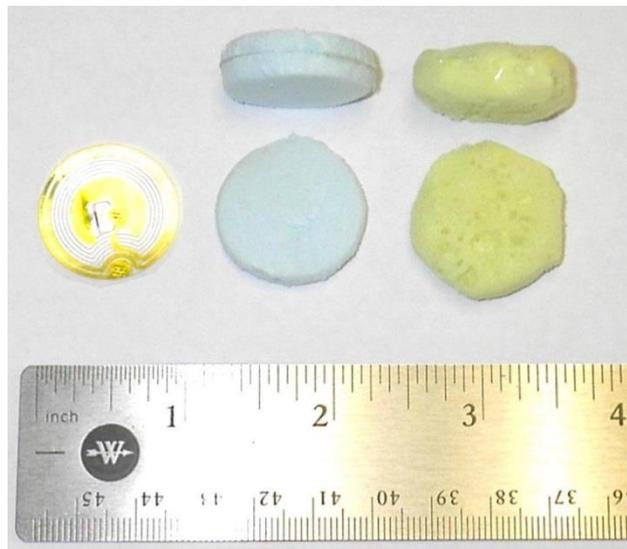
Figure 5 shows these tags after being encased in their respective protectant materials.

Figure 5. Tags encased using extruded polystyrene (center) and polyurethane spray foam (right)

In general, tags protected with a hard and relatively thick material functioned properly after being embedded in concrete. We found that materials that were particularly absorbent would not function after exposure to the hydrated cement mixture or salt water, in spite of the fact that the tag inside was still functional, as determined by later cutting the tag out of the material. The best results came from tags protected with certain kinds of foam, such as polyurethane spray foam and extruded polystyrene. It is also worth noting that these materials have low relative permittivity values, also making them ideal.

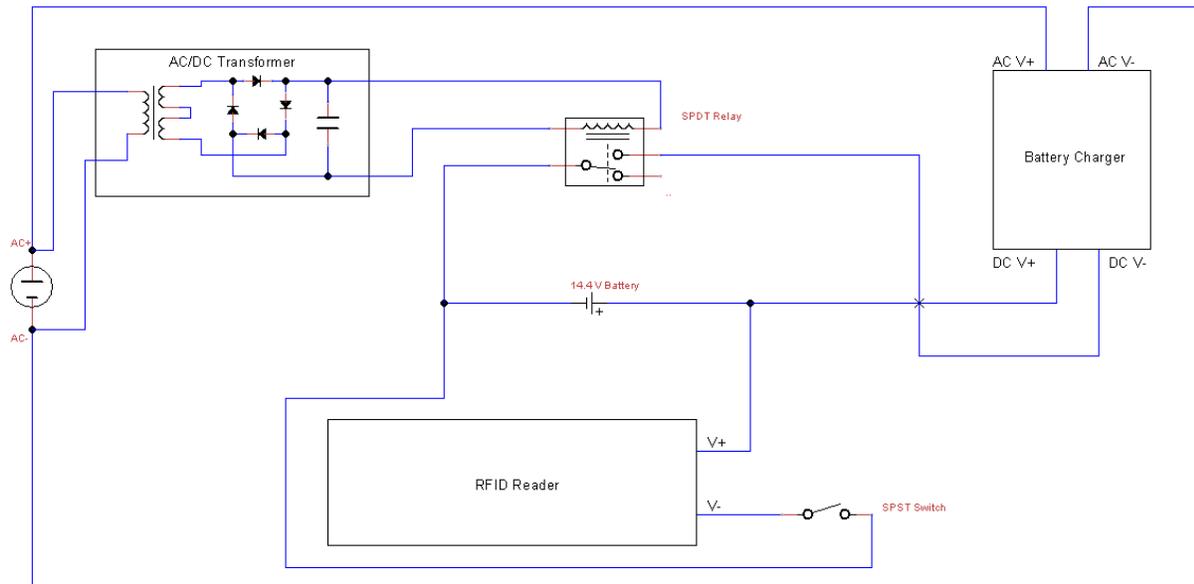
An infant stroller was modified to serve as the frame for the cart, and a wooden frame was assembled around it. Electrical components were installed into a National Electrical Manufacturers Association (NEMA) enclosure using the wiring diagram found in Figure A.1.

Figure A.1. Wiring diagram for RFID cart

Cart Frame	
Cart	Swivel Wheel Jogging Stroller – Target Part # 2097
Wood	1x3x8/1x2x8
Screws	8x1-1/2/6x2
Bolts/Wing Nuts	Lowe’s Part # 63334
Electric Box	
NEMA Enclosure	Hoffman ASE10x10x4 Pull Box
RFID Reader	DigiKey ID.MR101
Battery	NiMH Battery Pack – 14.4V 4500 mAh - BatterySpace Part #2627
Battery Charger	Universal Smart Charger – BatterySpace Part #2350
GPS	USGlobalSat BU-353 USB GPS Receiver
RFID Antenna	DigiKey Part # ISC.AMT340/240-A
