Pipe Rehabilitation with Polyethylene Pipe Liners

Final Report
Iowa Highway Research Board
Project HR-370

April 2003

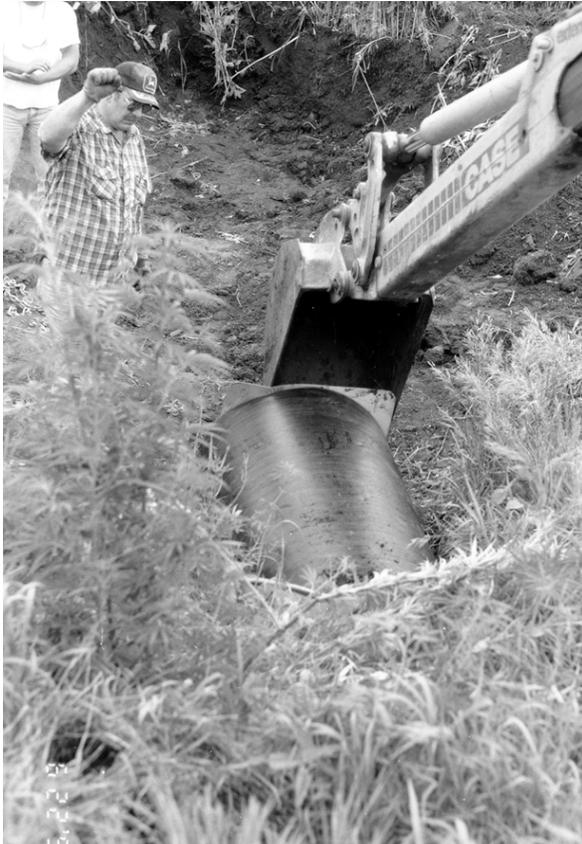
Figure 4
Inserting liner section into culvert with a backhoe.

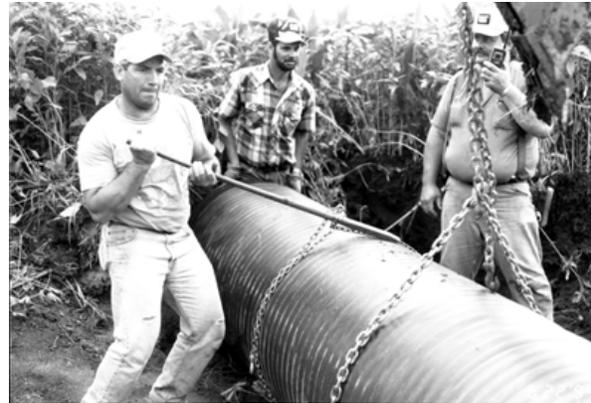
Figure 3
Threading two liner segments together.

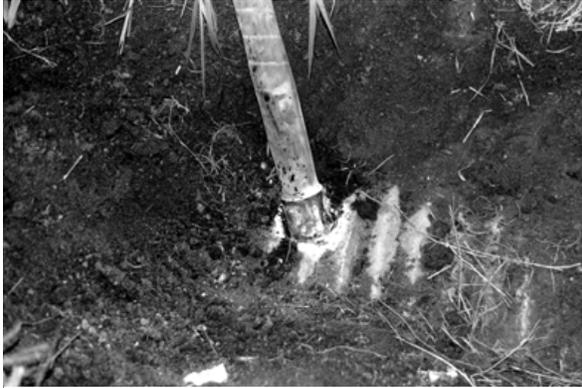
Once the insertion was complete, the contractor cut 100 mm diameter holes at the top of the exposed CMP to provide entry points for grouting. Grout was injected into the annular space under pressure from both ends. Unfortunately, the pressure from the grouting caused the center of the liner to float to the center of the CMP. The process required approximately 2.5 m³ of flowable mortar.

Figure 7
Pumping grout into annulus through access.

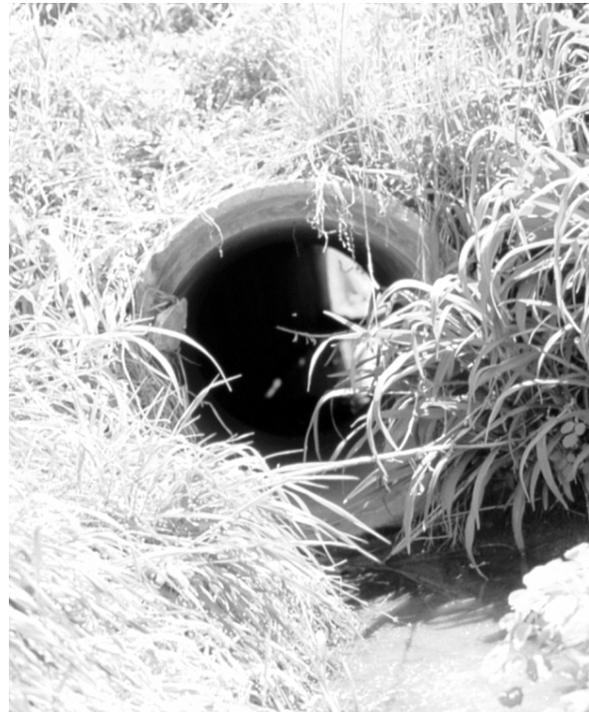
Figure 10
South end of original culvert with a short segment of PCC pipe inserted.

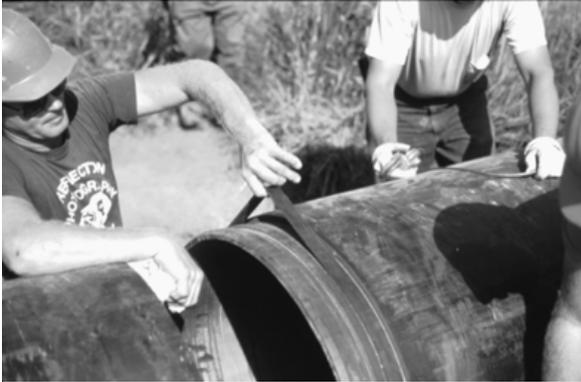
Figure 14
Joint between two segments showing sealing strap.

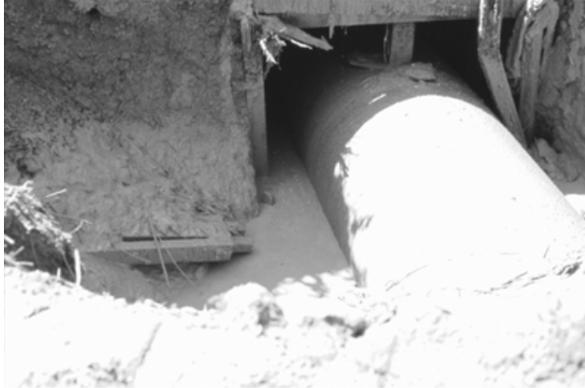
Figure 19
Mortar is half-placed. Note brace above the liner.

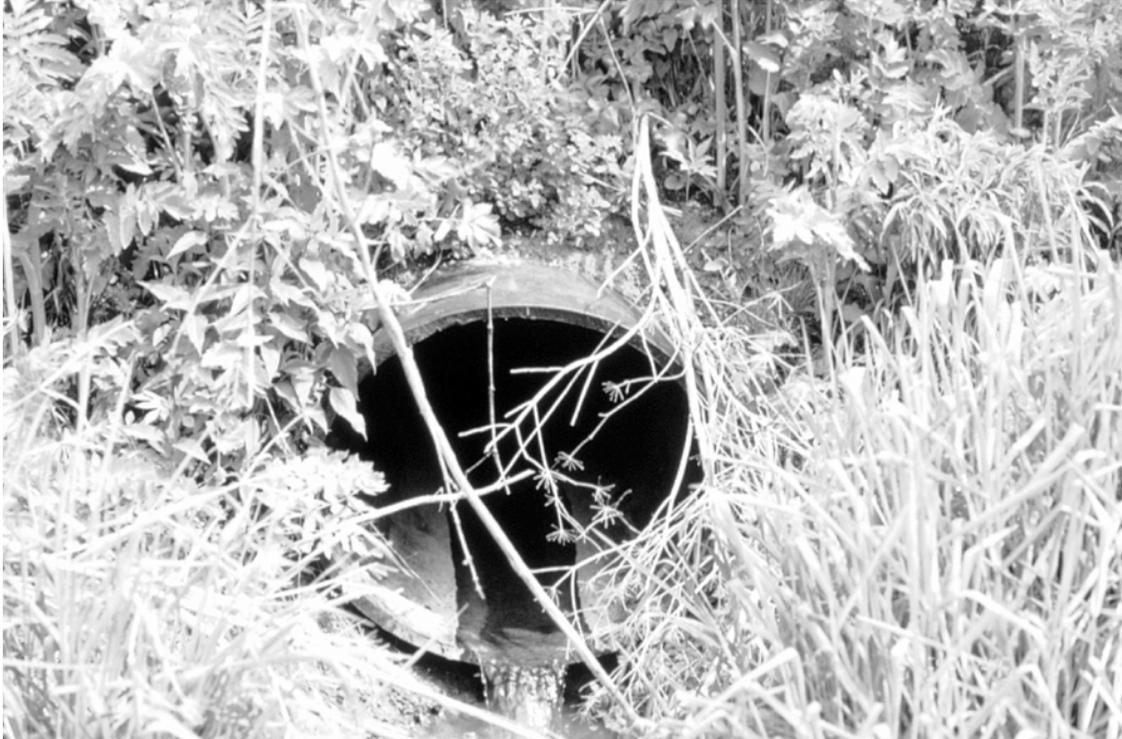
Figure 22
View of the south end of the culvert as it appeared in 2001.

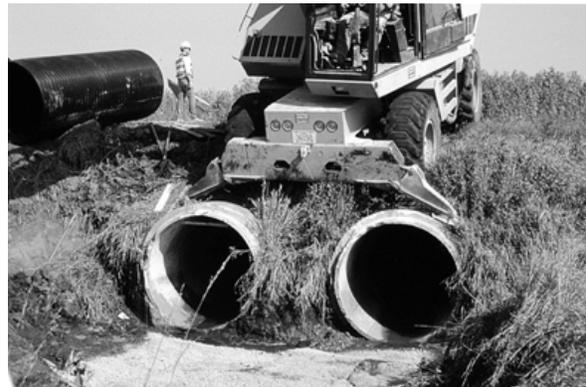
Figure 23
Original culverts with back hoe in place to assist with liner insertion. Note the aggregate placed to try to stabilize the soggy ground.

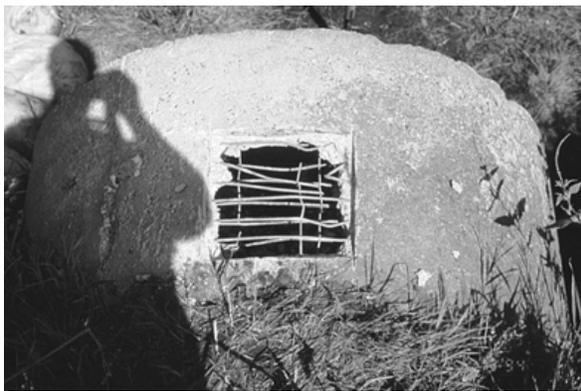
Figure 25

Grout entry hole in top of one culvert.

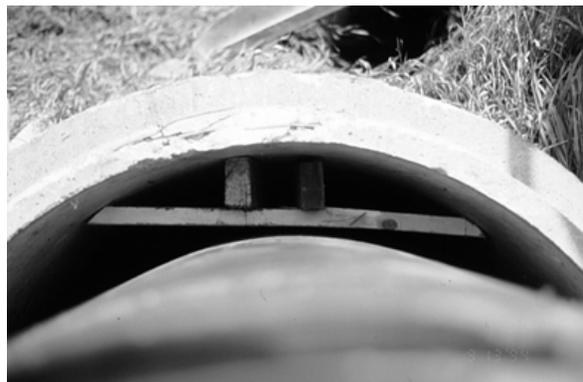
Figure 26

Transverse brace above liner in the west culvert.

either side. One brace was directly over a liner joint. This joint was deformed but remained connected and showed no indications of leaking.

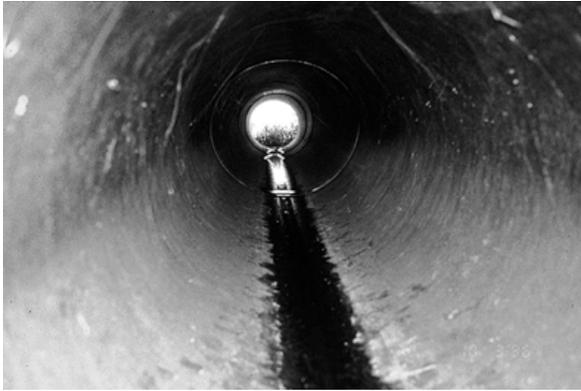
Both liners are performing well. There has been no significant movement to-date, and the joints have maintained their integrity.

Figure 31
Installed Snap-Tite™ liner as it looked in 1996.

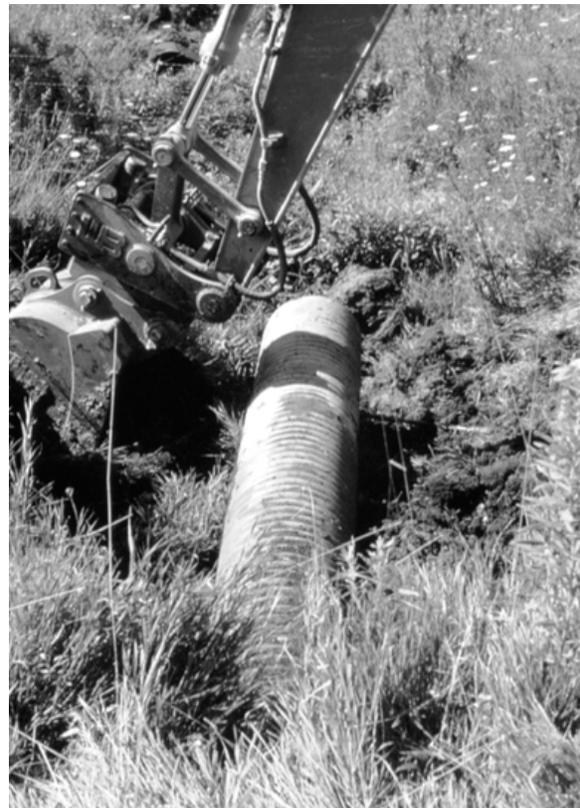
Figure 34
Clearing around the existing culvert to enable adjustment of the alignment.

Installation of the liner took place on July 27, 1994. The product used for this project was a Culvert Renew™ liner with an ID of 460 mm, OD of 510 mm and a length of 29 m. The work crew began at the south end of the culvert by attempting to straighten the bent portion to be in line with the rest. Earth was placed beneath the exposed CMP and compacted. After straightening, there remained about 5° of bend.

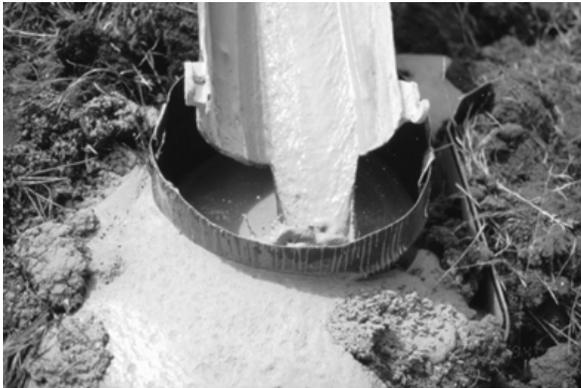
Figure 39

The funnel was placed over the entry hole and surrounded with soil.

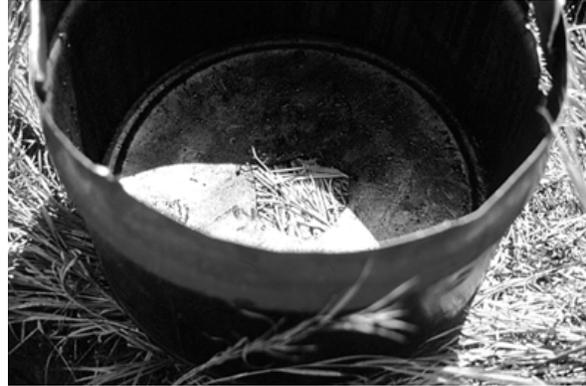
Figure 38

Funnel used to provide added head to the grout being poured into the annulus.

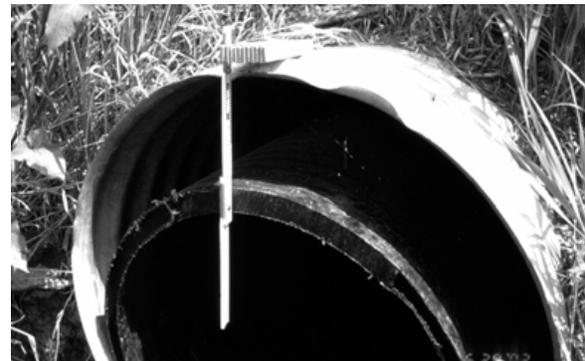
Figure 40

Grout was placed by gravity flow through the funnel on the north side. The standing head in the funnel was inadequate to push the mortar fully to the south side of the culvert leaving several meters of the south end of the culvert without grout in the annulus. However, the pipe liner supplier representative was of the opinion that enough of the

The grout did not reach the downstream end of the culvert leaving a large annular gap.

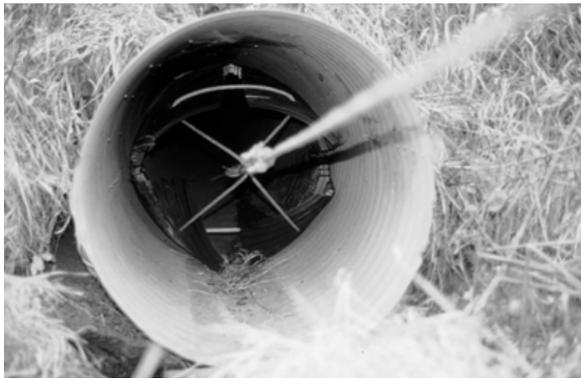
Figure 43
Cable attached to the cone at the front of the liner.

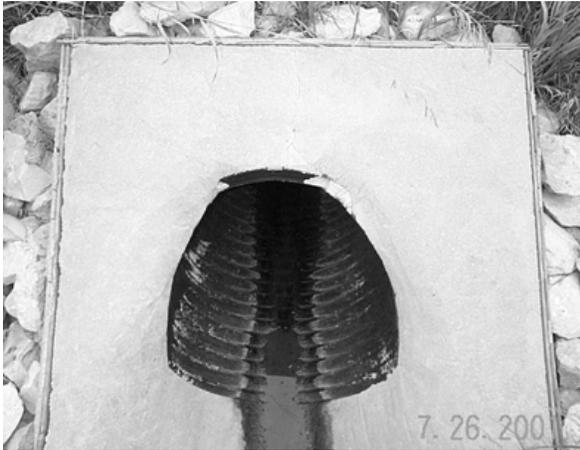
Figure 46

Outlet of lined culvert with headwall and rip-rap.

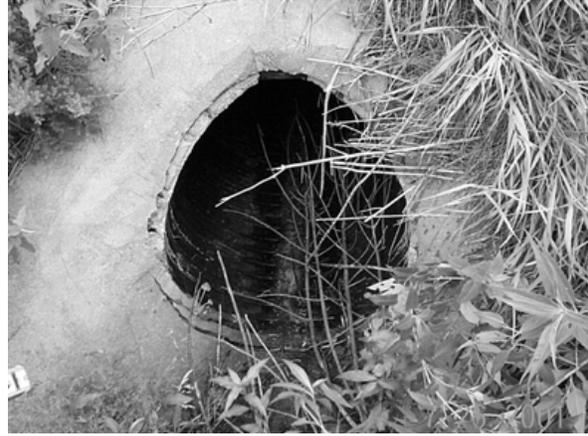
Figure 45

Inlet end of lined culvert showing headwall.

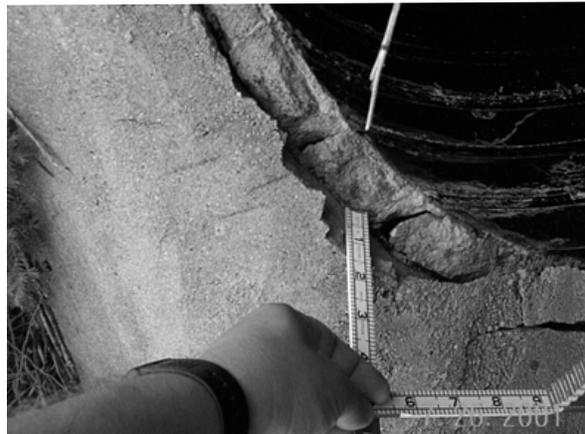
Figure 47

Movement of liner or headwall at inlet end.

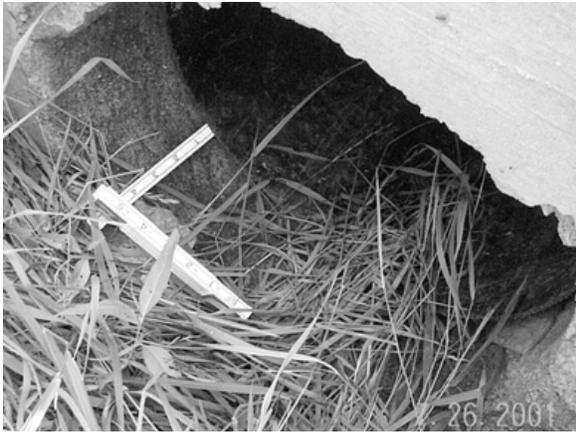
Figure 54

Measurement of slippage at the upstream side of the west culvert.

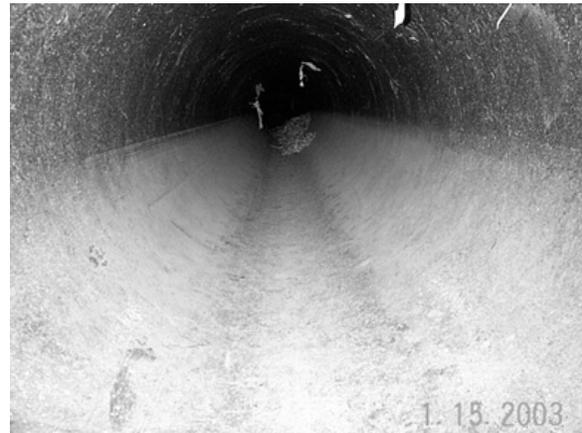
Figure 57

The opposite opening was slightly visible from the upstream end) in 2000 but was not visible in 2003.

Of greater concern is that the fill above the culvert appears to have settled in the intervening years causing cracks in the overlying road. This could indicate additional loss of material in the unlined portion of the culvert.

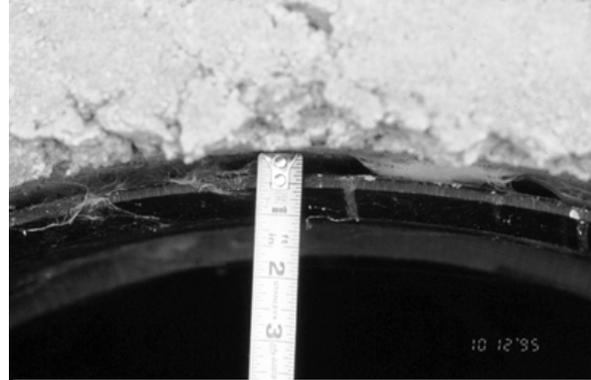
Figure 59
 Gap between the liner and the edge of the headwall.

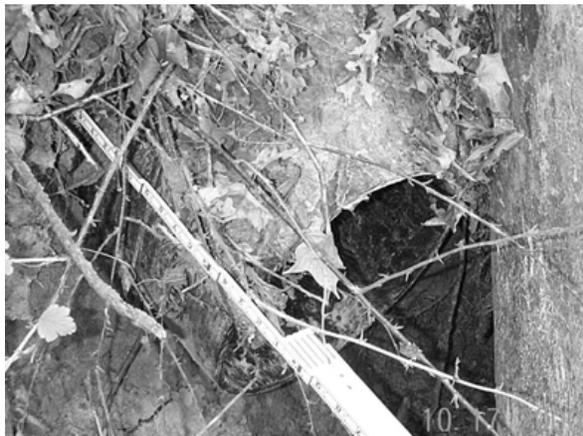
As of this writing, the slip liner has been performing well. There was no sign deformation from the grouting other than a slight curve downward at the downstream end of the liner. The liner does not appear to have moved since installation, but with no headwalls this is difficult to determine.

Figure 63
West end of lined culvert after about six years.

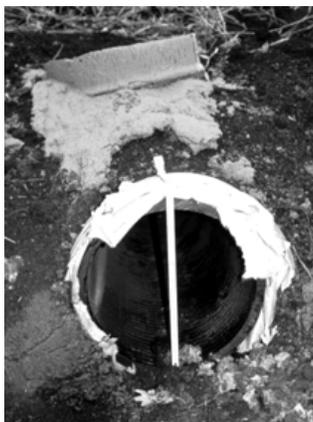
Figure 69

Inlet end of lined culvert. The annulus was blocked for grouting with fiberglass fabric. Note the funnel above the liner. It was the same design as the first Mahaska project.

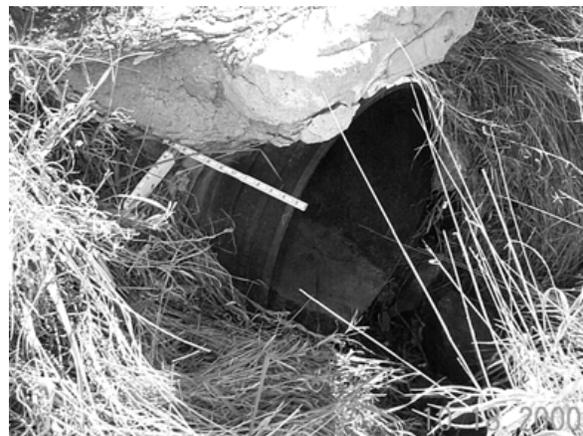
Figure 68

over the top of the liner. The mass on the west end of the liner eventually broke off. Nonetheless, measurement was still possible

Grout covering on the downstream side after several years of erosion of the slope around it. This piece subsequently broke off and rests in the ditch below.

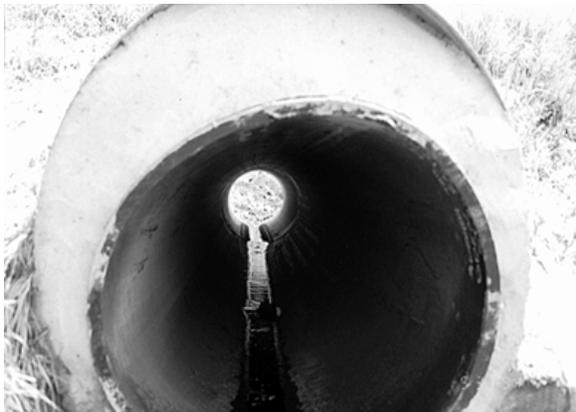
Figure 74

View through the lined culvert showing no deformations.

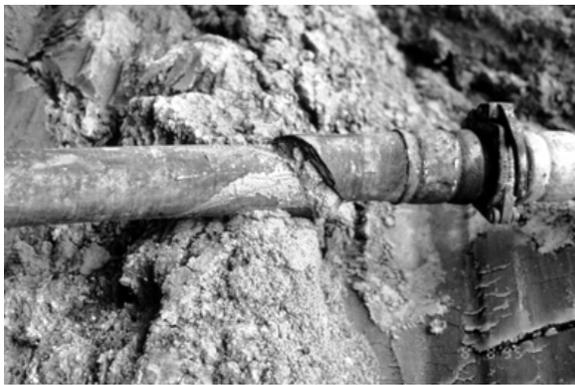
Figure 82
This is what happens if the pumping is stopped to wait for a second ready-mix truck.

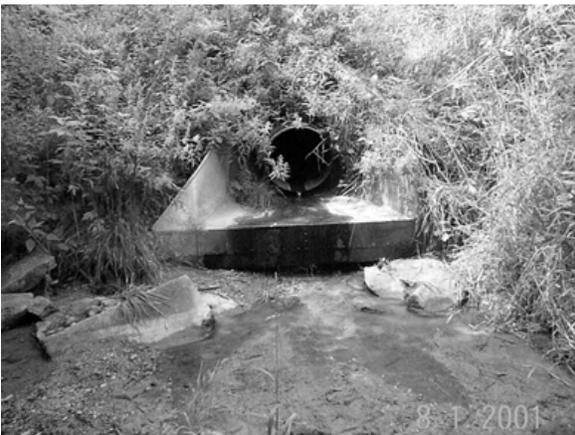
Figure 84
This is the outlet of the lined culvert after about six years. The headwall for this end was constructed from metal instead of concrete.
