## ASSESSMENT OF WEATHERING STEEL BRIDGE PERFORMANCE IN IOWA AND DEVELOPMENT OF INSPECTION AND MAINTENANCE TECHNIQUES

**Final Report**  
**SPR 90-00-RB17-012**  
February 21, 2013  
WJE No. 2011.1671

*Sponsored by:*  
**Iowa Department of Transportation**  
**Office of Bridges and Structures**  
**800 Lincoln Way**  
**Ames, IA 50010**

*Prepared by:*  
**Wiss, Janney, Elstner Associates, Inc.**  
330 Pflingsten Road  
Northbrook, Illinois 60062  
847.272.7400 tel | 847.291.4813 fax

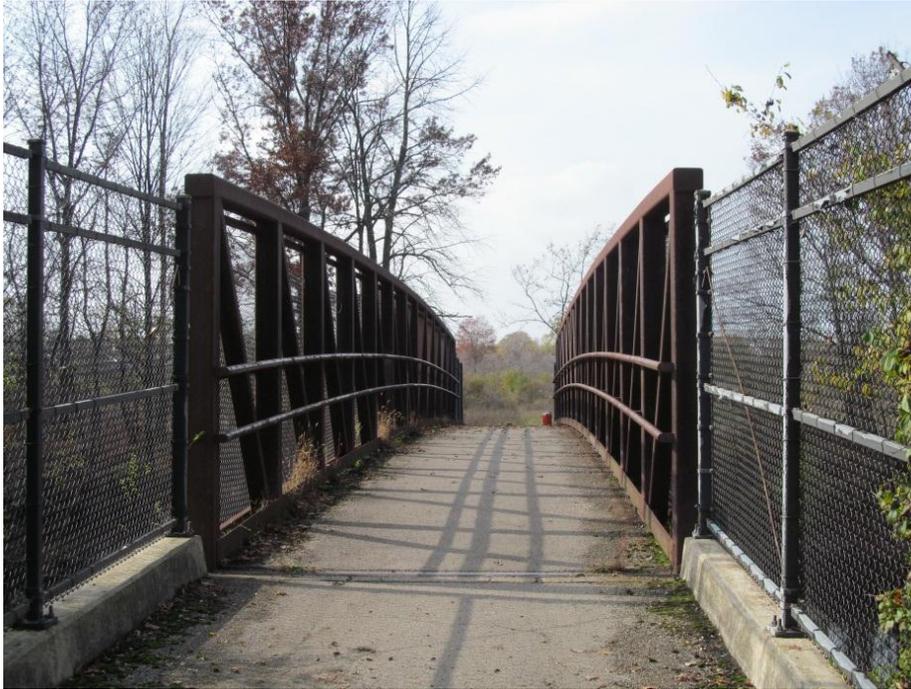
WJE also made notable observations during the inspection of a pedestrian bridge over the Des Plaines River located on an unpaved trail in a forest preserve. Figure 6 shows its general arrangement and environment. Though considerably older than the other local structures observed (aerial photographic records indicate the structure predates 1993), a combination of proper detailing and no salt exposure promoted excellent patina development and long-term performance of this truss bridge. A close-up photograph of a typical area of patina is shown in Figure 7.

*Figure 6. Pedestrian bridge carrying a trail over the Des Plaines River in an Illinois forest preserve, with no apparent salt exposure.*

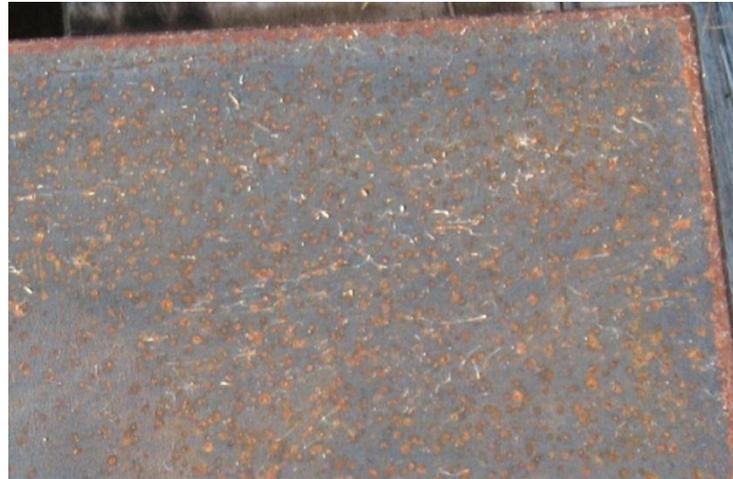
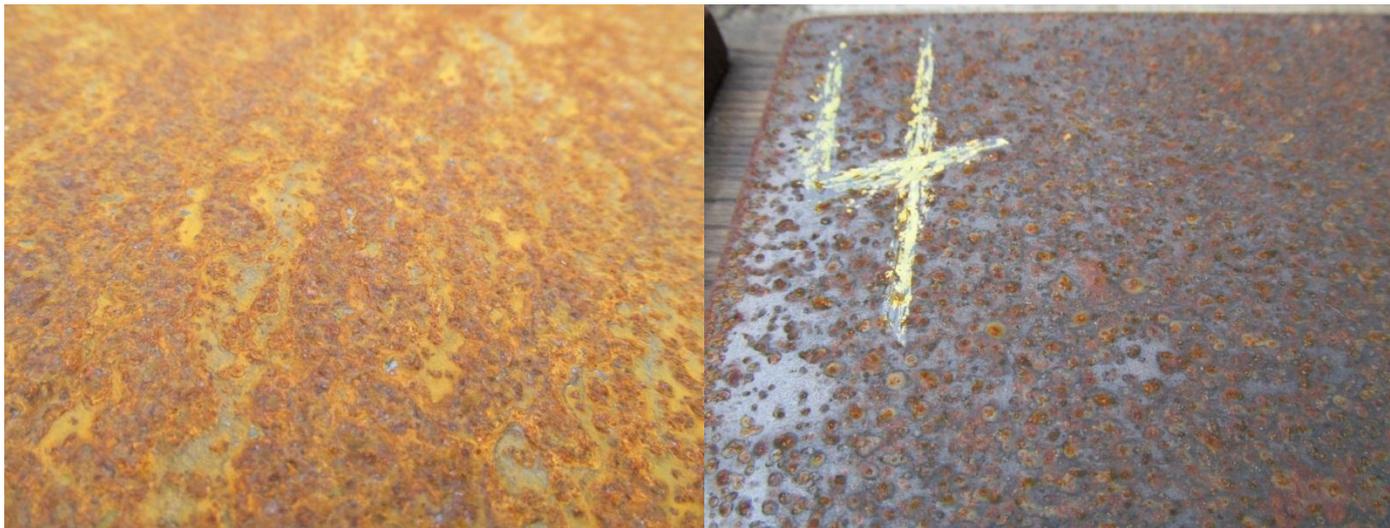
WJE photographed the plates before initiating testing on October 15, 2012 and again on December 7, 2012. In general, the plates exposed only to natural moisture and deionized water showed minor advancement in patina development, but the rust forming on the steel surface did appear to be consistent with good patina performance. In contrast, the heavily salted plates began to exhibit reddish, streaky surface rust formation after only a few spray cycles. This rust progressed more aggressively despite intermittent natural washing by rain and showed beginning signs of distress. At the time of final photographs, 17 days had passed since the last spray application, with several natural wetting cycles in the interim. Figure 8 shows representative conditions of the plates before and after testing.

*Figure 8. Close-up photos of plate condition before testing (top center), after salt spray (bottom left), and after deionized water spray (bottom right).*

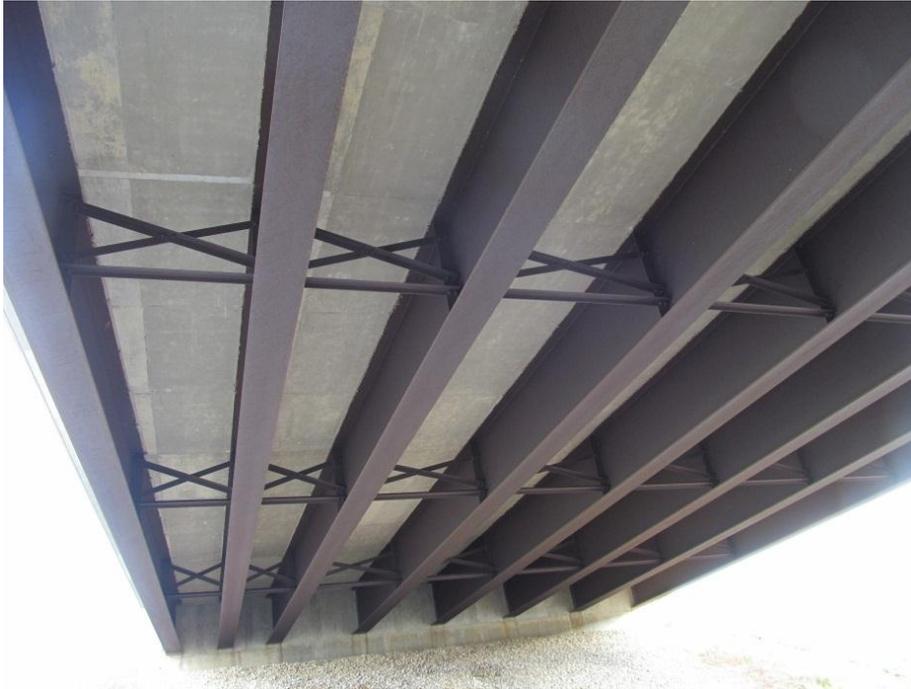
*Figure 10. Typical framing for weathering steel bridges in Iowa, note narrow flange width, minimal use of transverse stiffeners, and lack of longitudinal stiffeners and bottom flange lateral bracing.*

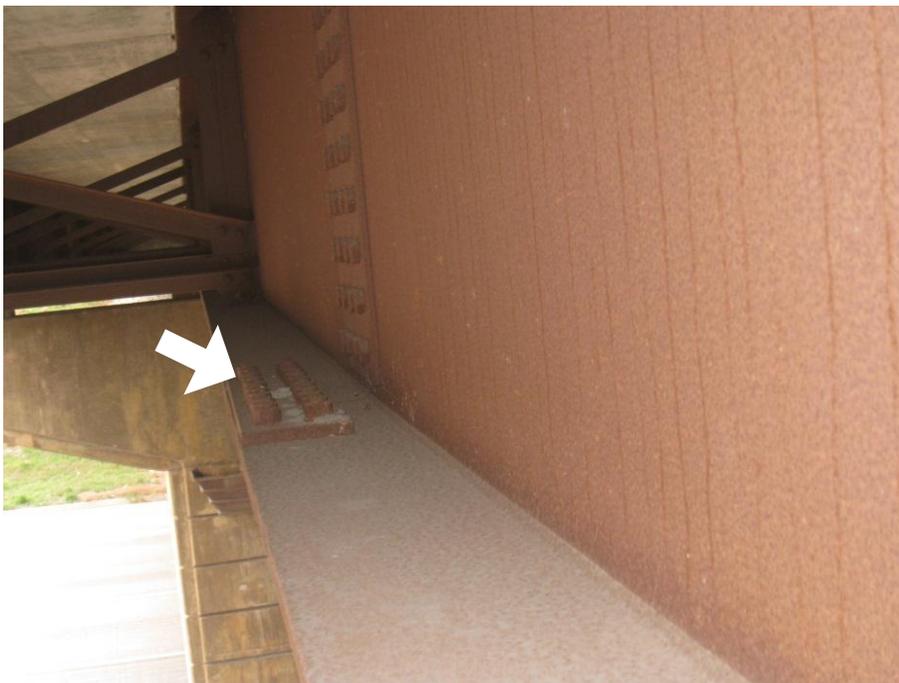
*Figure 11. Typical detailing for weathering steel bridges in Iowa, note the narrow flange splice plate that prevents ponding water at the leading edge.*

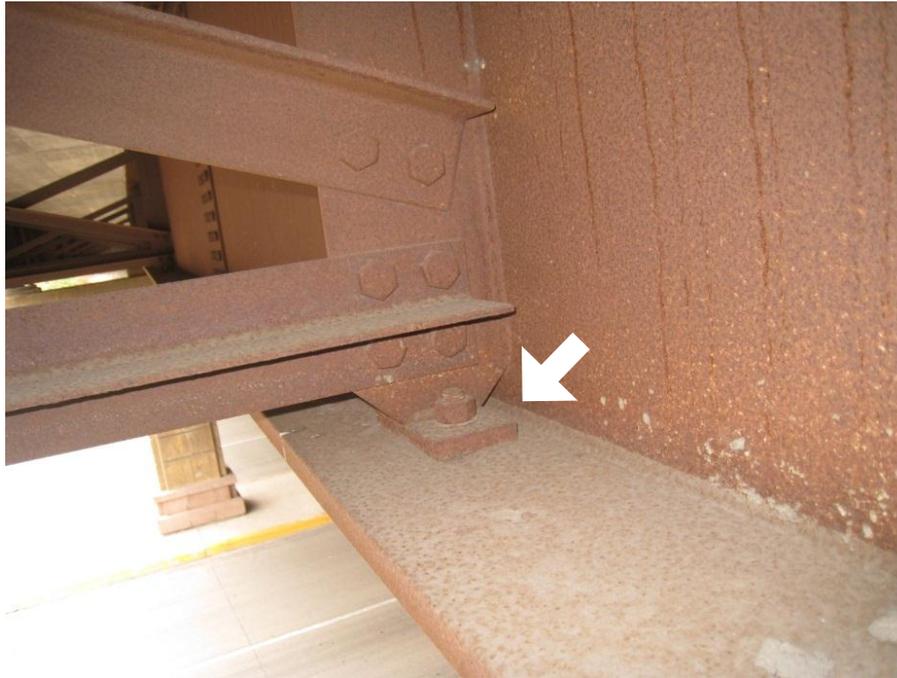
*Figure 12. Typical detailing for weathering steel bridges in Iowa, note the coped stiffener that allows water to pass.*

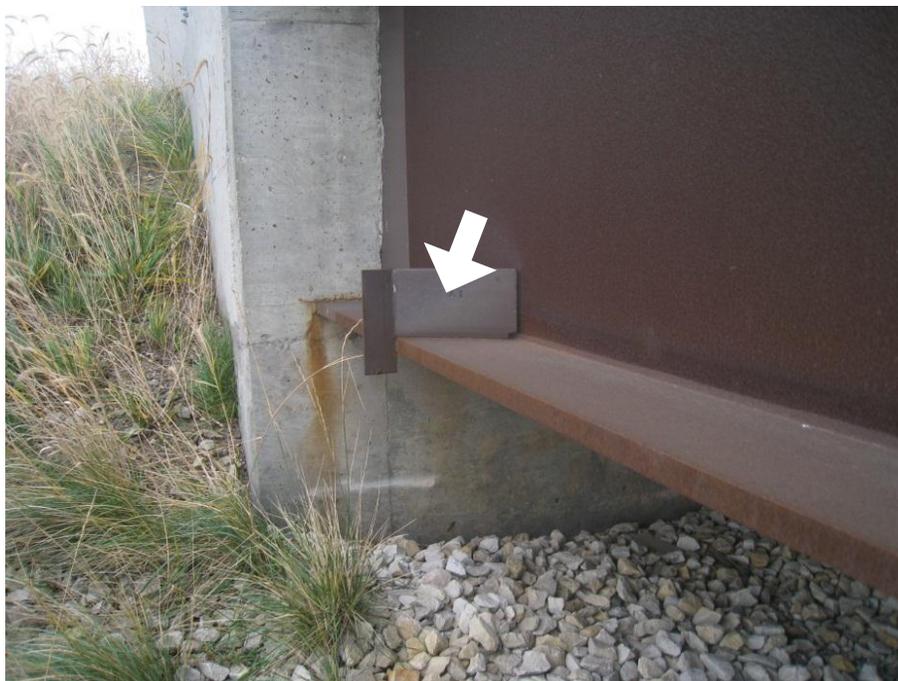
*Figure 13. Typical detailing for weathering steel bridges in Iowa, note the water diversion plate (arrow), the painted ends of the girder, and the use of integral abutments.*

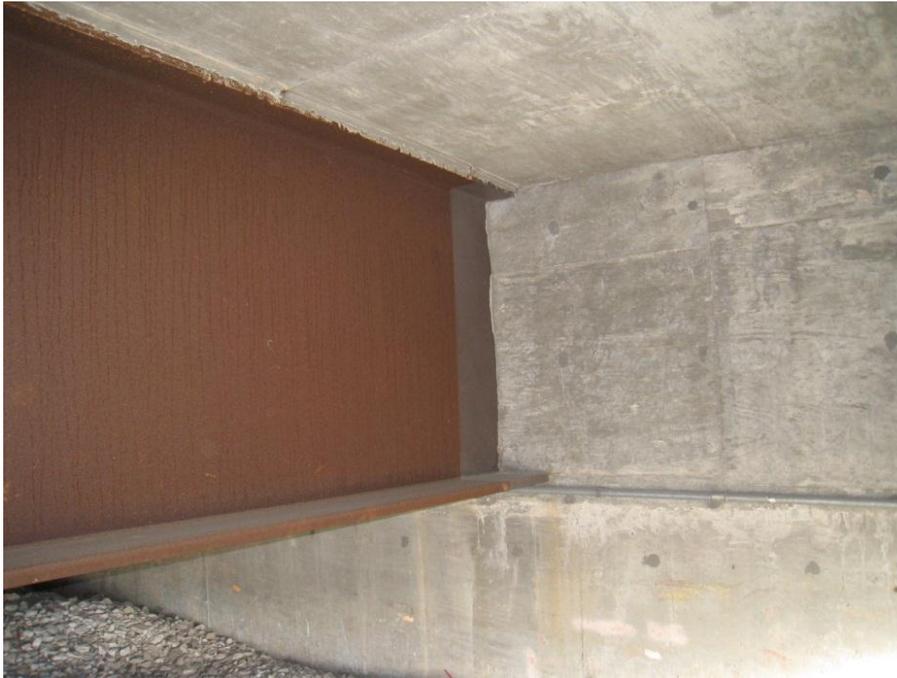
*Figure 14. Typical detailing for weathering steel bridges in Iowa, note the use of integral abutments and the painted ends of the girder.*

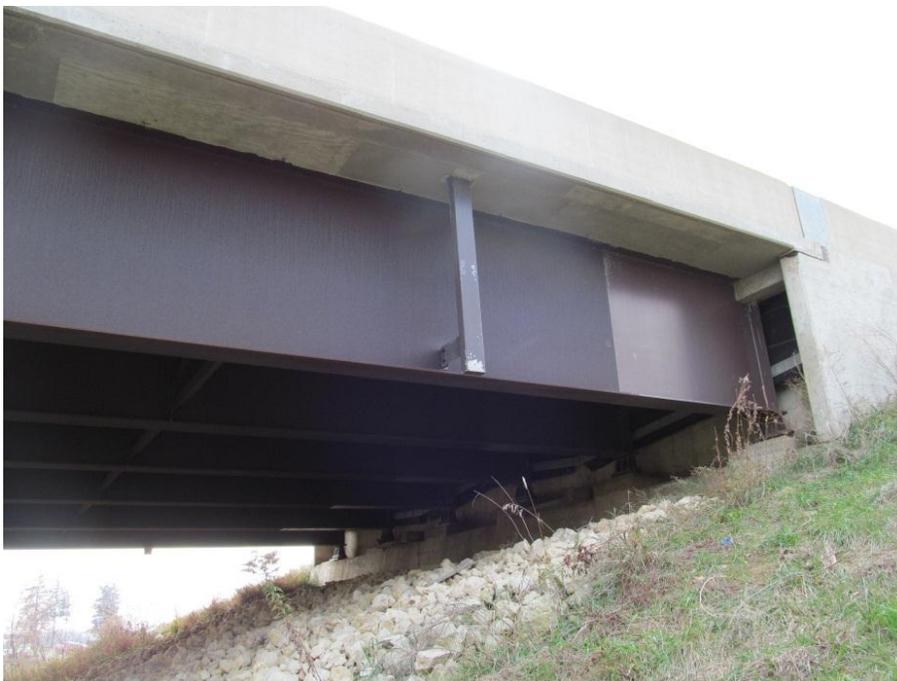
*Figure 15. Typical detailing for weathering steel bridges in Iowa, note the painted ends of the girder.*

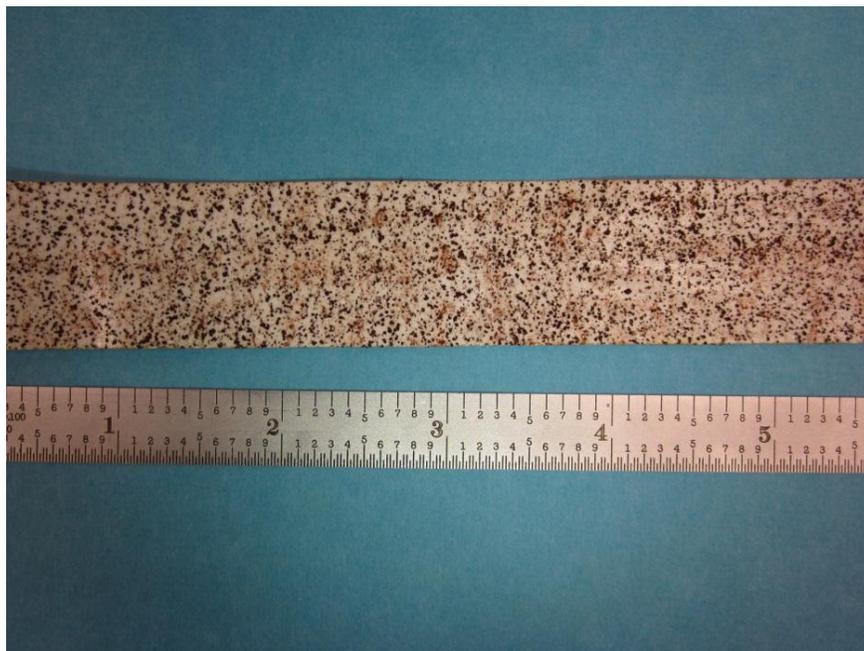
*Figure 23. Category 5 tape test sample; note fine reddish rust phase particulates interspersed with more typical dark brown patina flakes.*

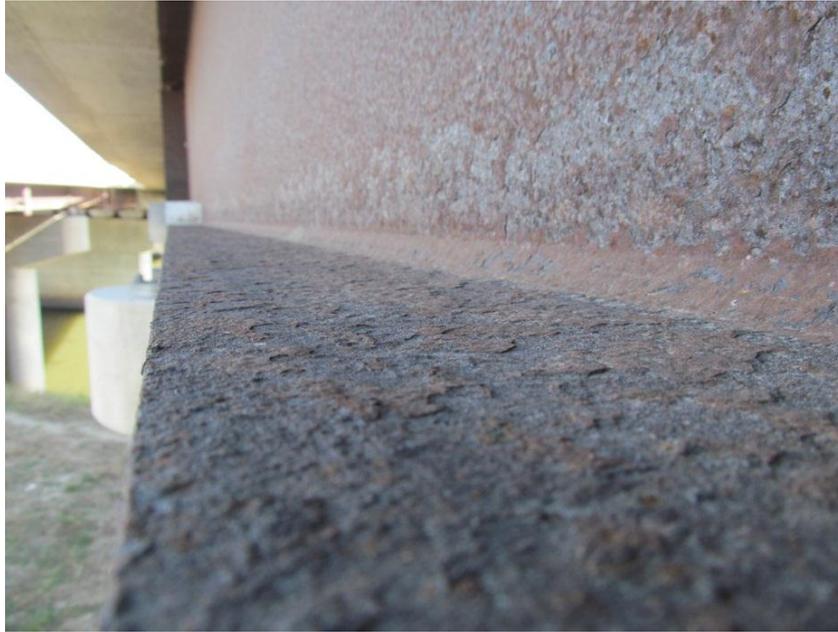
Also of interest are tape tests of a fascia girder from an eastbound on-ramp adjacent to the I-235 Bridge over the Des Moines River, Structure 7708.5A235. The ramp crosses a minor access road parallel to the riverfront. The tape adhesion tests performed on the ramp fascia girder adjacent to the I-235 mainline structure suggest that heavy salt spray from the adjacent interstate caused significant deterioration of the exterior face of the fascia web and bottom flange. The middle portion of the exterior web fared reasonably well with an index of 3, but the patina was increasingly distressed as we examined lower on the girder, as shown in Figure 28. The bottom of the web, top of the bottom flange, and bottom of the bottom flange rated at indices of 2.5, 2, and 1.5, respectively. This corrosion is concerning given that records indicate

this ramp structure was constructed in 2003; however, the damage was limited to a relatively short portion of the bridge where chloride-contaminated snow from plows on the I-235 mainline is deposited onto the ramp fascia girder. At other locations along the girder, the curvature of the ramp brought the exposed fascia surface out of range of direct snow or close enough to the mainline structure that the concrete deck shielded the girder from direct snow, as shown in Figure 29. The interior faces of the fascia girder were in considerably better condition, with an index rating of 3.5. Though some poultrice corrosion was present on the interior bottom flange, the patina was adherent and showed no signs of flaking. This may be an indication that the interior surfaces of the ramp have a relatively short time of wetness each year since they see little moisture from the low-speed, minor traffic below.

*Figure 28. Fascia girder of I-235 eastbound on-ramp at 2nd Avenue. Note transition from Category 3 patina at mid-height of the web to Category 2 at the top of the bottom flange in areas subjected to direct salt spray from the I-235 mainline.*

Once a patina evaluation is made at the typical locations recommended above, WJE recommends performing patina evaluations at specific known areas of poor patina performance, potential problem areas of the bridge, or other unique locations. For example, potential problem areas could include leaking deck joints, areas with visible salt staining, low points in the bridge slope, the vicinity of drainage scuppers, and/or poultice layers or chalking on the top of the bottom flange and other horizontal surfaces. Unique locations on a bridge structure may include areas below cracks in the concrete deck that are exposed to chloride contaminated water (Figure 35) or fascia girders that are subjected to direct snow/salt spray from an adjacent roadway (Figures 28 and 29).

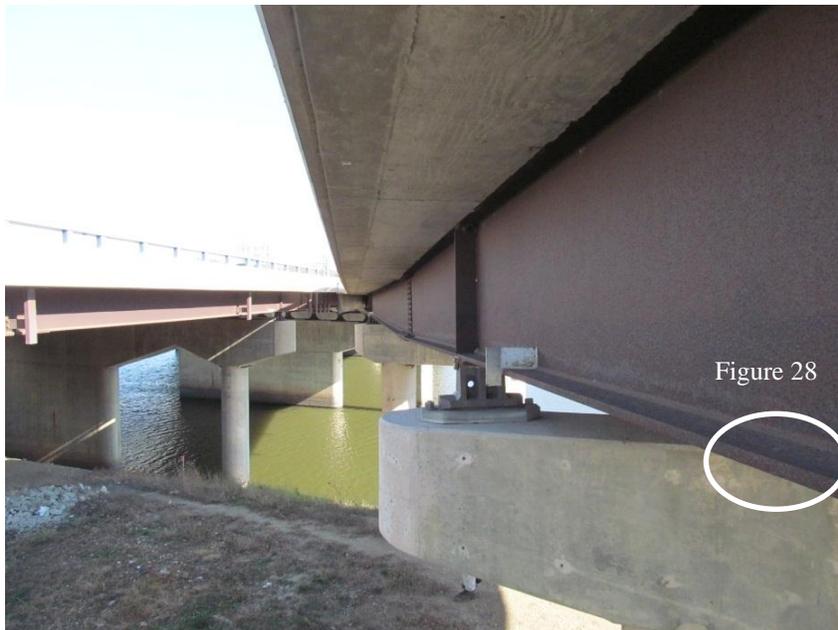
*Figure 29. Overall view of I-235 eastbound mainline (left) and on-ramp at 2nd Avenue (right). Note that the portion of the on-ramp fascia girder subjected to salt spray depends on the distance from the mainline structure. As the structures come closer together, the fascia girder is shielded by the deck.*

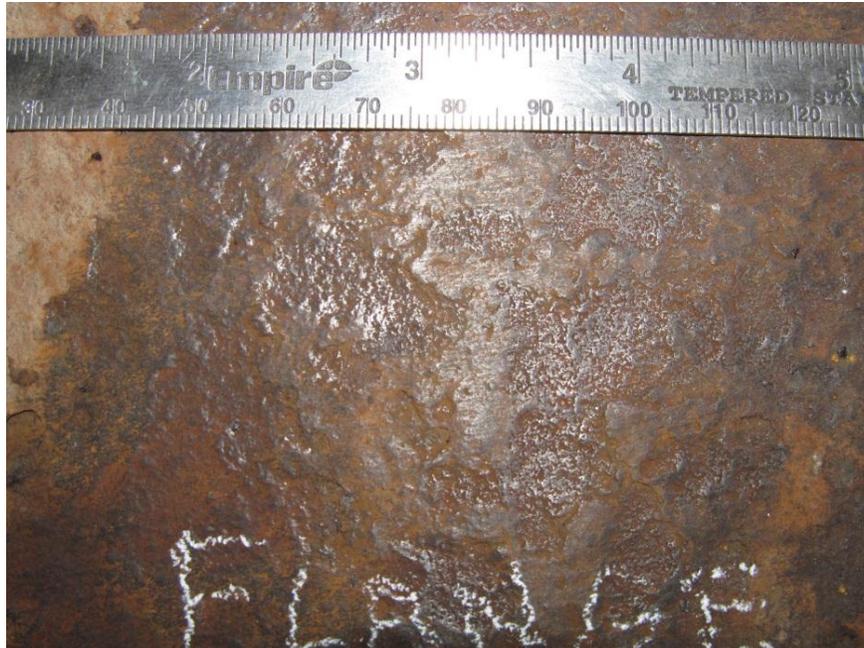
Figure 33. Close-up photo of steel on top surface of girder bottom flange after wire wheel grinding at Field Selection 3; delaminated patina removed down to bare steel with oxide layer remaining in pitted areas.

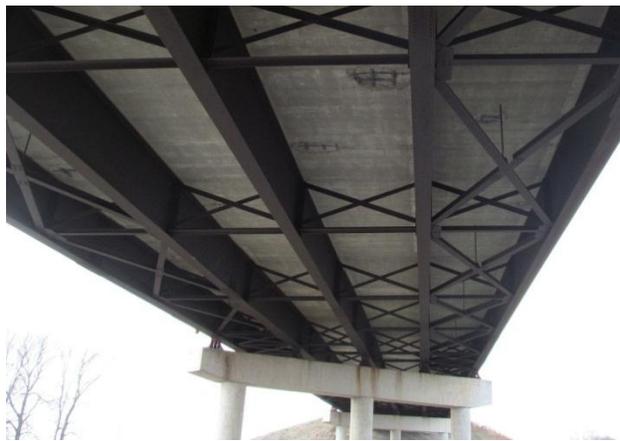
*Figure 1. North roadway span showing bracing arrangement and spall locations in the deck.*

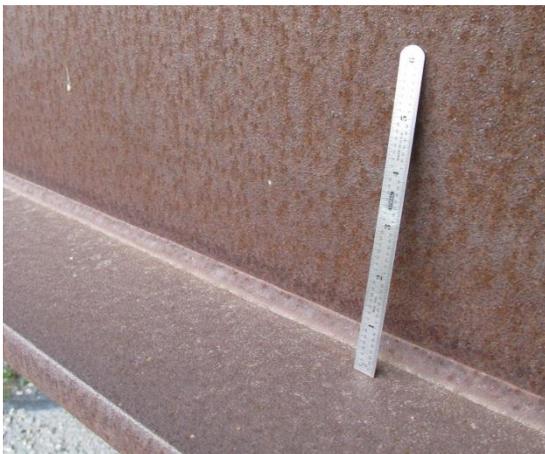
*Figure 5. Excellent patina performance on exterior fascia faces after 40 years, typical of rural bridges.*

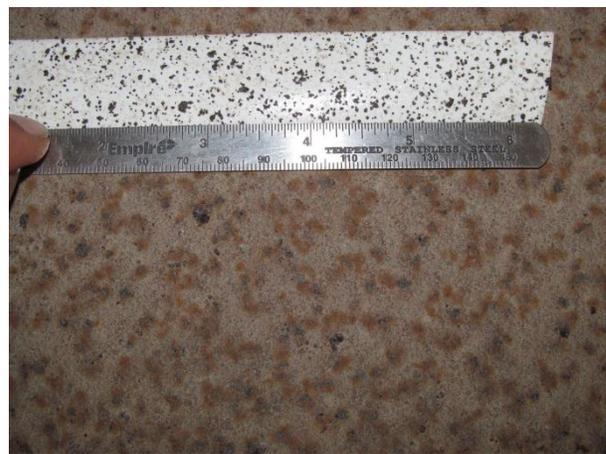
*Figure 6. Non-flaky poultice over traffic, typical of narrow rural bridges.*

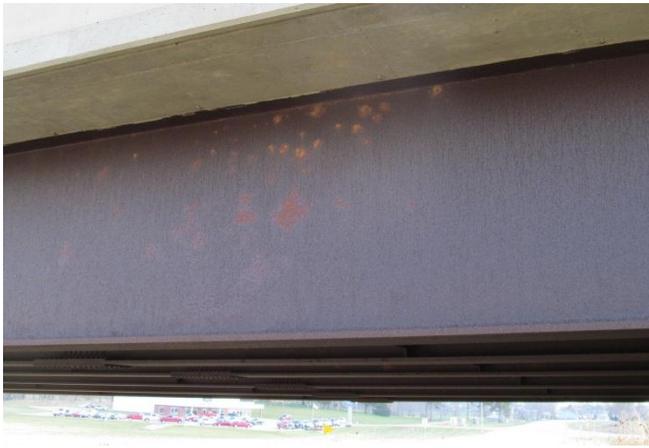
*Figure 1. Patina discoloration on west fascia of northbound bridge, possibly due to mill scale (Index = 5 locally in these areas).*

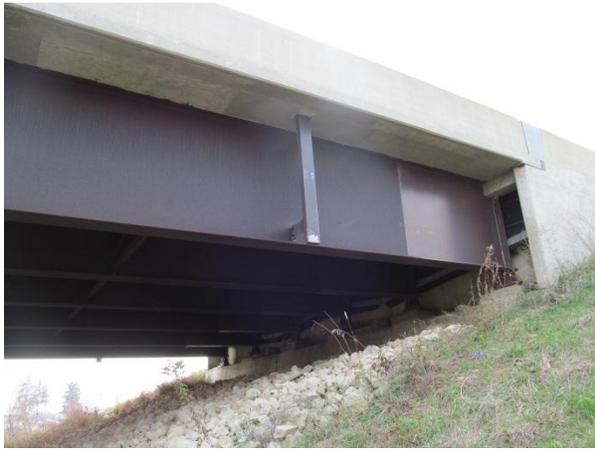
Figure 1. West fascia near south abutment, showing short downspout, painted girder end, and rock apron.

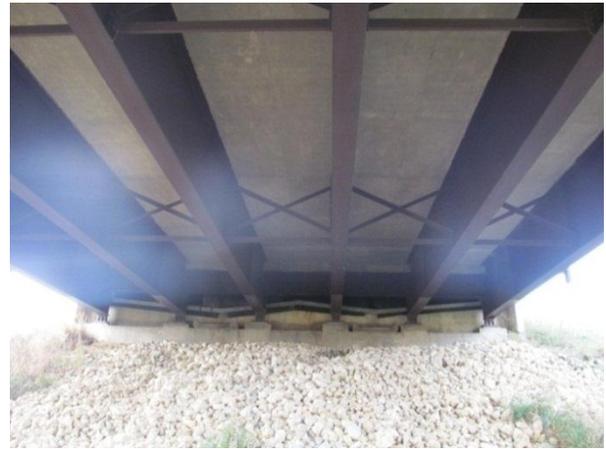
Figure 2. South abutment, showing typical cross-frames and diaphragms detailed to not stain concrete.

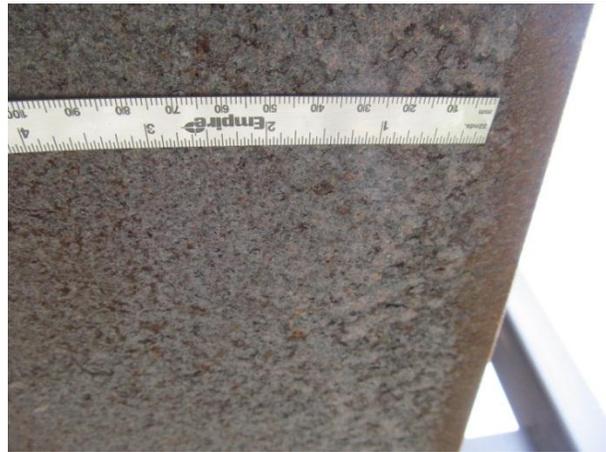
Figure 4. Larger flakes on bottom of fascia bottom flange near downspout by south abutment.

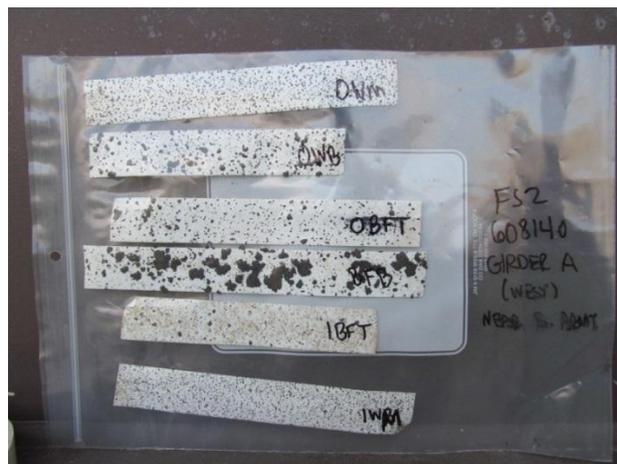
- Visual inspection limited to foot access only since no access road was available.
- Tape, chloride, and color tests taken on exterior and interior surfaces near south abutment; typically little patina variation (Index 4 to 3.5), chlorides measured at 1 ppm or less. No meaningful color data.
- Tape test on west fascia near drain reveals moderate flaking on the bottom of the flange (Index = 2).

Figure 5. Tape test series taken from west fascia girder adjacent to downspout showing large flakes (Index=2) on bottom of bottom flange.

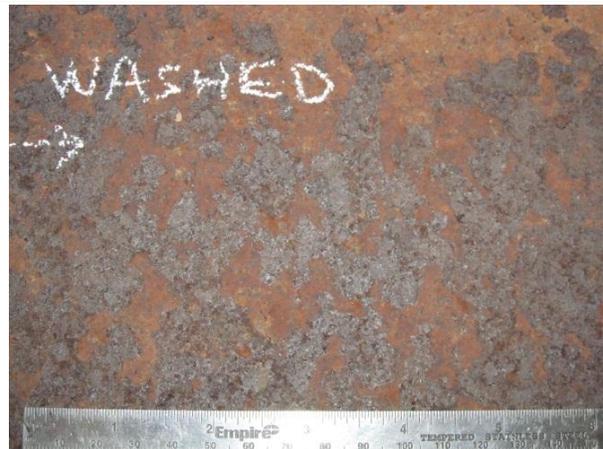
Figure 2. Top of bottom flange after washing; some of poutlice remains, Index = 2, chlorides = 10 ppm.

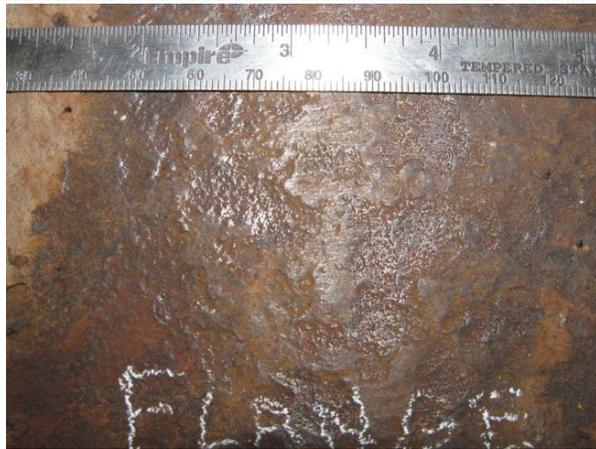
Figure 3. Top of bottom flange ground with wire wheel. Chlorides in ground area before washing = 20 ppm; after washing, 14 ppm extracted by test.

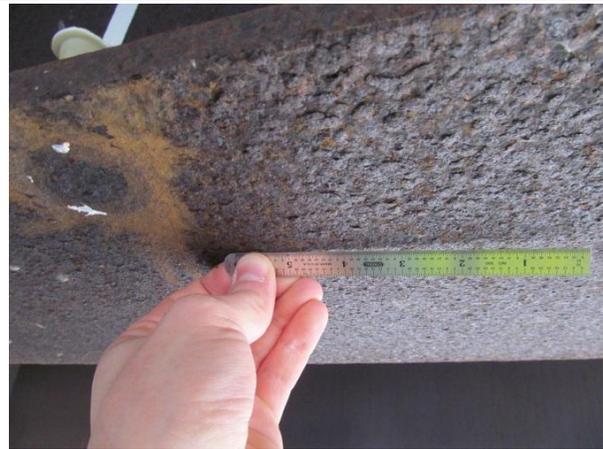
Figure 4. Flaking on bottom of flange near east abutment of 601615; Index = 2. Chlorides at this location measured at 14 ppm.

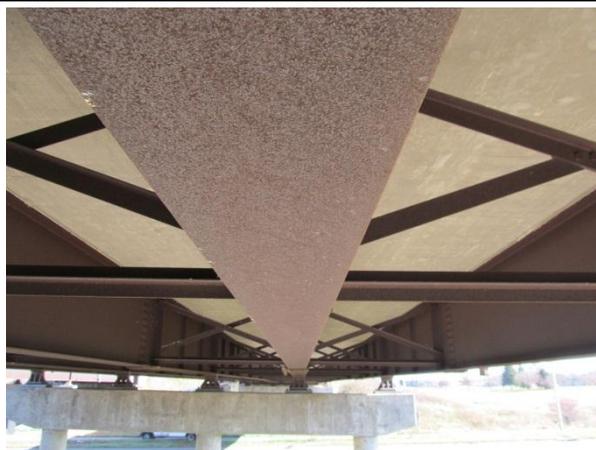
Figure 5. Bottom of flange near west abutment shows less flaking than east side; Index = 3.

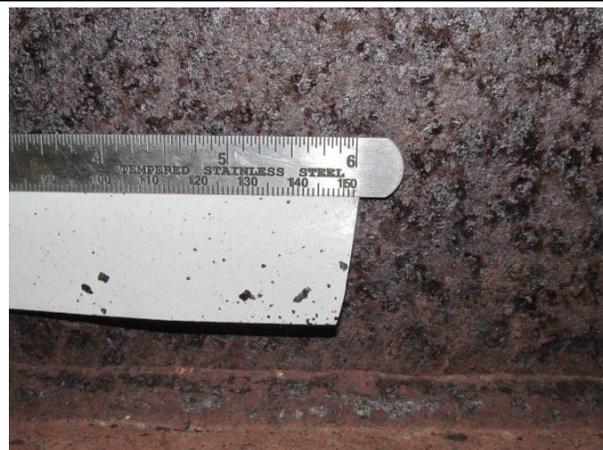
Figure 6. Bottom of web after washing; tape test (sparse, Index = 3) shows improvement in adherence (Index before = 2 with dense coverage).

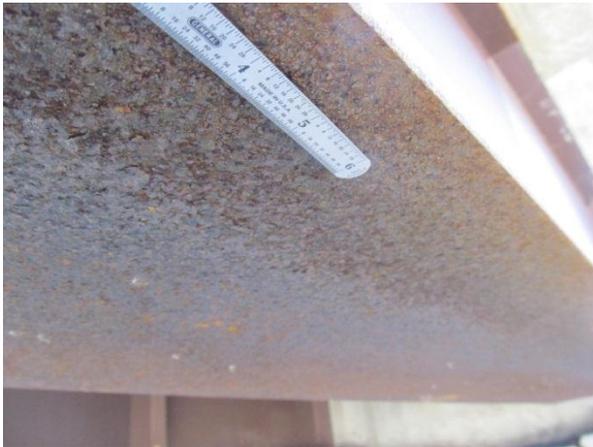
Figure 1. Flakiness of bottom flange near south abutment (Index = 2.5).

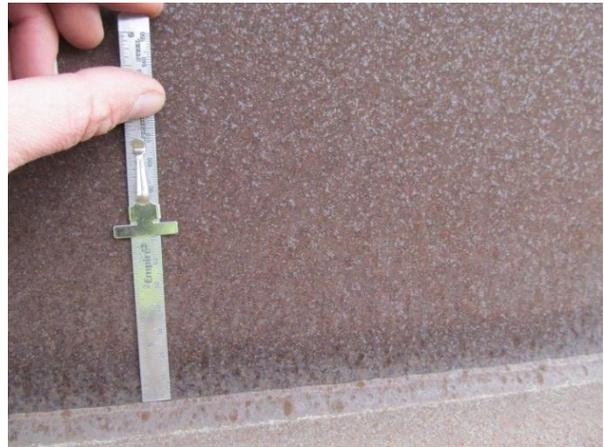
Figure 2. Fascia girder exterior web patina over traffic (Index = 4). Note darker band above weld.

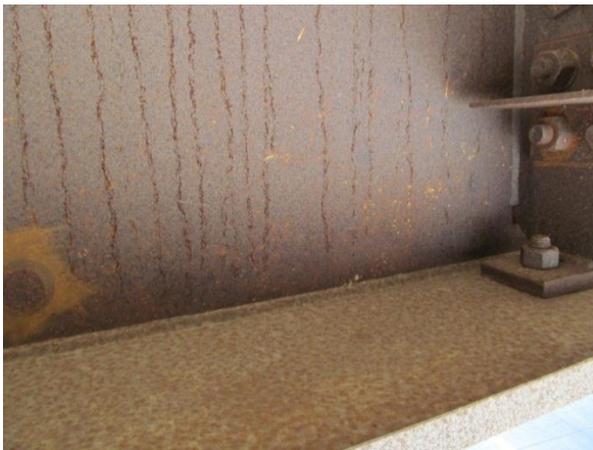
Figure 3. Interior girder over traffic showing pouttice with minimal flaking and reddish web discoloration, possibly due to mill scale.

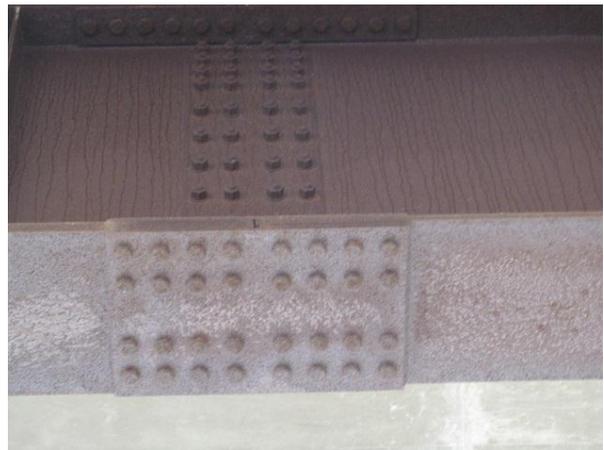
Figure 4. Flaking on and around girder splice.

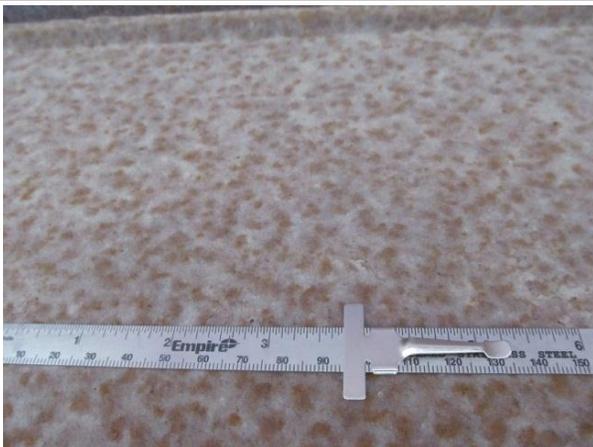
Figure 5. Pouttice on flange before washing.

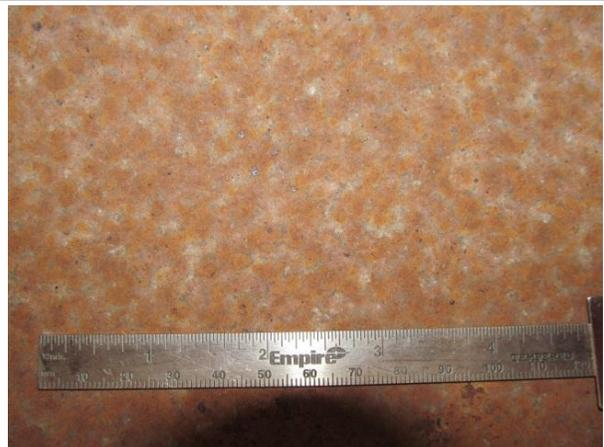
Figure 6. Flange pouttice partially reduced by washing.

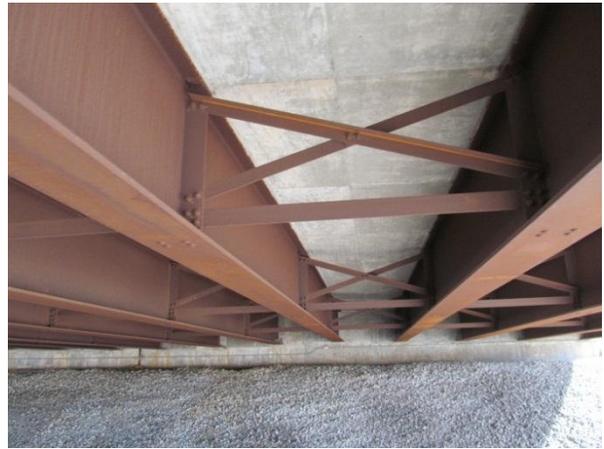
*Figure 2. Some discoloration on bottoms of flanges, but only minor flaking. Conditions near abutment similar to those over traffic.*

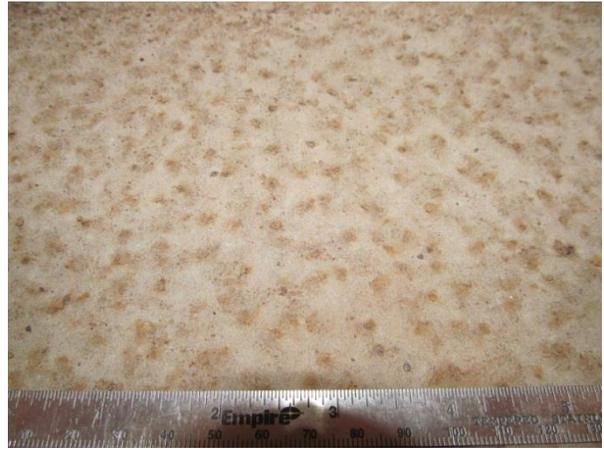
*Figure 4. Heavy flange chalking with only minor flaking (Index = 3).*

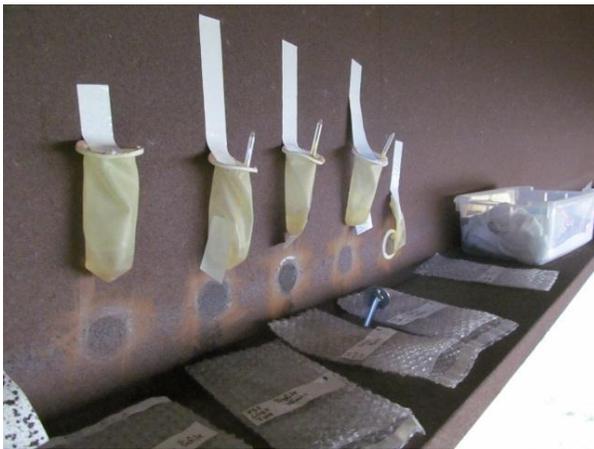
*Figure 5. Chloride test time vs. extraction efficiency profile taken on bottom of interior web (Index = 3).*

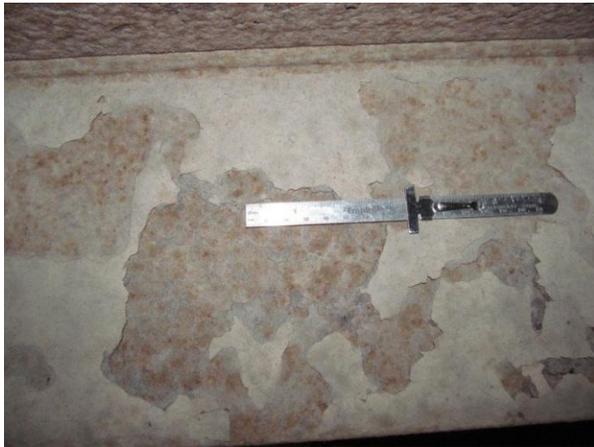
*Figure 1. Heavy poultrice on interior flange with multiple thin layers of delamination forming.*

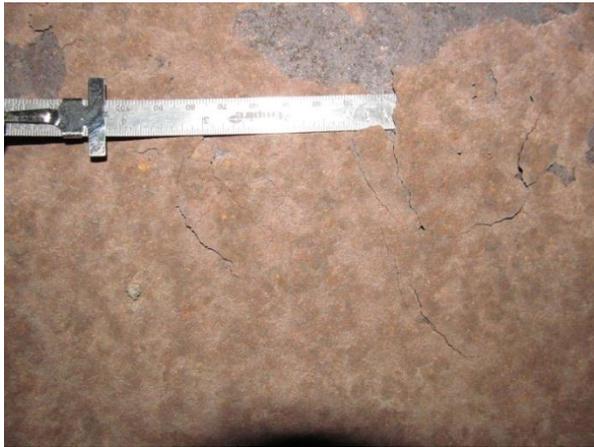
*Figure 3. Close-up of web delamination progressing with scale inserted behind loose flake*

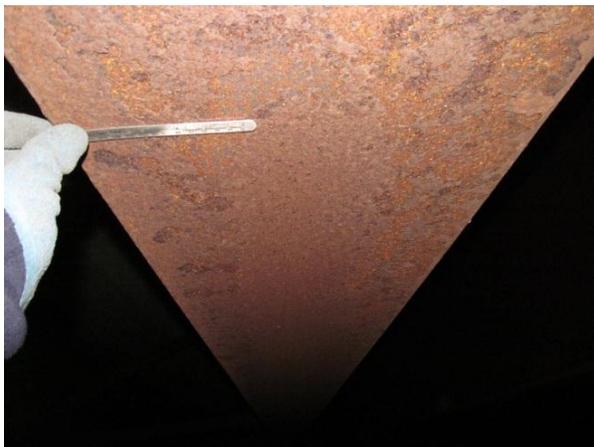
*Figure 5. Flaking and small delaminations on bottom of flanges over traffic.*

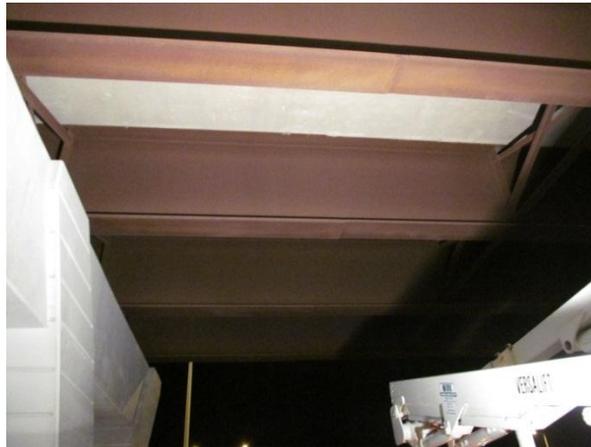
*Figure 1. Bottom flanges exhibiting some mild reddish discoloration and possible flaking near pier over eastbound left shoulder.*

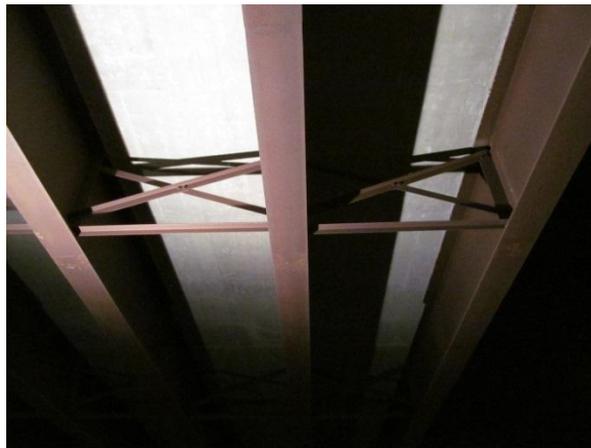
*Figure 2. More distinct spots of local discoloration visible near middle of south span.*

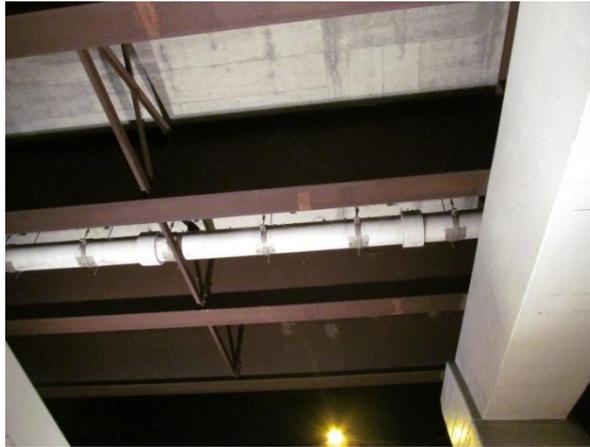
*Figure 2. Rectangular, reddish stains on bottom flanges. Also note grayish staining on interior web of fascia girder beyond. Such stains occasionally noticed throughout Field Selection 7.*

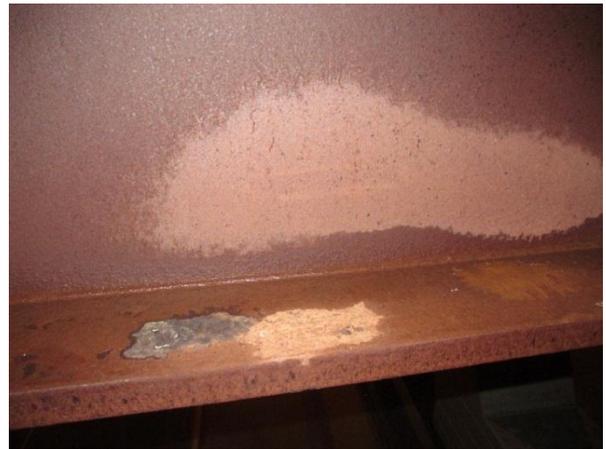
Figure 4. Test area after washing and partial drying: wire wheel area on left, wire brush area on far right.

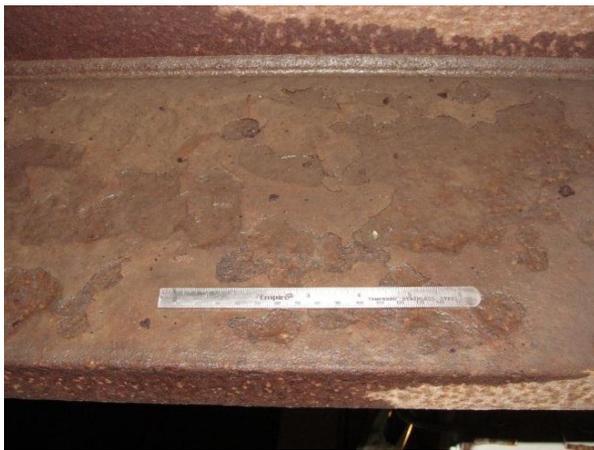
Figure 5. Washing as-is: poultrice reduced, but delamination remains.

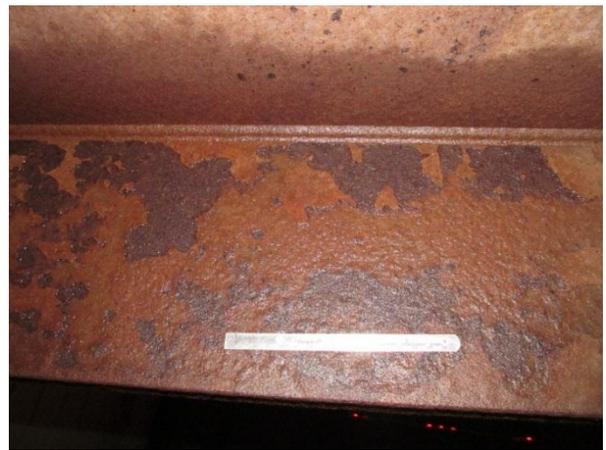
Figure 6. Washing after hand brushing of poultrice: Cleaner, but delaminated patina remains.

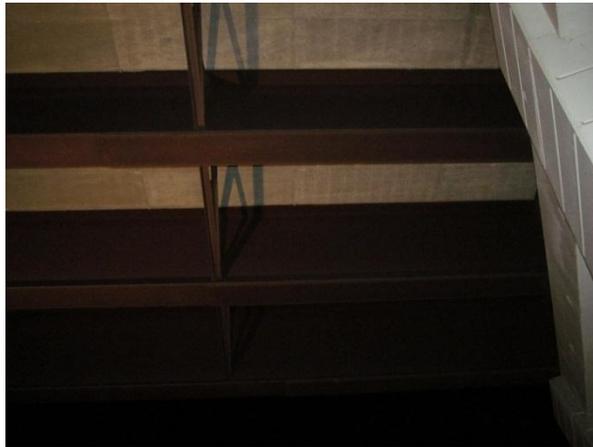
*Figure 1. Patina in good condition on all surfaces visible from ground; here near pier.*

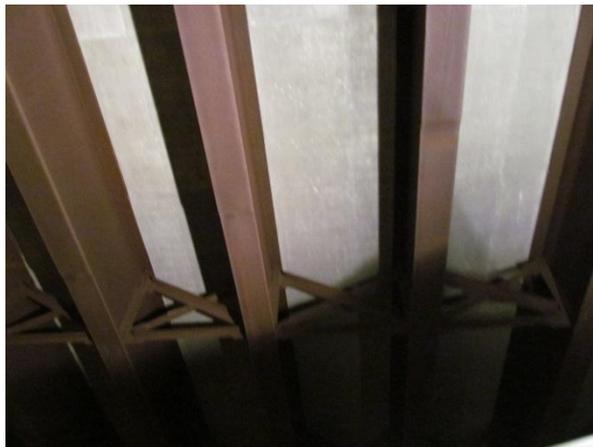
*Figure 2. Uniform, dark patina performing well near mid-span.*

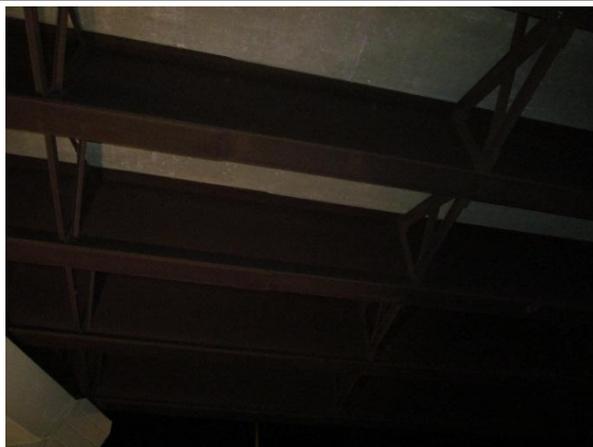
*Figure 3. Some localized blotchy stains and flaking; otherwise patina is uniform when viewed from the ground.*

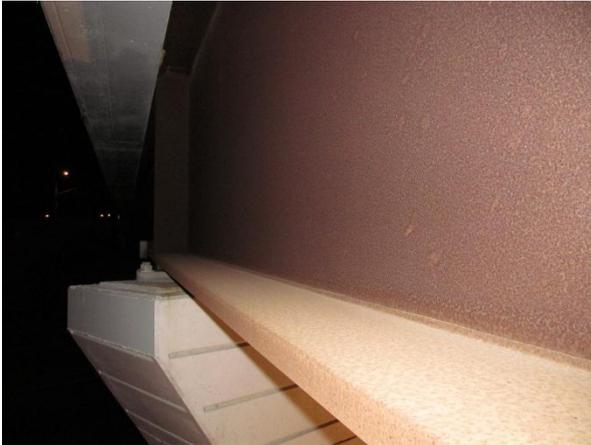
Figure 1. Index = 3.5 to 3 patina on exterior fascia surfaces.

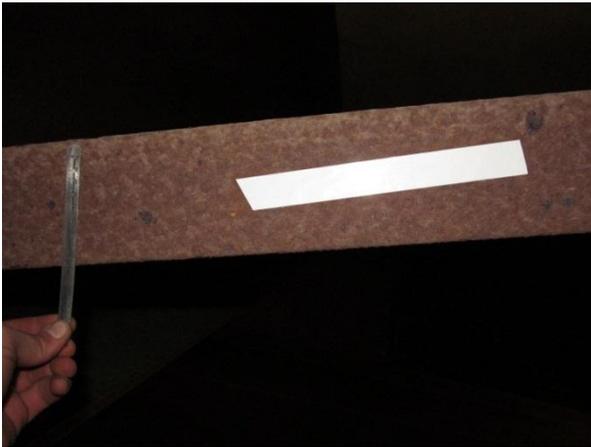
Figure 3. Index = 2 patina on vertical face of cross-brace where tape test conducted.

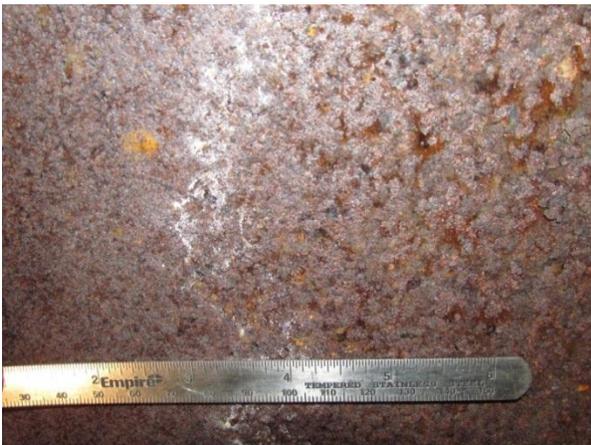
Figure 5. Close-up of discoloration and flaking on bottom flange adjacent to staining, Index = 2.

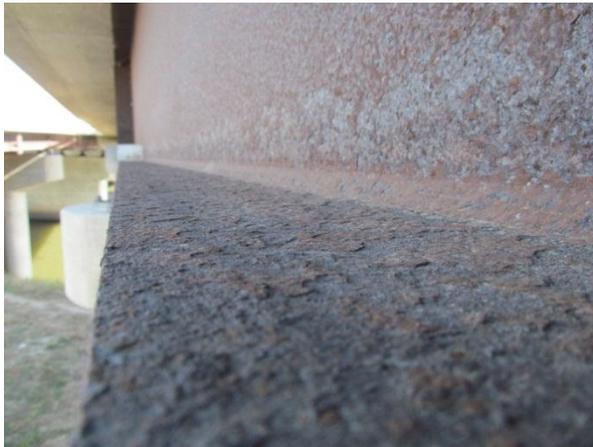
- Overall, patina in excellent condition on all surfaces, both interior and exterior, due to low moisture and salt exposure (Index = 3.5 to 4). Uniform dark brown coloration, except for a few spots of underdeveloped patina.
- Entrance ramp north fascia girder showing signs of distress where it is likely receiving direct snow/salt spray from adjacent I-235 eastbound. Full range from Index 1.5 to 4 present, but in this case typical trends reversed, as exterior fascia surfaces seeing direct spray rapidly deteriorating, while interior surfaces performing well.

*Figure 1. Delamination of top of exterior bottom flange and web of north fascia girder on I-235 eastbound entrance ramp.*

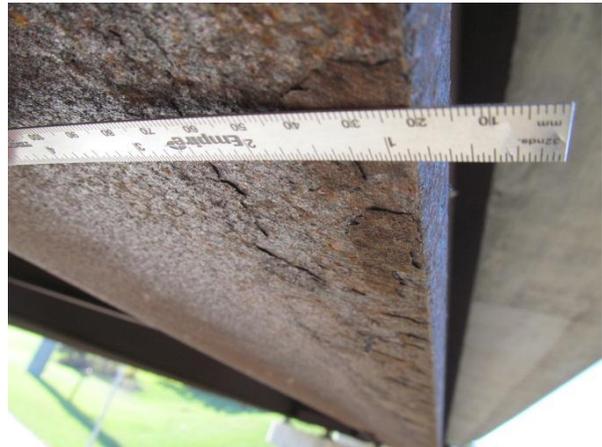
*Figure 2. Bottom of bottom flange delaminations, north fascia girder of entrance ramp.*

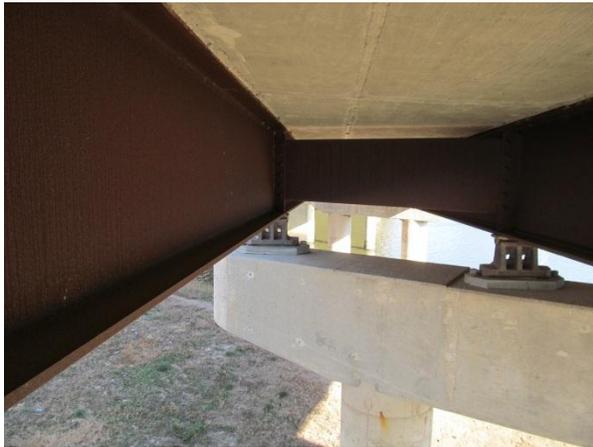
*Figure 3. Interior side of entrance ramp north fascia girder demonstrating good patina performance.*

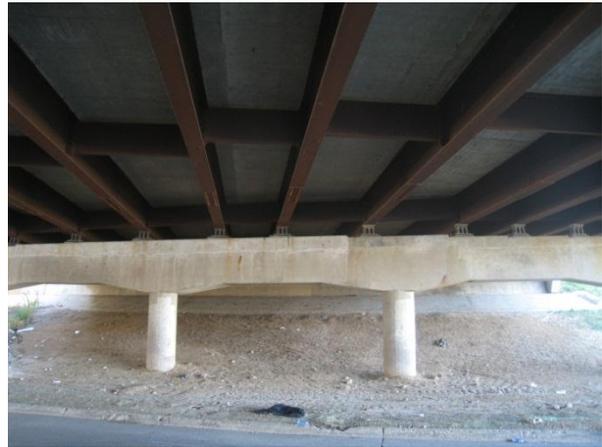
*Figure 4. Interior girders of westbound mainline bridge showing good patina performance.*

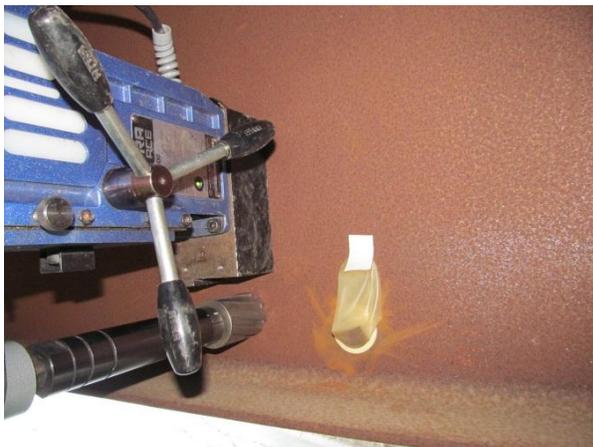
*Figure 5. Magnetic drill coring a channel diaphragm web on westbound I-235 bridge.*

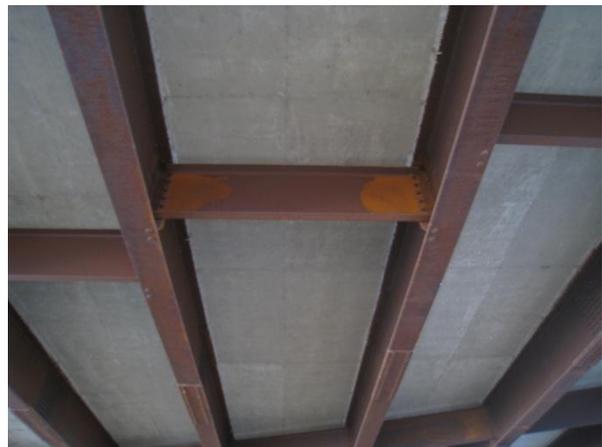
*Figure 6. Areas of underdeveloped patina due to spill during construction or mill scale (Index=5).*

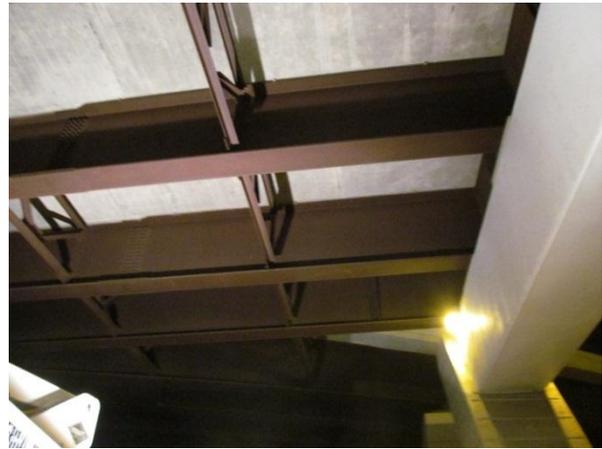
*Figure 2. West half of girders near pier, where ramp comes in (background).*

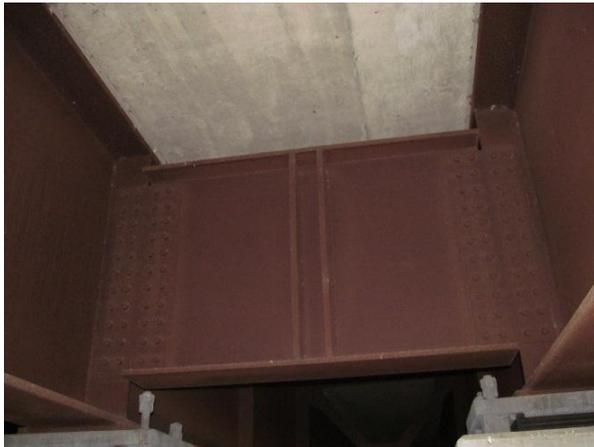
*Figure 3. Stiffened I-beam diaphragm at pier.*
