## ASSESSMENT OF WEATHERING STEEL BRIDGE PERFORMANCE IN IOWA AND DEVELOPMENT OF INSPECTION AND MAINTENANCE TECHNIQUES

**Final Report**  
**SPR 90-00-RB17-012**  
February 21, 2013  
WJE No. 2011.1671

*Sponsored by:*  
**Iowa Department of Transportation**  
**Office of Bridges and Structures**  
**800 Lincoln Way**  
**Ames, IA 50010**

*Prepared by:*  
**Wiss, Janney, Elstner Associates, Inc.**  
330 Pflingsten Road  
Northbrook, Illinois 60062  
847.272.7400 tel | 847.291.4813 fax

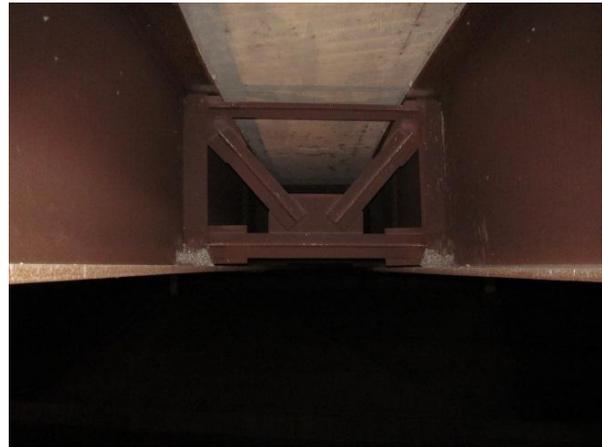
*Figure 4. Typical K-brace cross-frame with bird droppings on girder bottom flanges.*

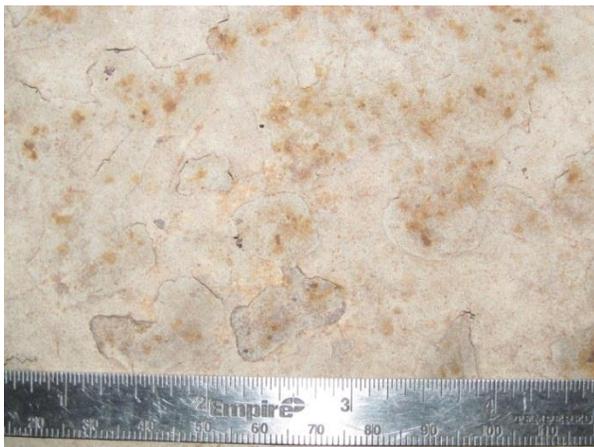
*Figure 5. Delaminating patina with heavy poultrice corrosion on interior girder bottom flange.*

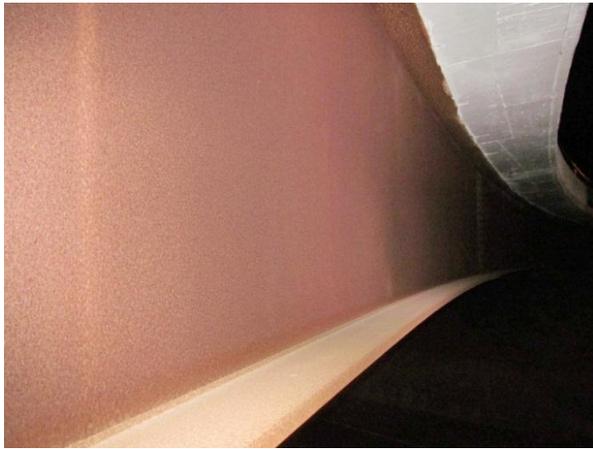
*Figure 1. Excellent patina performance (Index=4) on exterior fascia surfaces.*

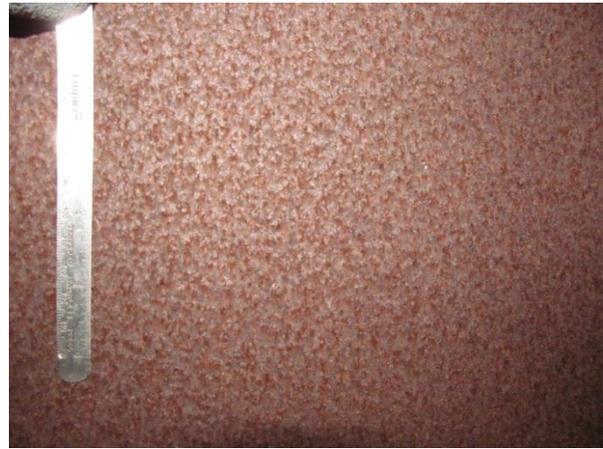
*Figure 2. Close-up of exterior fascia web patina.*

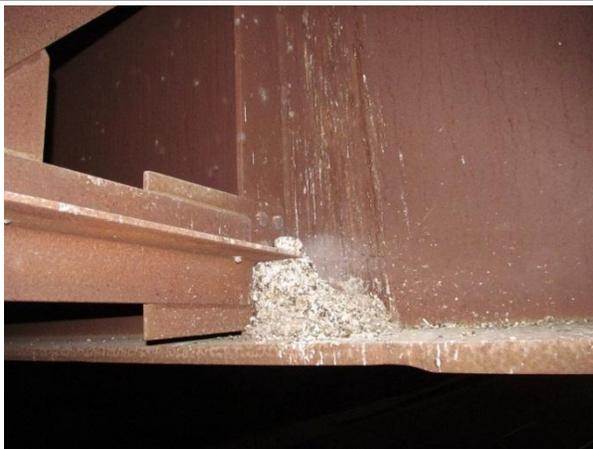
*Figure 5. Bird droppings contributing to poulitice on interior bottom flange.*

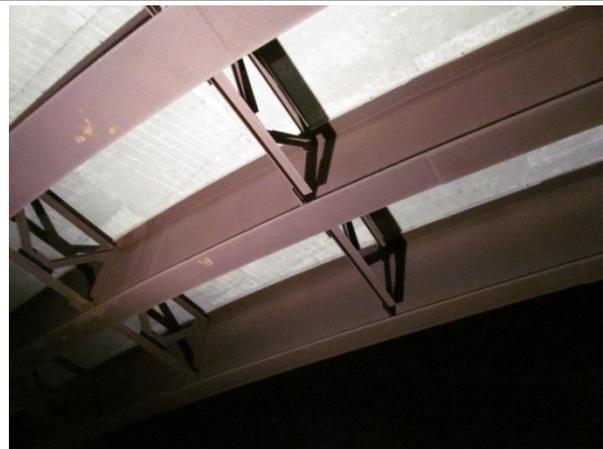
*Figure 6. Some localized discoloration and flaky areas on otherwise good patinas near pier.*

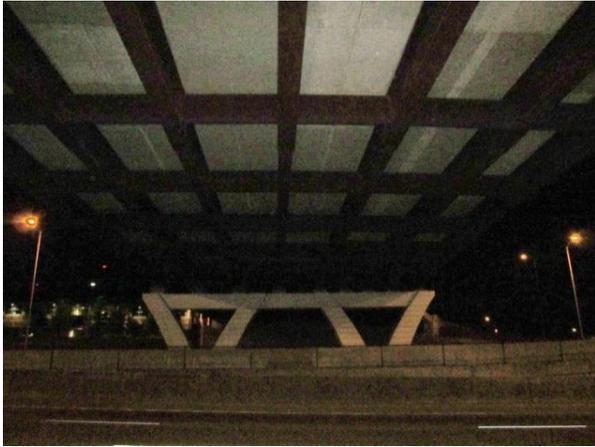
Figure 1. Overall view toward north two spans and north pier.

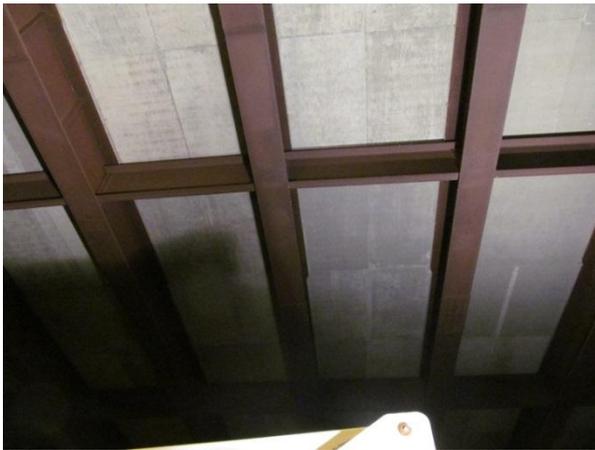
Figure 3. Middle of south span.

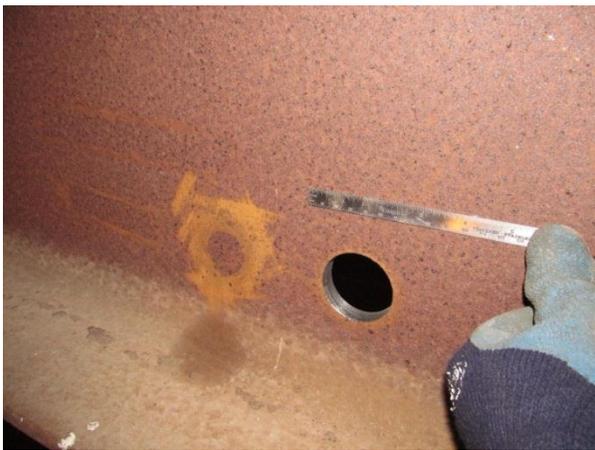
- Visual inspection, including use of aerial lift.
- Core sample taken from bottom of web of interior diaphragm in south span. Other tests conducted here include:
  - Tape test: Index = 3.5, flake size = 0.5 mm to 2 mm, medium density.
  - Chloride test: 6 ppm

Figure 5. Tape and chloride tests also taken adjacent to core.

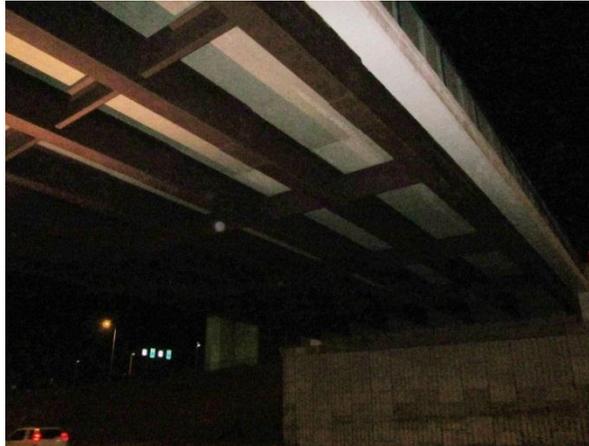
*Figure 1. South span over eastbound I-235. Some staining noted on fascia girder and 1st interior girder over the center lane, but not readily visible in this photo.*

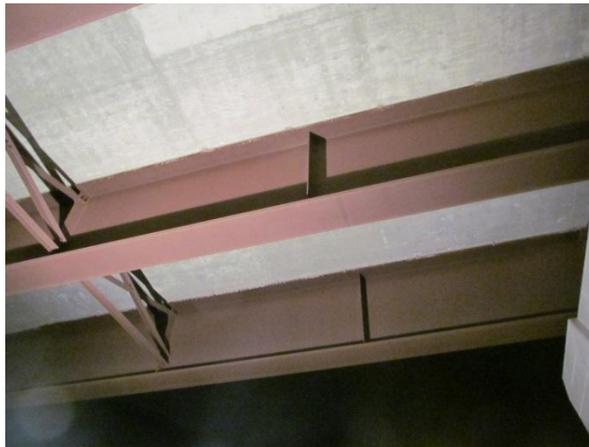
*Figure 2. Girders and cross-frames near center pier; no significant deterioration visible from below.*

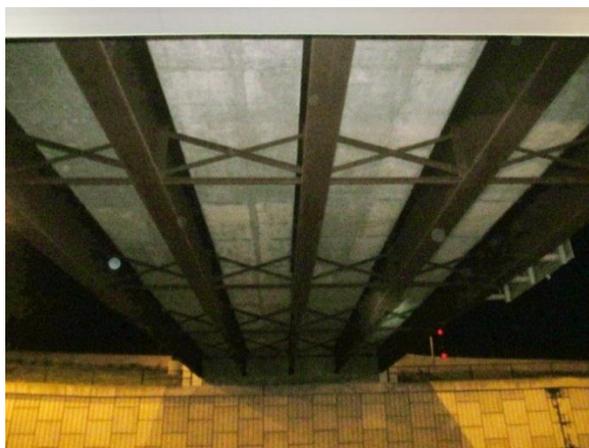
*Figure 3. North span over westbound I-235.*

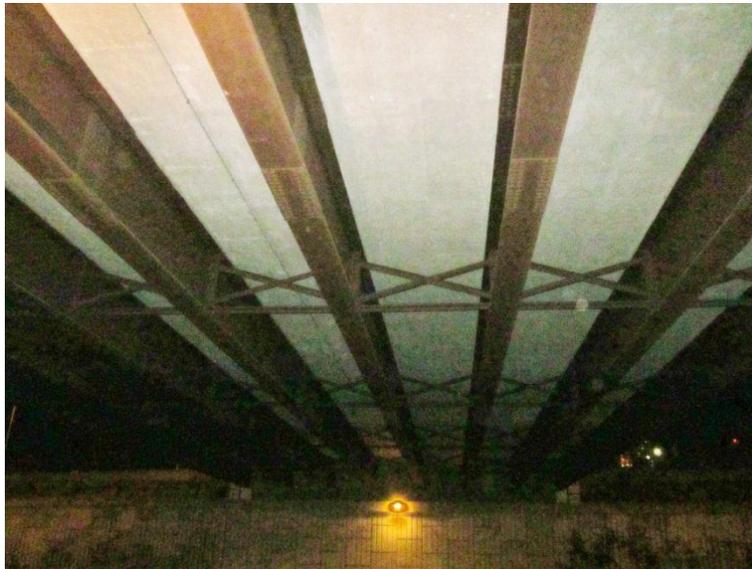
*Figure 2. Overall photo of the second span.*

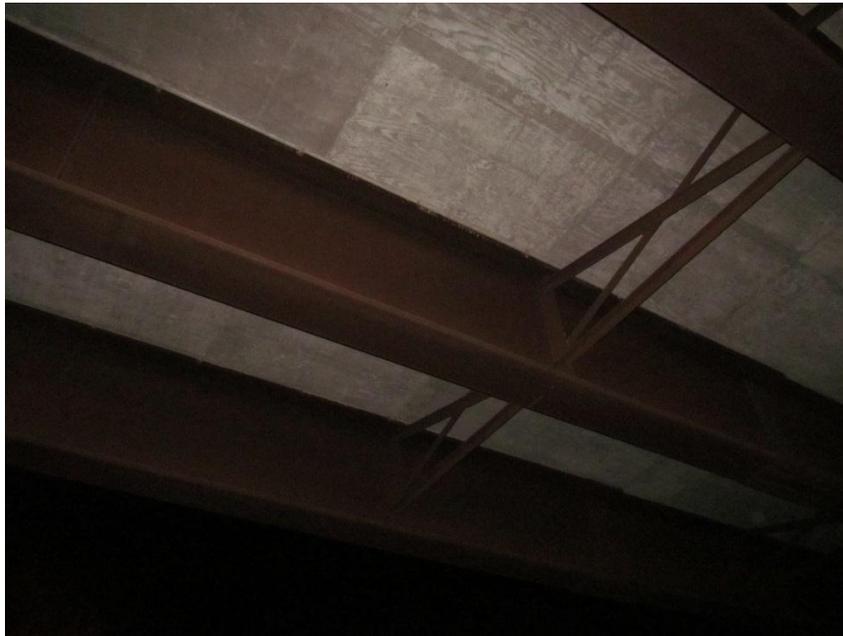
*Figure 1. Girder and cross-frames near mid-span; representative of conditions throughout the structure.*

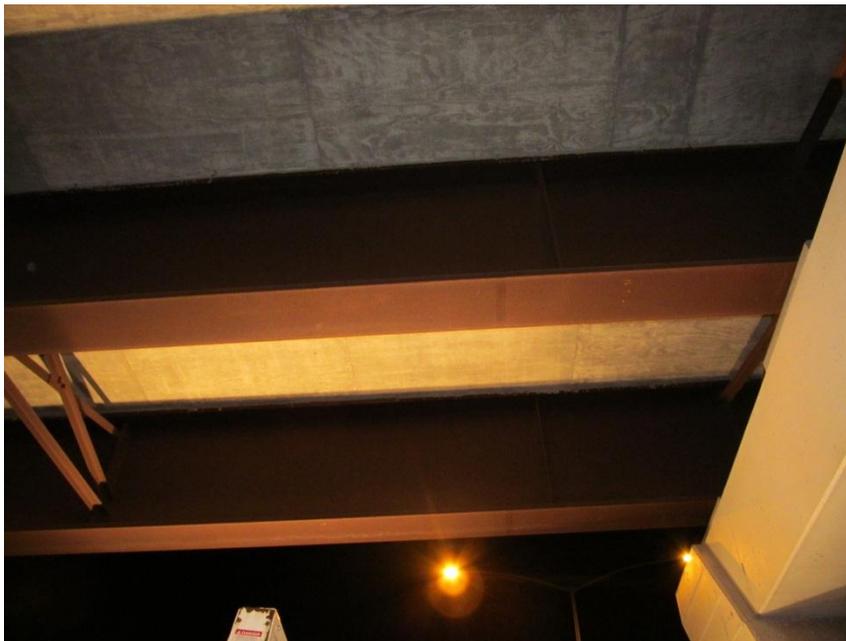
*Figure 2. Girders and cross-frames near the intermediate pier.*

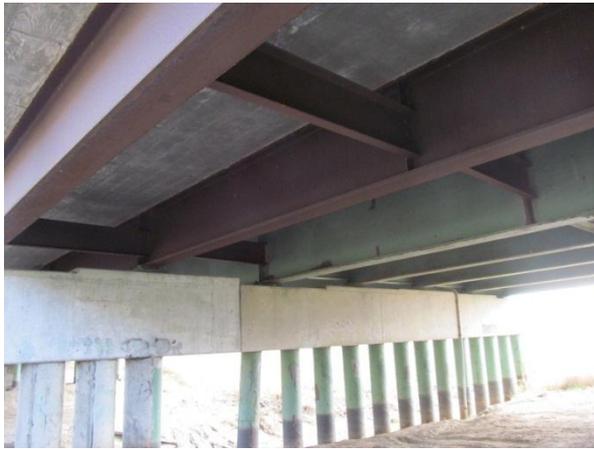
*Figure 1. West pier showing framing arrangement and tie-in to original structure.*

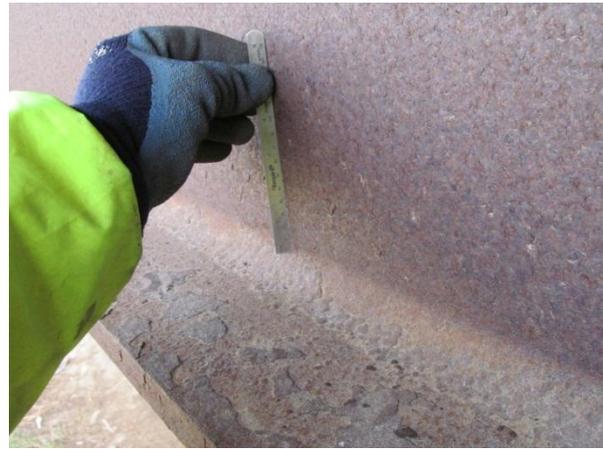
- Interior patina surfaces are in excellent condition with Index = 3.5 to 4. Little to no salt exposure and low moisture; Indian Creek is small and though the bridge is low, does not likely contribute much moisture.
- North fascia exposed surfaces likely see extensive direct snow/salt spray from westbound I-80 bridge given proximity. Lots of delamination and flaking on exposed web and top and bottom of fascia bottom flange. Average Index = 2 on these surfaces. Similar to conditions on I-235 entrance ramp structure at 2nd Avenue (7708.5A235).

*Figure 2. Heavy delamination of fascia bottom flange top (without poutlice); also flaky on web.*

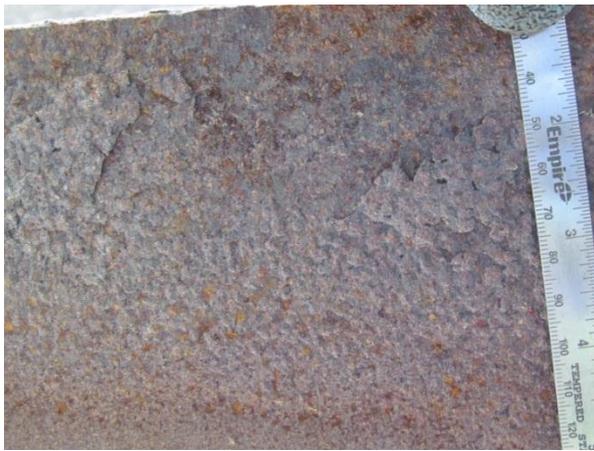
*Figure 3. Close up of delaminations and discoloration of bottom of fascia girder bottom flange.*

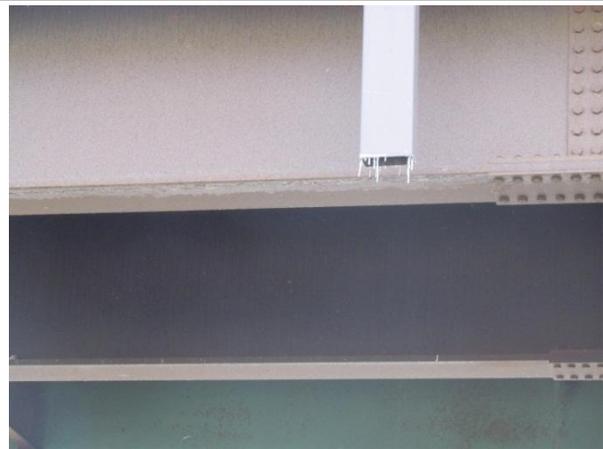
*Figure 6. Fascia problems continue over main span.*

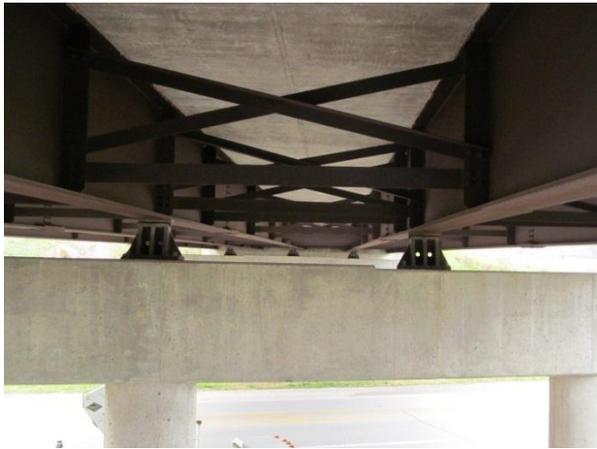
Figure 1. View of south pier looking north; note lack of drainage deflector plates on bottom flanges, typ.

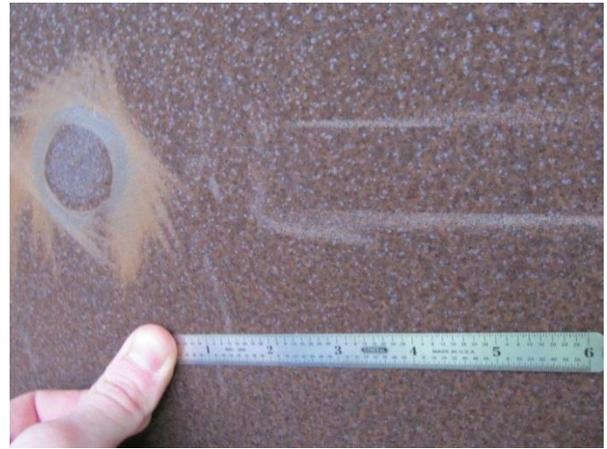
Figure 2. Exterior of east fascia web near south abutment. Index = 4 by tape, chlorides = 0 ppm.

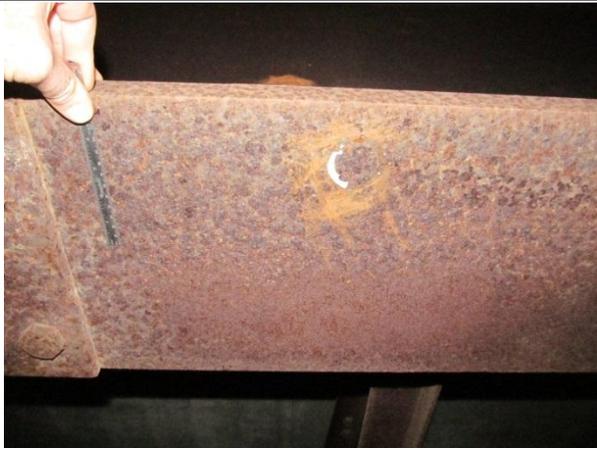
Figure 3. Heavy flaking (Index = 2) on bottom of west fascia bottom flange over shoulder.

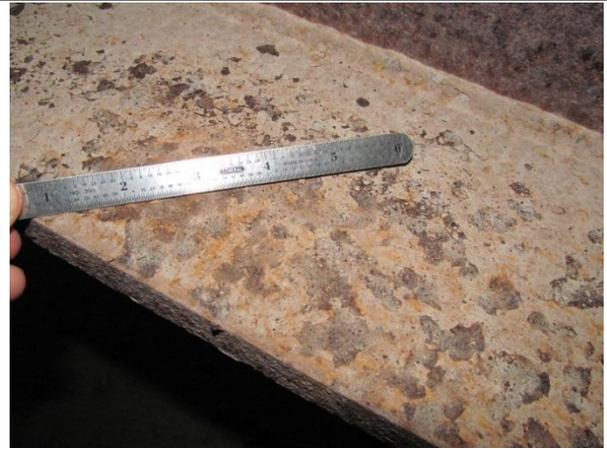
Figure 4. Delamination of interior girder bottom flange with heavy poultice subjected to light scraping.

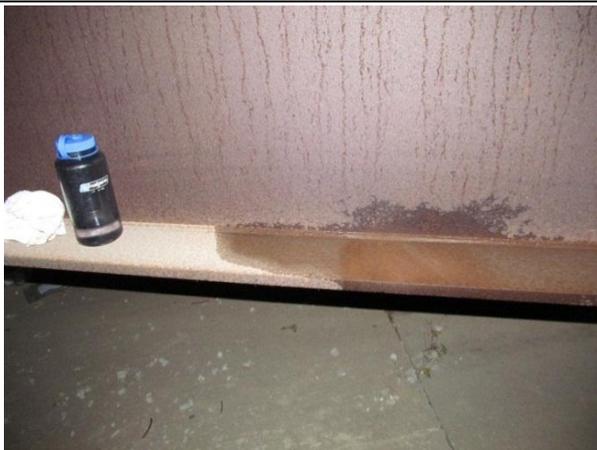
Figure 5. Poultice on east fascia interior side (not flaky). Washed with water and blotted dry.

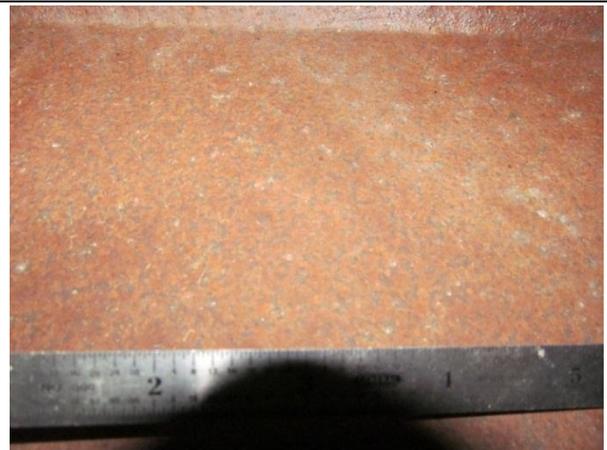
Figure 6. Washed area of top of flange patina after fully dried; adherent, well-behaved beneath chalking.

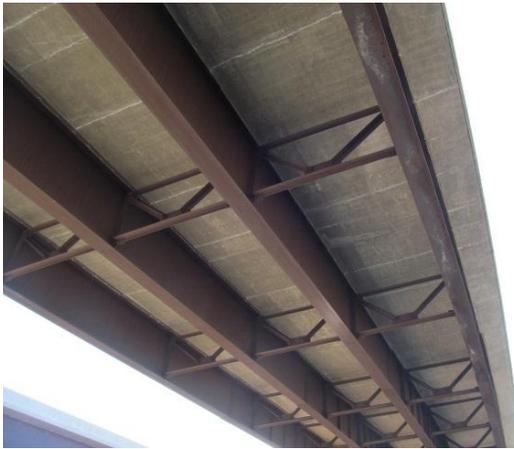
- Typically, the patina condition index rating for these bridges ranges from 4 on the middle and upper portions of the girders and frames to 3 on the bottom flanges and bases of the webs.
- The west fascia girder of each bridge has heavy salt staining on the underside of the bottom flange and larger rust flakes (i.e. Index = 2). Chalking on tops of bottom flanges is slight to moderate.
- Bridge decks have numerous transverse cracks, particularly in the middle spans. Evidence of salt contaminated water leaking onto steel below cracks, with localized delamination/flaking of the top flange beneath the crack (possibly Index = 1 locally). The patina of the lower elements beneath each crack is typically reduced by at least 0.5 index points compared to adjacent surfaces away from the cracks. Sealing the deck cracks will address the root cause of the localized areas of poor patina performance.

Figure 1. Typical middle bay of southbound bridge; note regular cracking with efflorescence and heavy salt staining on west fascia girder bottom flange.

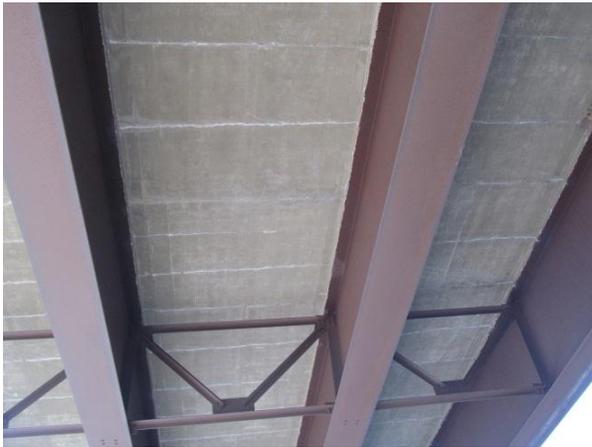
Figure 3. Other girders of southbound bridge show little change in patina condition beneath cracks.

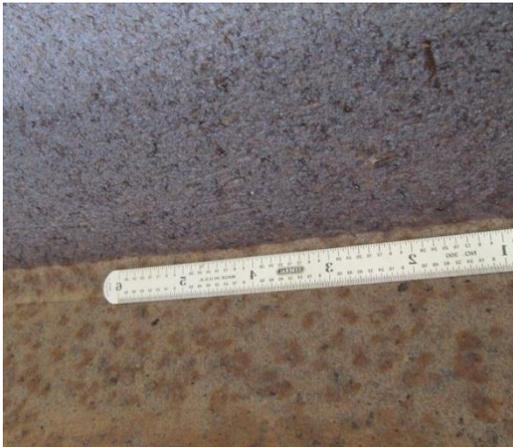
*Figure 3. Interior surfaces near east abutment with less deterioration than areas over traffic.*

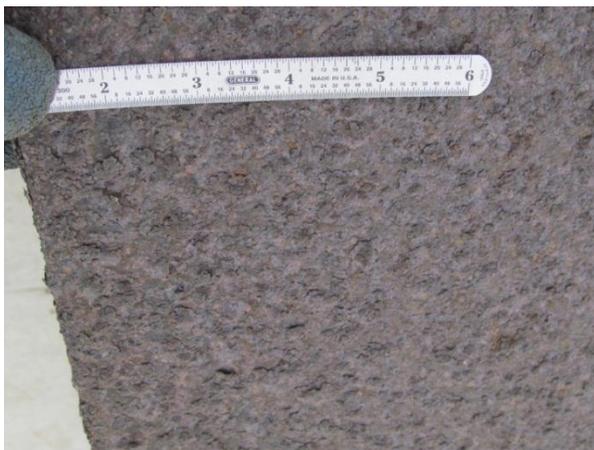
*Figure 5. Heavy flaking of bottom of flange in traffic span, typically Index = 2 or worse.*

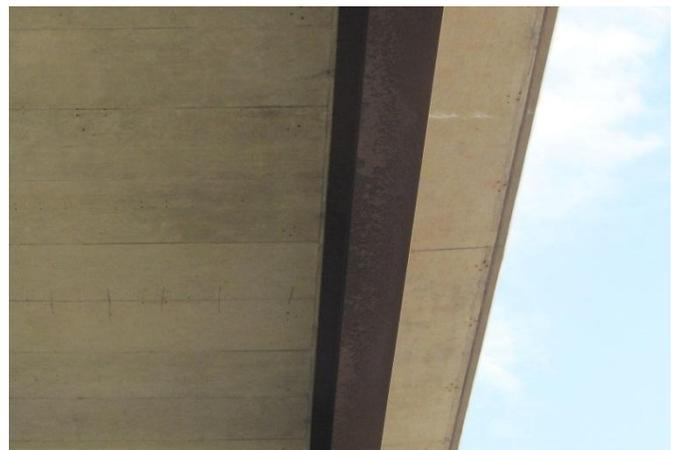
*Figure 6. Flaking and delamination of bottom of flange on interior half of fascia girder over southbound lanes.*

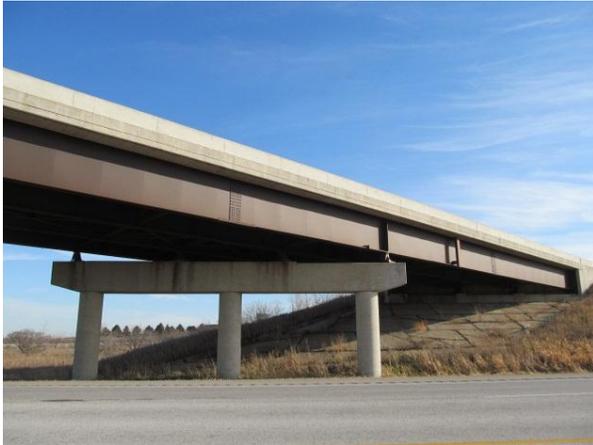
Figure 1. Overall appearance of north end of bridge showing high skew.

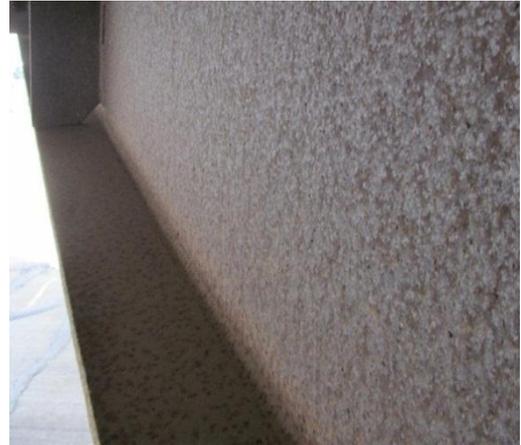
Figure 2. Typical interior web and top of bottom flange near south abutment; poutlice not flaking. Index for both surfaces is 3.

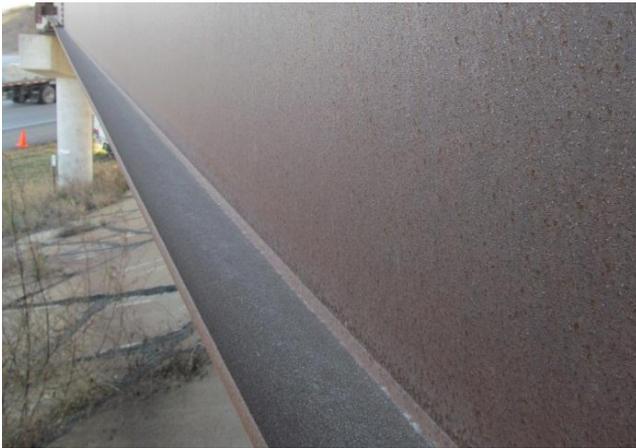
Figure 3. West fascia girder exterior; Index = 3.5 after over 40 years of service.

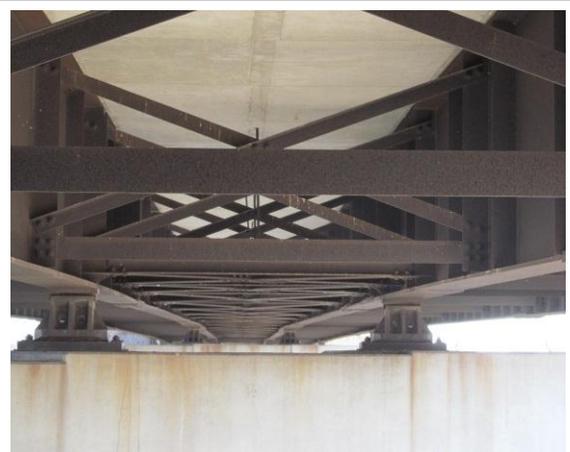
Figure 6. Center bay viewed over top of south pier; note lack of deflector plates and concrete staining.

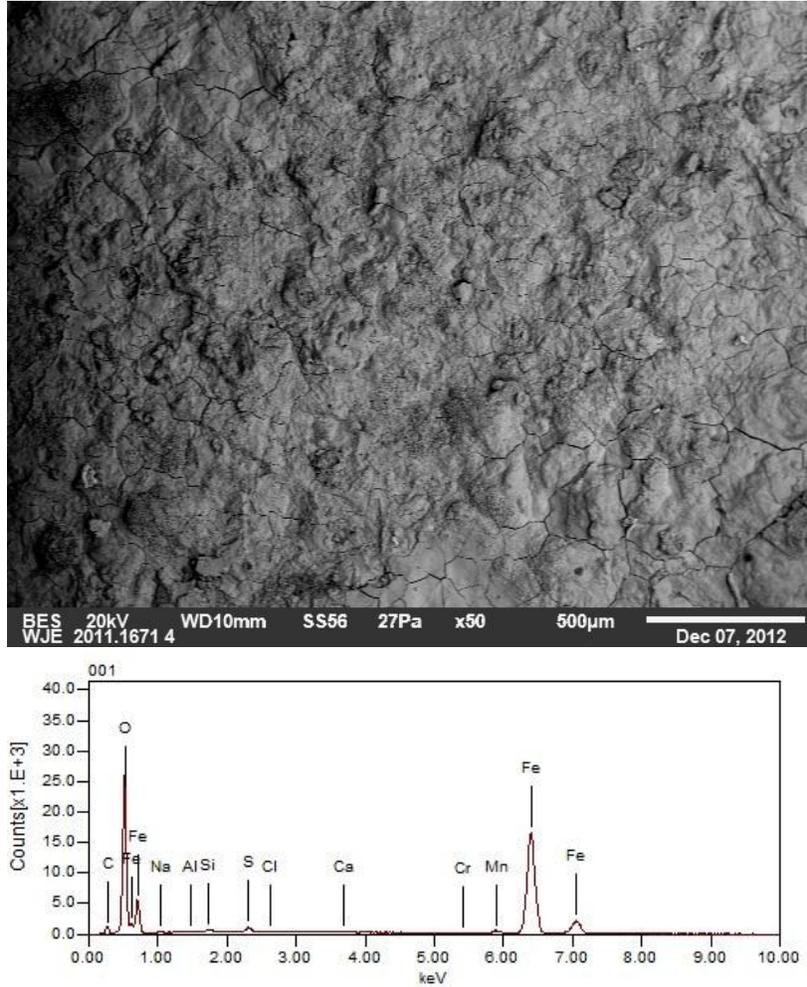
For all three samples examined, iron and oxygen were the primary elements present in the corrosion product. Sulfur was typically present in low quantities. Chlorine was present in some areas, but was not present in all areas examined. The low peak intensity of the chlorine indicates that the chlorine is present in low quantities. With the SEM, EDS data can be collected over a relatively large area (square millimeters), or the probe can be focused on a small area. Even when focused on a small area, the chlorine and sulfur contents remained low, indicating that these elements, and the compounds in which they are contained, are not concentrated in certain areas of the corrosion product.

*Figure E-1. BE micrograph and area EDS spectrum of the surface of Sample FS4.*

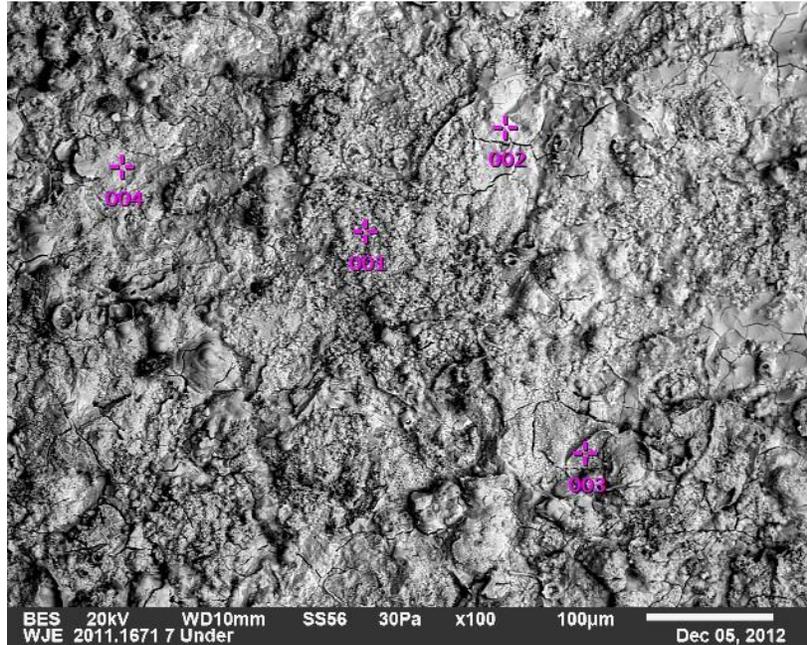
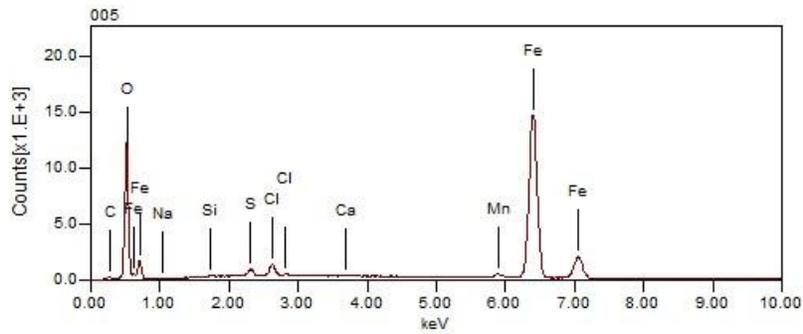
Figure E-2. BE micrograph and point EDS spectrum from the surface of Sample FS7-Over. The EDS spectrum presented is from point 005, and represents the general composition of the area imaged.

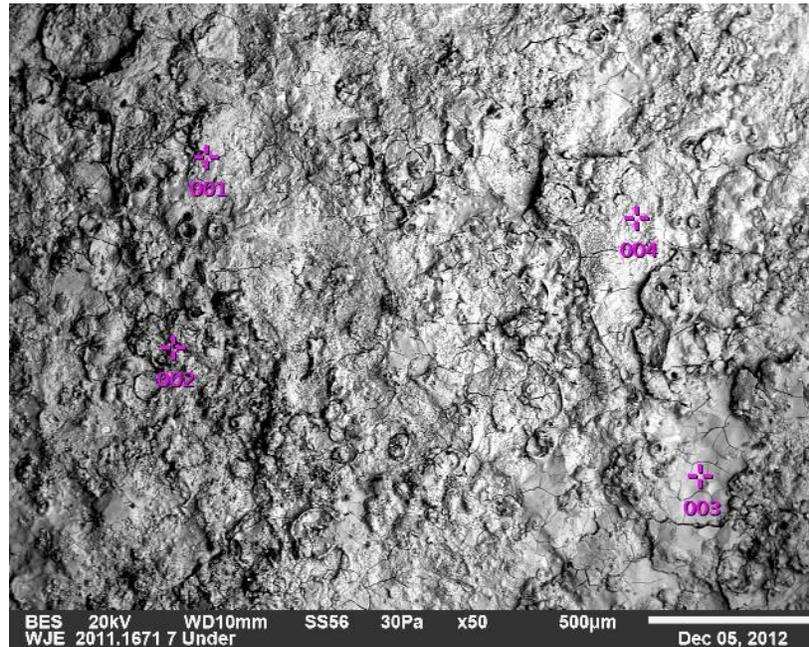
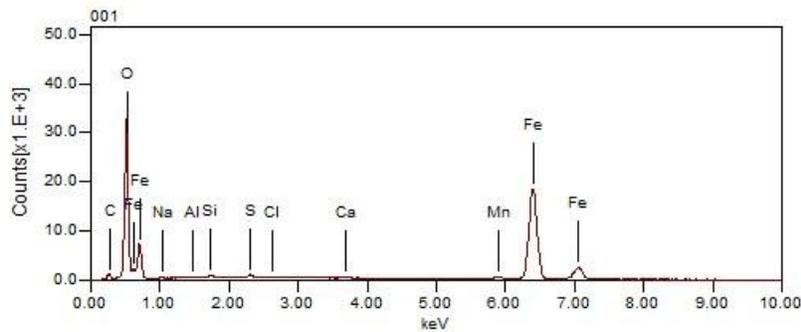
Figure E-3. BE micrograph and point EDS spectrum from the surface of Sample FS7-Under. The EDS spectrum presented is from point 001, and represents the general composition of the area imaged.

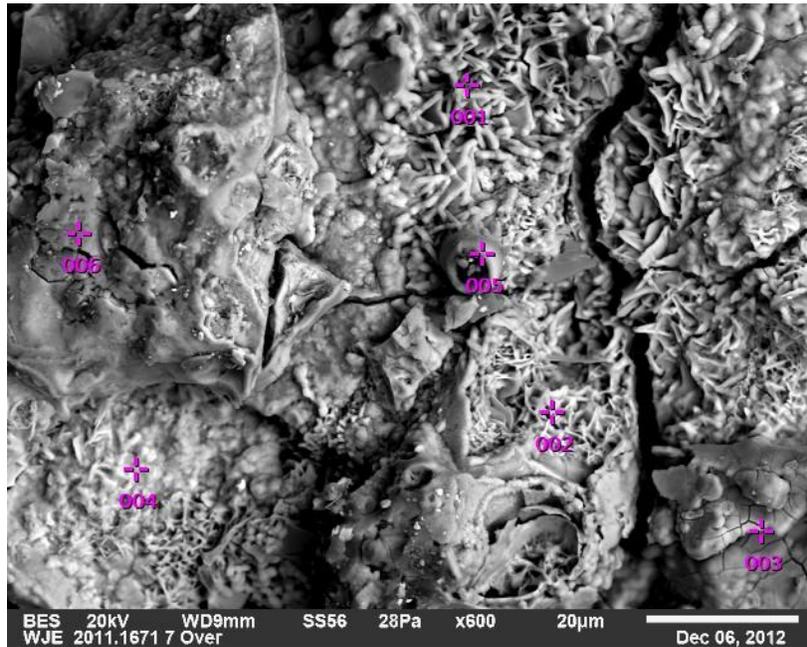
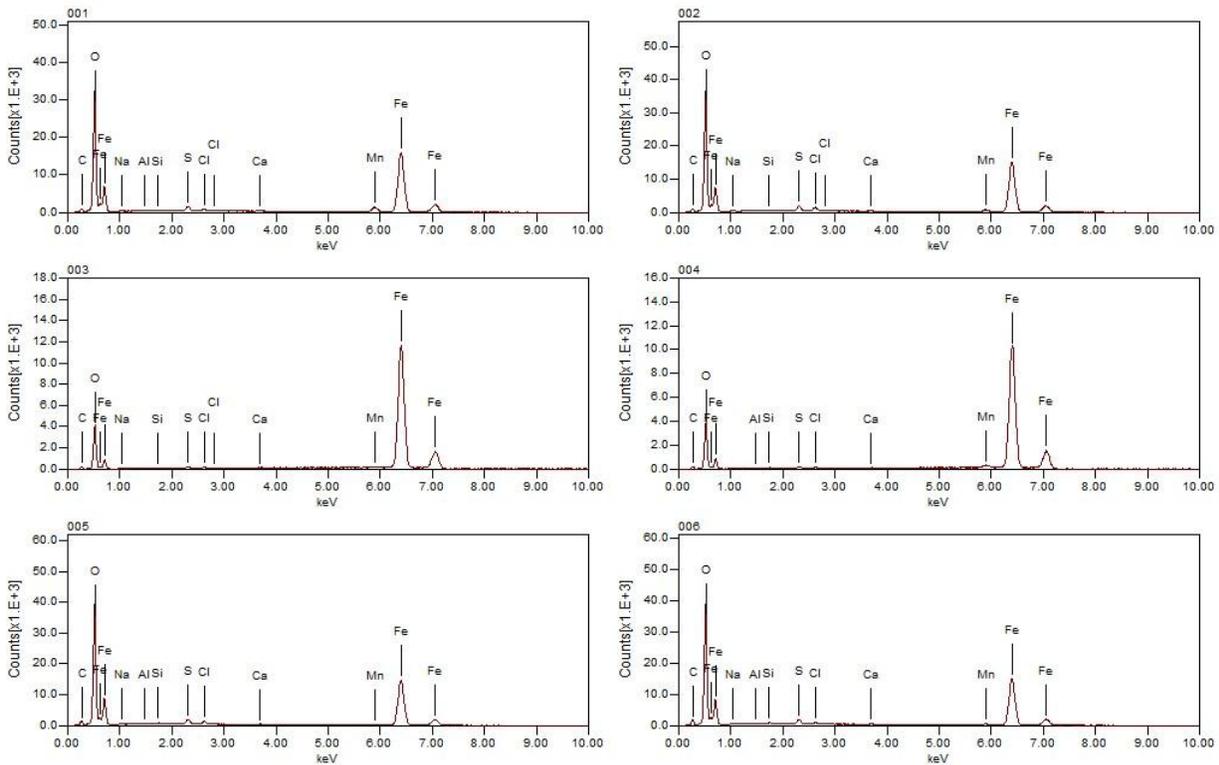
Figure E-4. BE micrograph and point EDS spectra from the surface of Sample FS7-Over. Each EDS spectrum corresponds to a point indicated on the micrograph. The number in the upper left corner of the EDS spectrum correlates to the number on the micrograph.

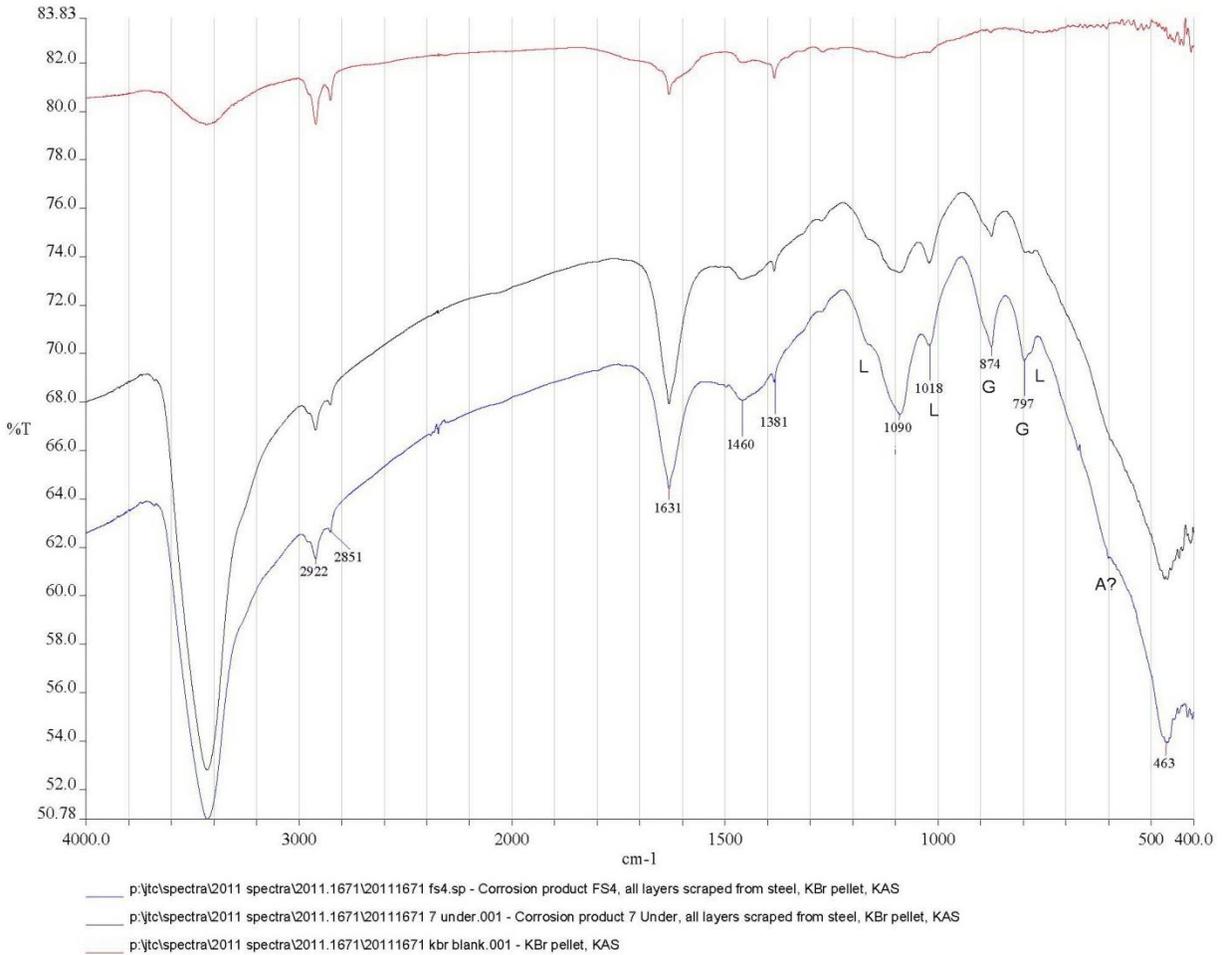
*Figure E-5. FTIR spectra of Sample FS4 (bottom line), Sample FS 7-Under (middle line) and a blank (top line). Peaks correlating to goethite are marked with a “G,” peaks correlating to lepidocrocite are marked with an “L,” and a peak tentatively identified as correlating with akagenite is marked with an “A?”*
